JAEA-Review
2009-055

Investigation on Integrity of JMTR Concrete Structures, Cooling System and Utility Facilities

Hiroyuki EBISAWA, Kenji TOBITA, Akitomi FUKASAKU and Masanori KAMINAGA

Department of JMTR Operation
Neutron Irradiation and Testing Reactor Center
Oarai Research and Development Center

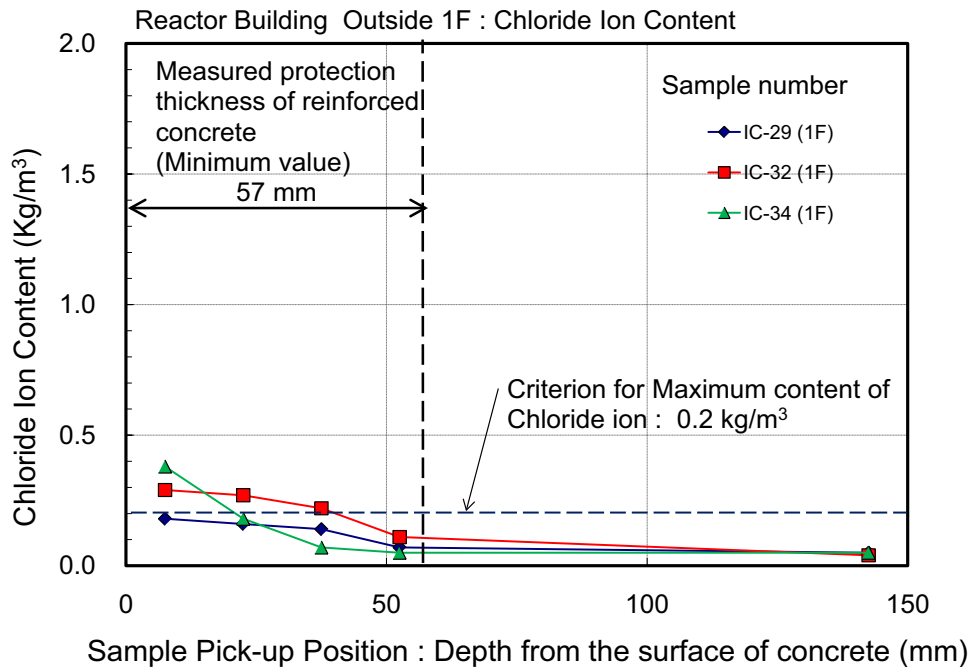
Fig. 2.1 Chloride ion content as a function of depth

Fig. 2.1 shows a chloride ion content measurement result as a function of depth. The chloride ion content in concrete was kept below 0.2 kg/m³ which is the criterion value of JASS 5N³⁾, at the position of the reinforced bar, even that of near the surface was greater than 0.2kg/m³. Chloride ion content near the surface has been increased by accumulating the coming flying salinity.

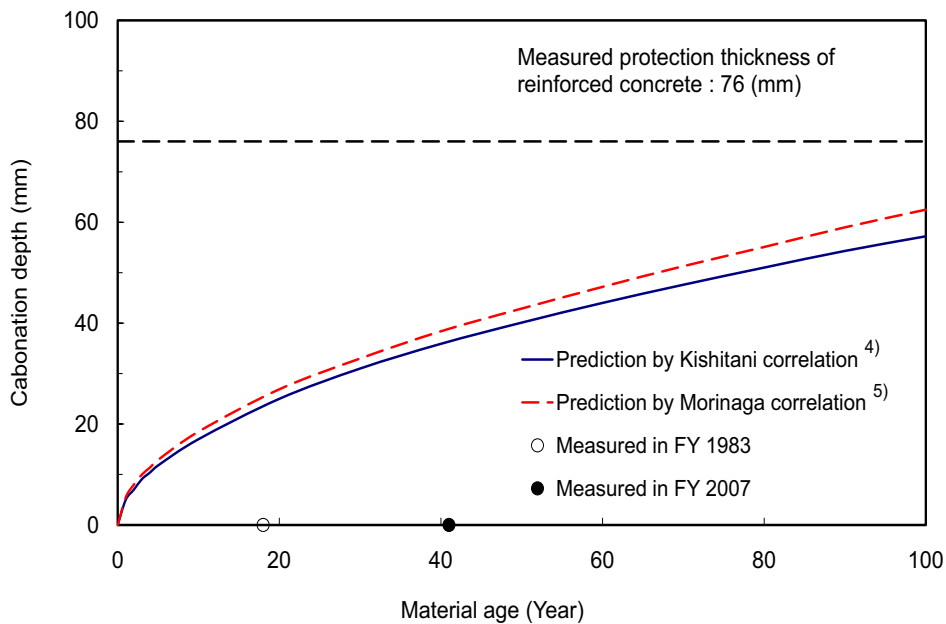
Fig. 2.2 Carbonation depth of inner wall

Fig. 2.2 shows carbonation depth of inner wall and Fig. 2.3 shows carbonation depth of outer wall. Carbonation of the inner wall didn’t become significant because of protection effect by wall paint. On the other hand, carbonation of the outer wall became significant gradually, but the maximum carbonation depth of 23mm was small enough against measured protection thickness of reinforced concrete (57 mm). Therefore, the concrete structure of the JMTR reactor building will keep its integrity more than 60 years according to the prediction by Kishitani correlation as shown in Fig. 2.3.

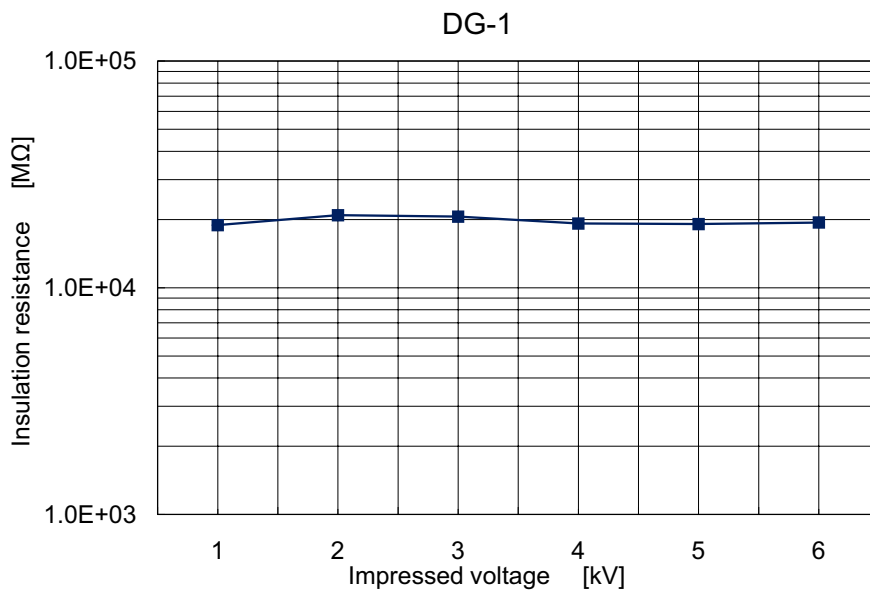
Fig. 4.1 Insulation resistance for DG-1

There was no surface leakage of current was measured as shown in Figs. 4.1 and 4.2. There is no deterioration of insulation resistance caused by moisture uptake.

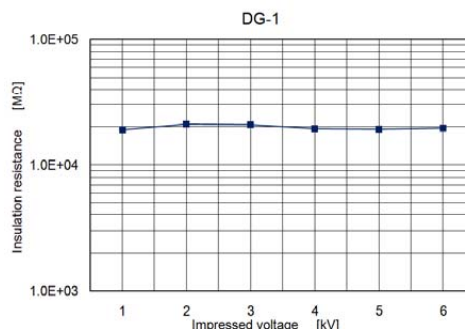
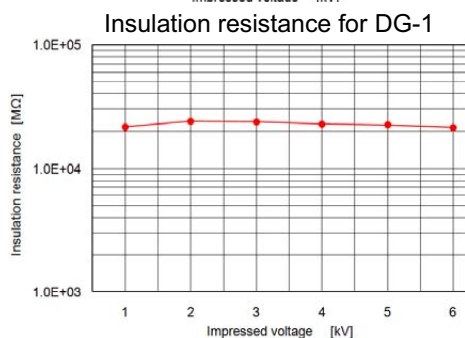
Insulation resistance for DG-2 11

There was no surface leakage of current was measured(see figures). There is no deterioration of insulation resistance caused by moisture uptake.

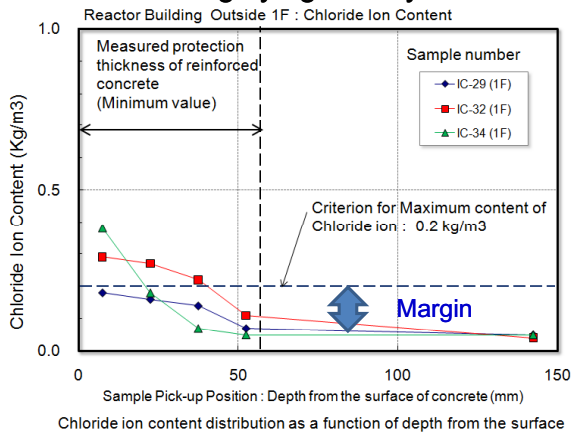
Chloride ion content in concrete was kept below 0.2 kg/m^3 which is the criterion value of JASS 5N*, at the position of the reinforced bar, even that of near the surface was greater than 0.2 kg/m^3 . Chloride ion content near the surface has been increased by accumulating the coming flying salinity.

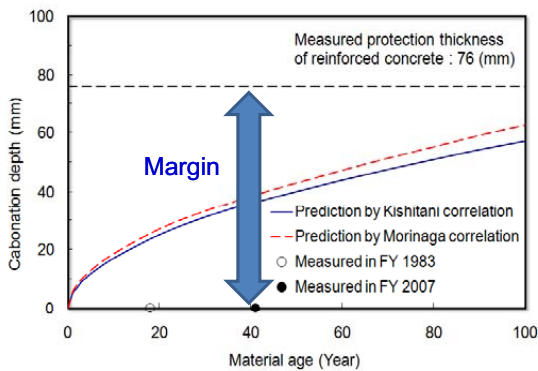
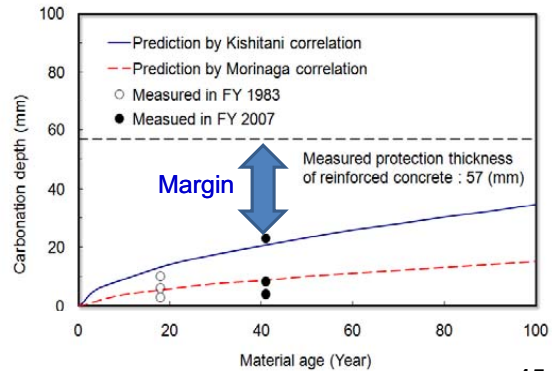
Carbonation of **the inner wall** didn't become worth because of protection effect by wall paint. On the other hand, carbonation of the outer wall became worth gradually, but the maximum carbonation depth of **23mm** was small enough against measured protection thickness of reinforced concrete (**57 mm**).

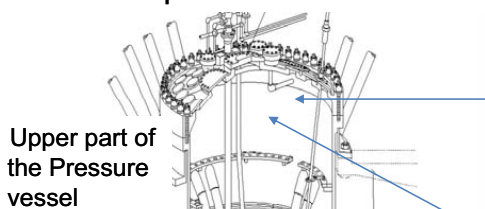
Upper part of the Pressure vessel

- ❑ As a result of the visual observation, the harmful wound was not confirmed. Moreover, there was no loosening of the bolts and the screws. Negligible rust was observed near the upper part of the reactor pressure vessel.

- ❑ It is thought that the rust observed near the upper part of the reactor pressure vessel comes from the adhering iron etc. Because the upper part of the reactor pressure vessel will be exposed to the air during the reactor shut-down period in order to carry out necessary work for irradiation samples.

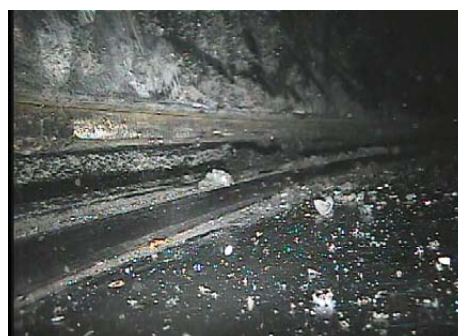
Surface of the diaphragm seal

As a result of the visual observation, the harmful wound and rusts was not confirmed.

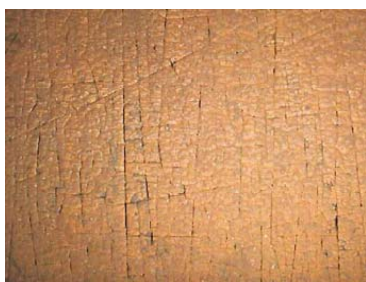
- ❑ As a result of the visual observation, the lining of the secondary cooling system pipes had swelling and cracks overall and the aged deterioration of the lining progressed.
 - ➔ Repair of the lining has been carried out.
- ❑ There was no corrosion or thinning of the pipes.

Remarkable cracks

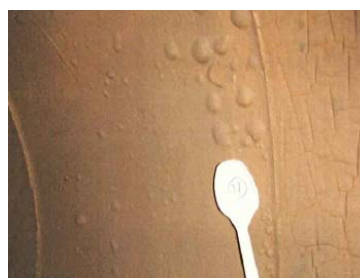
Swelling of lining

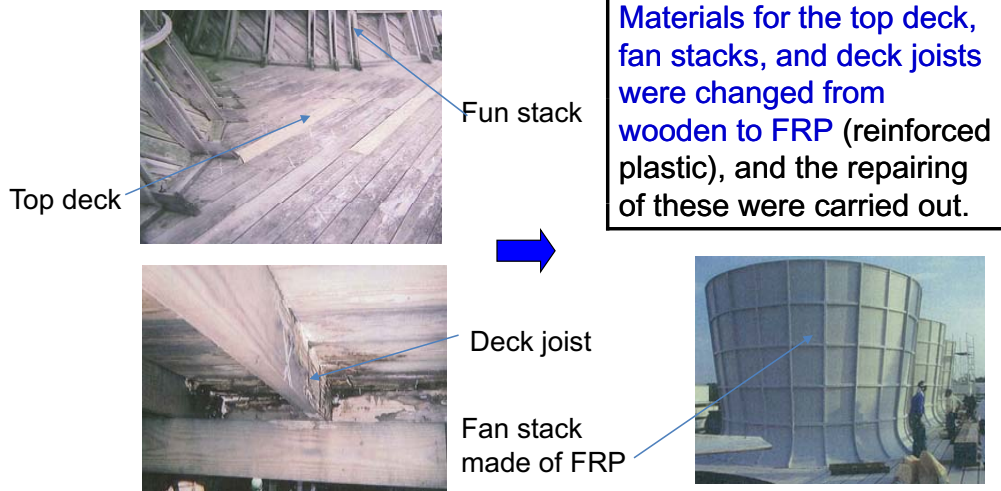
- As a result of the visual observation, partial internal decay and cracks caused by dryness were confirmed at the top deck, fan stacks, and deck joists, etc. It was confirmed that there were no remarkable corrosion or rust of bolts.
