## JCO Criticality Accident Termination Operation

Masashi KANAMORI

Nuclear Emergency Assistance and Training Center

July 2010

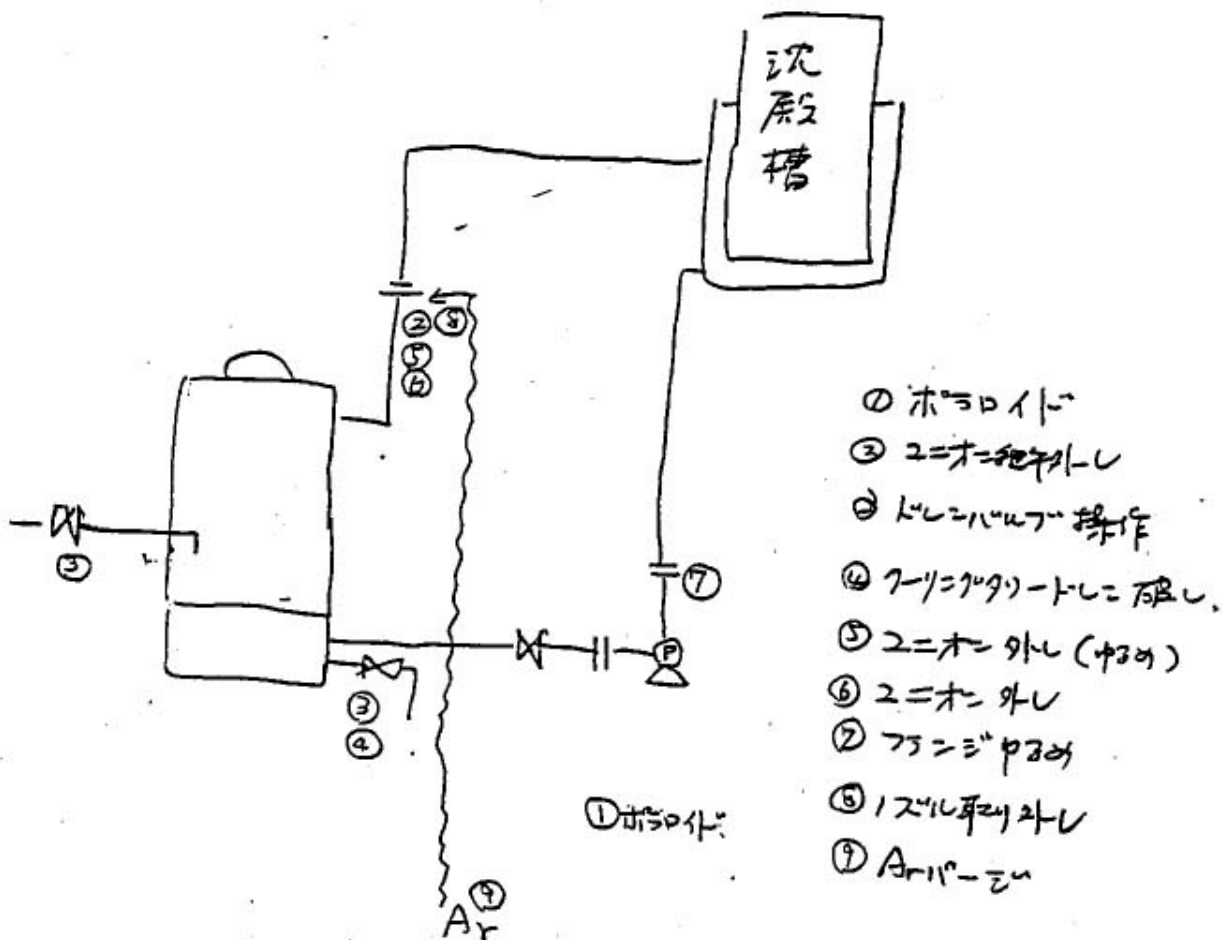
Fig.11 Precipitation tank system diagram

However, when drawings and cooling system drawings were reviewed later, it was found that there were cooling water tanks on the top side in the entire cooling system, and equipment for other systems was installed below that. The sedimentation tank was further below that, and the cooling tower was located on the outside of the Conversion Test Building. Therefore, it was thought that a significant amount of cooling water remained.

In the beginning, it was envisioned that, because the discharge side pipe would be cut and purging would be done from there, cooling water would drain as is into the cooling tower. But it was found that the pump was operating and that there was a union on the near side of the cooling tank, and thus we changed to the method of purging from there. There was a possibility that, when that was done, water would not drain because the pump was blocking it, and thus it was decided to drain by loosening flanges.

The pump was operating and it was decided that the eighth team would loosen flanges in the line to create outlets for water drainage. Four flanges were loosened and it was confirmed that water came out. The water was reported to be lukewarm.

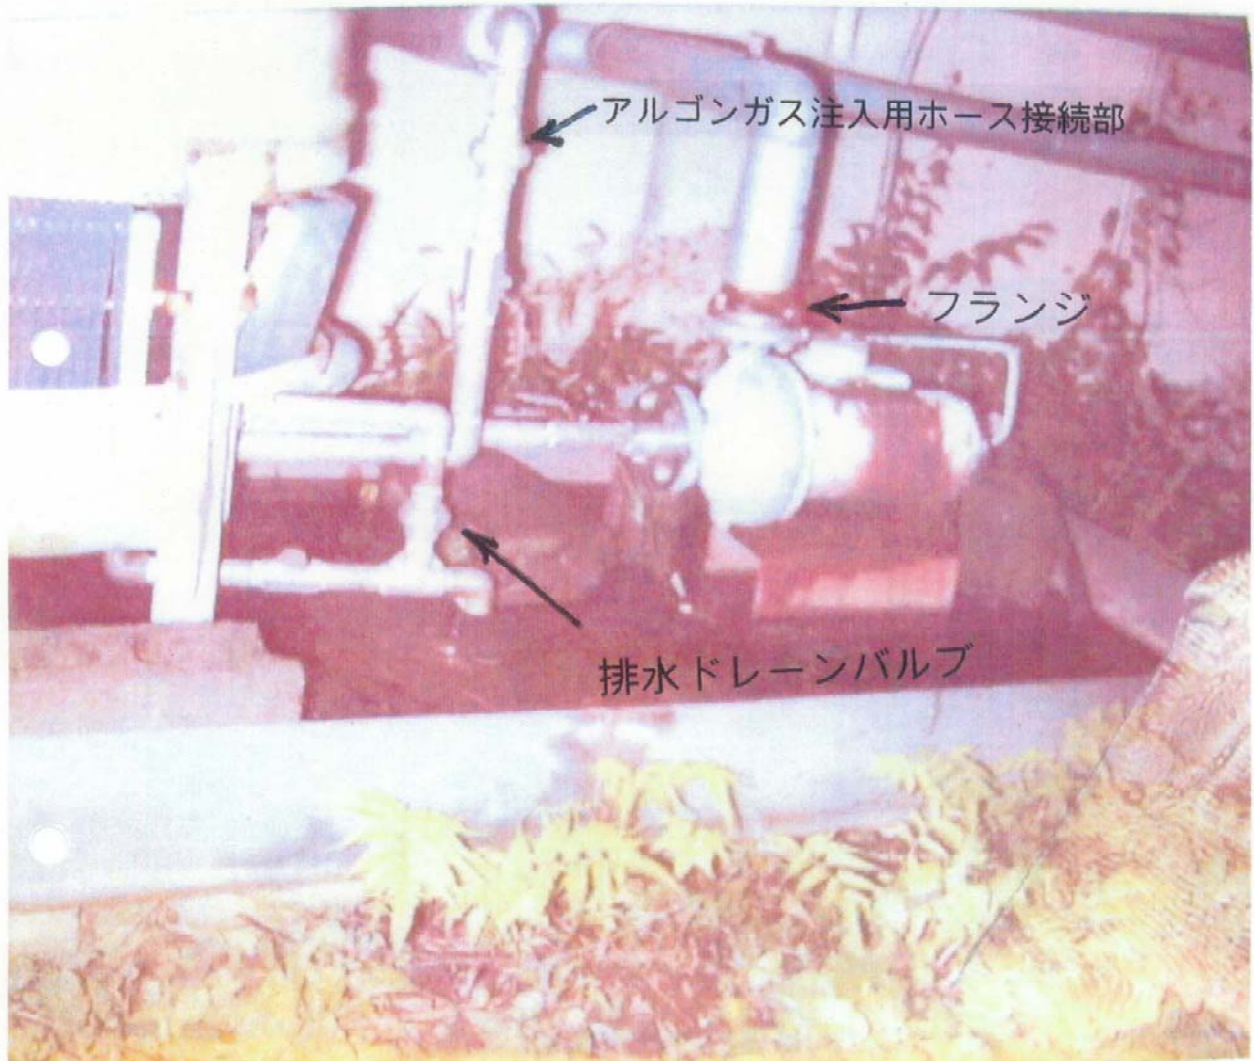
Fig. 12 Polaroid photos

Although the workers of the third team fully opened the drain valve, they reported that water was not draining well, and it was decided to add this work step for the fourth team. From photographs and other information, it was expected that the material of the cooling tower was ordinary PVC, and thus it was determined that the drain pipe at the bottom of the tower could be forcibly broken with a hammer.

However, it was found that water drainage from the drain valve was not very good, only a trickle. Since there was almost no change in the neutron radiation situation, it was decided to break the drain pipe with a hammer.

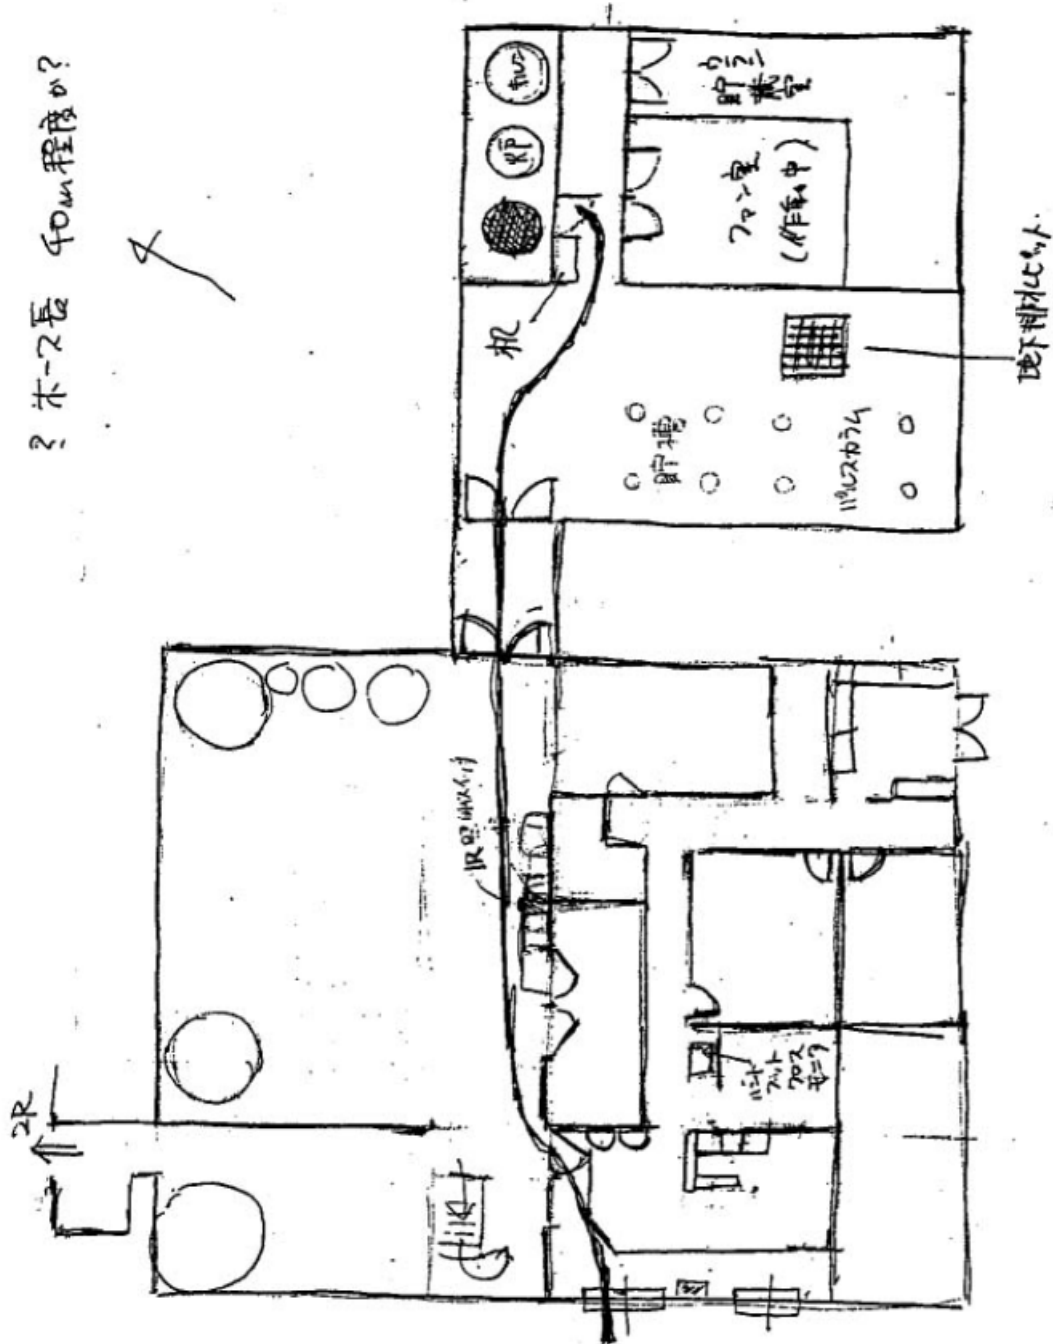
Fig.14 Diagram of infusing route of boric acid solution

Prior to the work, we created a schematic diagram of the Conversion Test Building and the Access Control Building next to it, and investigated the length of the hose. The hand-drawn drawing is shown in Fig. 14. As a result, the length was found to be about 40 m, and we requested Team Leader N of the firefighting team to test the supply of boric acid solution. The test was conducted in front of the Administrative Building. It was found that they could somehow manage to supply the solution, but
