10. Operation and Maintenance

11. Accidents and Failures

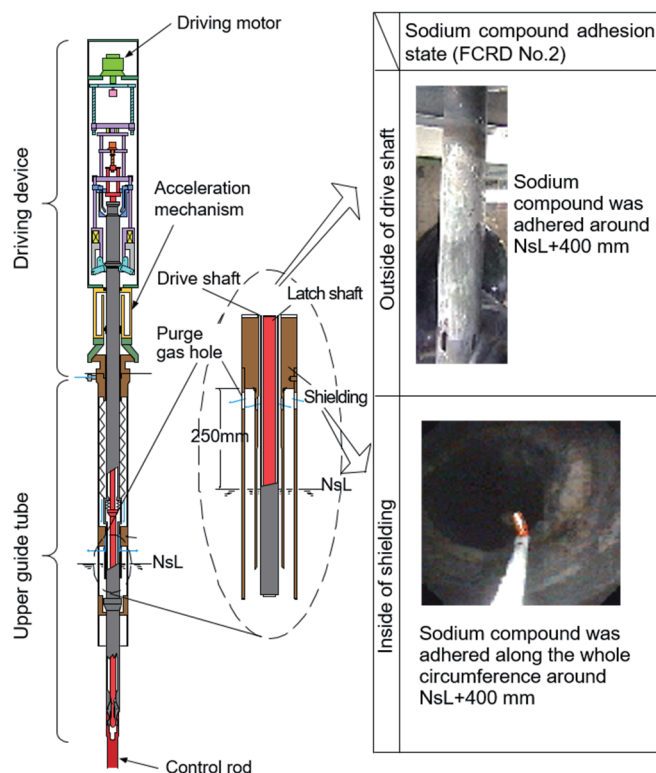
Fig.10-9 Sodium compound adhesion state in FCRD (No.2)

During SKS and SST, an alarm indicating an abnormal load to fine CRDM unit 2 was set off three times. A disassembling investigation revealed that sodium compounds had become stuck in the gap between shield and drive shaft in the upper guide tube (Fig. 10-9). A possible cause of the increased load was thought to be the dirt (a film of impurities floating on the surface of the sodium) left during the initial sodium charge in combination with the configuration in which sodium becomes stagnant. As a countermeasure, flow holes were added to the upper guide tube at the surface wetted by sodium to facilitate sodium flowing. This event might occur not only during the initial sodium charge but also during sodium charge after work involving the opening of a sodium boundary. To reduce these risks, it is important to minimize the mixing of impurities (air) into sodium systems.

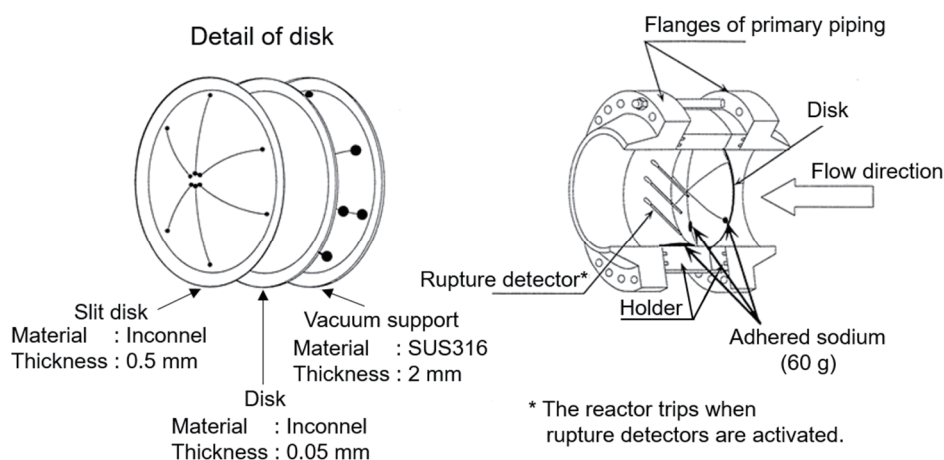
Fig.10-10 Sodium adhesion state around the rupture disk

In March 1998, during planned replacement of the pressure relief plate, a small amount of sodium was found adhered to the secondary side (in nitrogen atmosphere) of superheater pressure relief plate (A) (Fig. 10-10). A possible cause was stress corrosion cracking caused by

melted caustic soda (sodium hydroxide) that was generated by a reaction of sodium with moisture absorbed in the process of manufacturing the pressure relief plate. A test confirmed that stress corrosion cracking would not occur in an environment with a large amount of sodium vapor where caustic soda changes to sodium oxide by reaction with sodium. This event is regarded as a rare case in which caustic

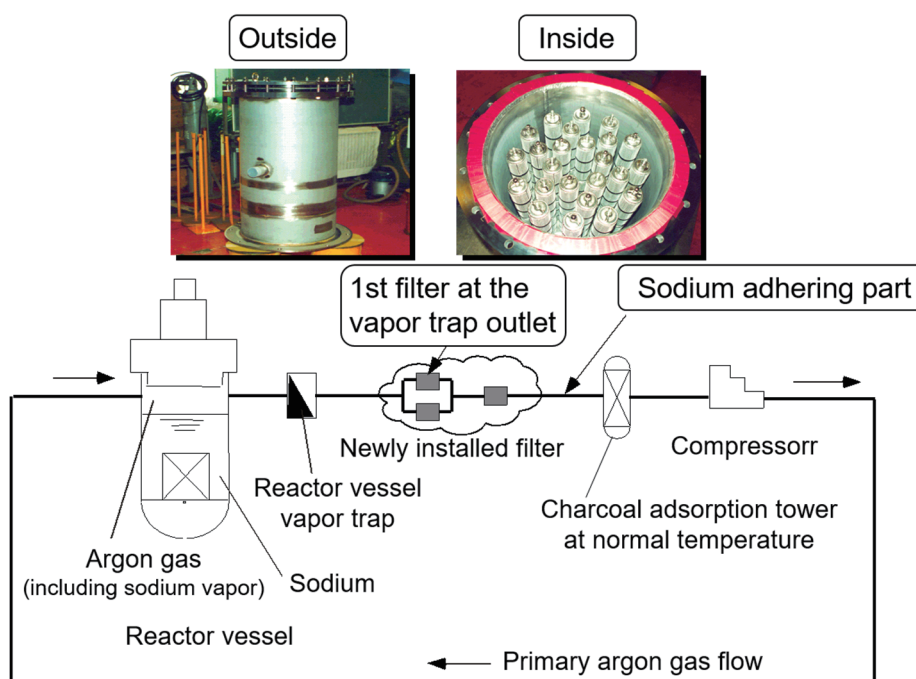
Fig.10-11 Pressure loss increase in primary argon gas system

Since the reactor startup in October 1995, the pressure differential between RV vapor trap outlet and compressor surge tank increased with increased sodium temperatures. The cause was a blockage formed due to the deposition of sodium vapor to the valves downstream from the vapor trap (Fig. 10-11). As

countermeasures, two sintered filter lines and one HEPA filter line were added to the vapor trap outlet. The effectiveness of the countermeasure was not confirmed because the plant has not been restarted.

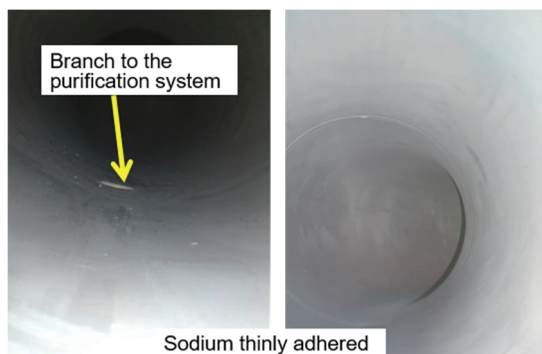
Photo10-5 Sodium adhesion state

Photo 10-5 shows a view of sodium adhering to the SHTS pipe wall.

posited to piping of the three loops was estimated to be 82 kg. The estimated amount of sodium deposited to loop C piping was larger than that to the other loop piping. The cause is likely a shorter preheating time after sodium draining because the preheater was turned off immediately after draining.

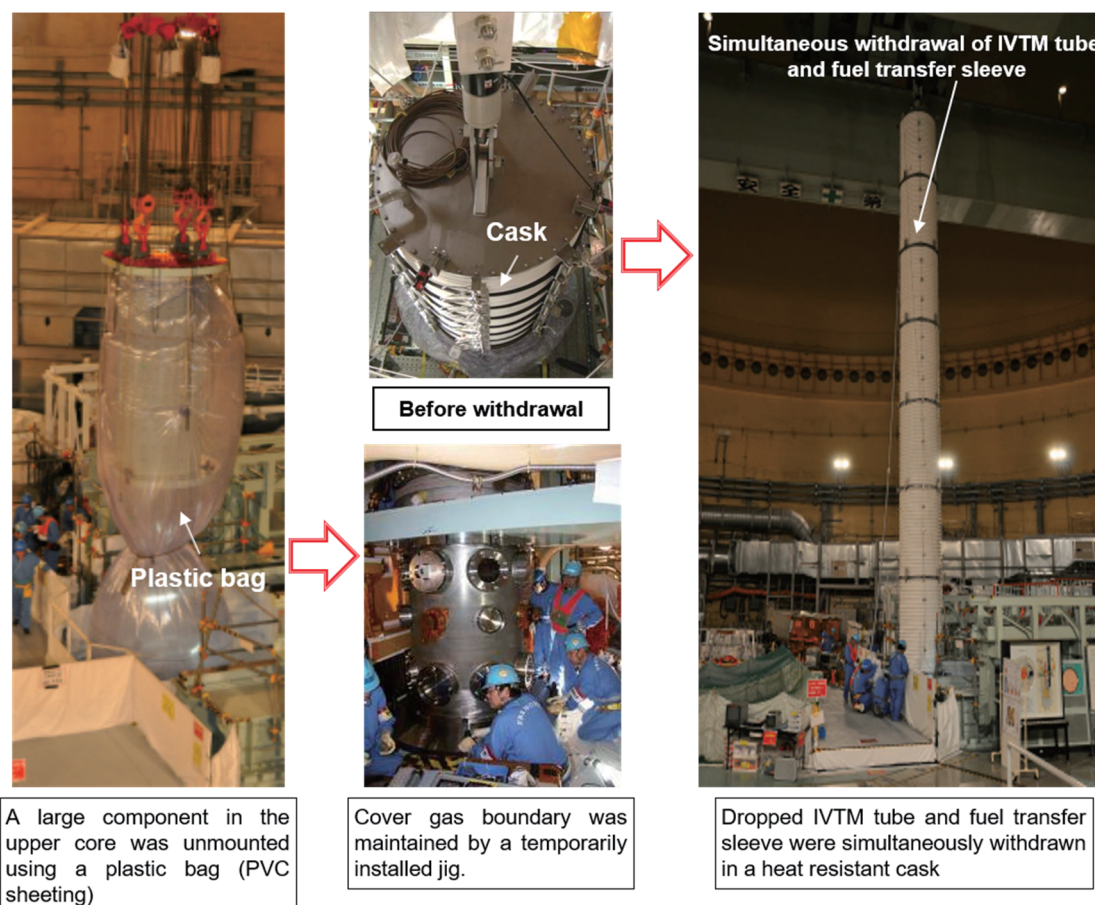
Photo10-6 Recovery work of dropped IVTM

This work is characterized by the fact that a large sodium component is handled in an activated environment, though the actual radiation dose is extremely low. Photo 10-6 shows the procedure of the work to withdraw the failed IVTM. The achievements obtained through this work are:

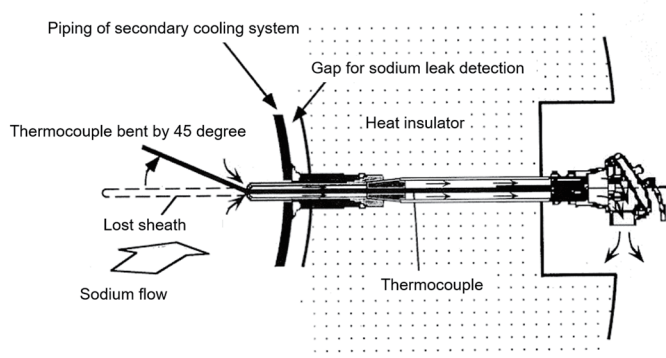
Fig.11-4 Breakage of the thermocouple and sodium leak path

The cause of the thermocouple sheath failure was investigated by various tests and analyses. It was clarified that the narrow part of the thermocouple sheath of a stepped structure was oscillated by the hydrodynamic force of the symmetric vortices generated in flowing sodium. The resultant high-cycle fatigue concentrated at the stepped part of the sheath caused the breakage of sheath. The result of the numerical simulation of a coupled structural and hydrodynamic analysis is shown in Fig. 11-6. It

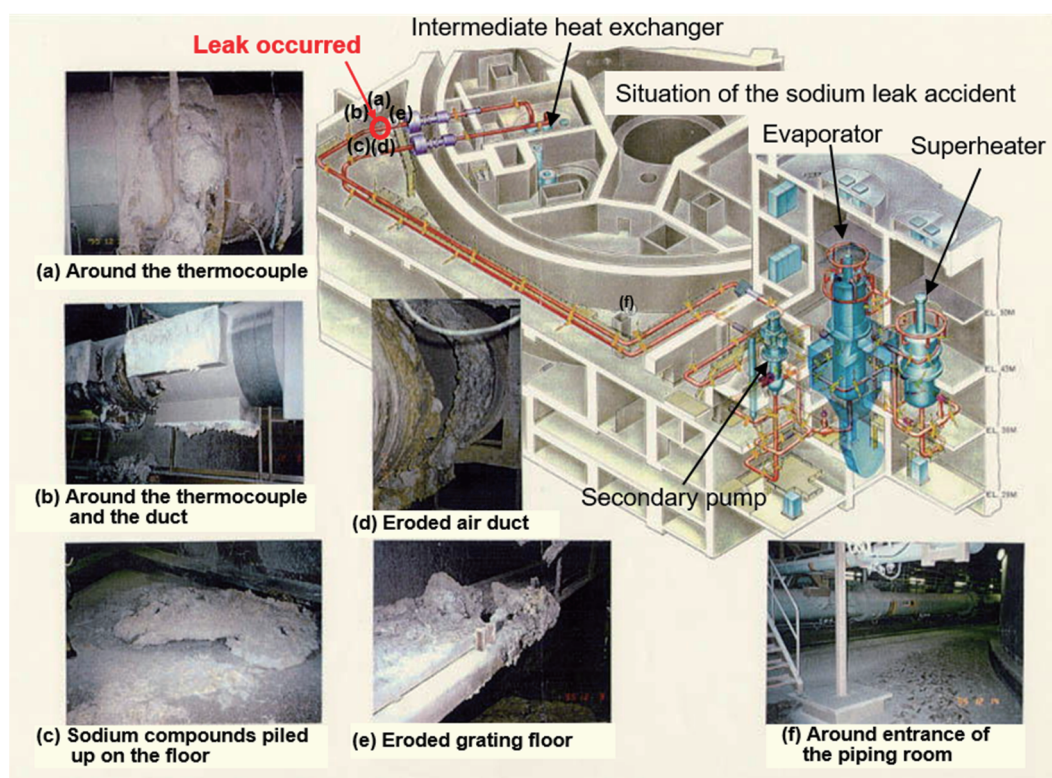
Fig.11-5 Scene of the Secondary Sodium Leak Accident

As shown in Fig. 11-5, holes were formed on the air duct and grating floor located under the leaked piping area, and the leaked sodium was piled up on the floor in an oval shape with a diameter of about 3 m and a volume of about 1 m³. In addition, the sodium compound (sodium aerosol) generated during the burning of sodium in air diffused to the other rooms of SHTS loop C and outside through the HVAC system.

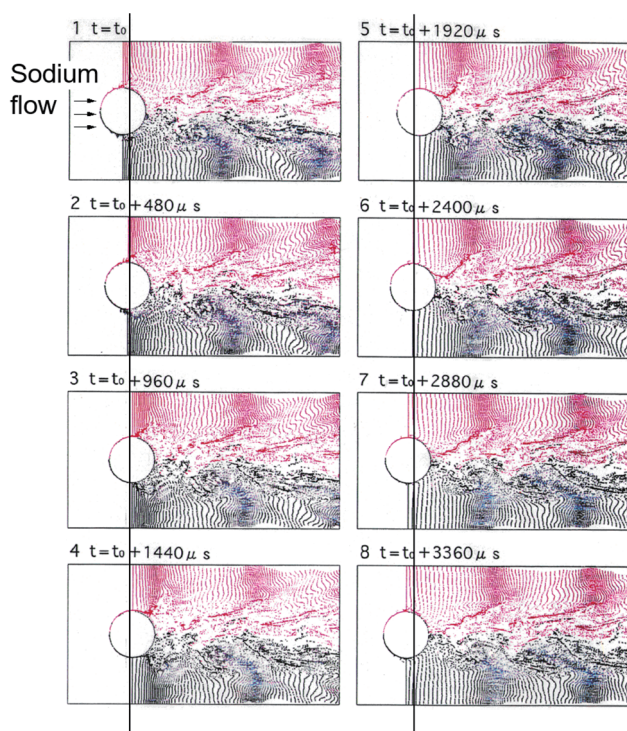
Fig.11-6 Symmetrical vortex generated at the back side of the Tc well

Note) Solid line shows the neutral position of the well.
The 8 figures represent one cycle of vibration.

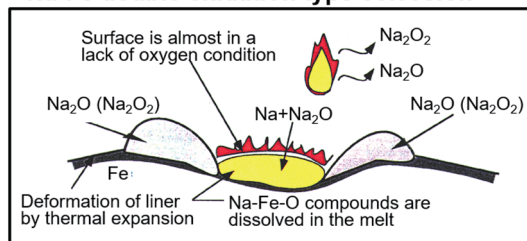
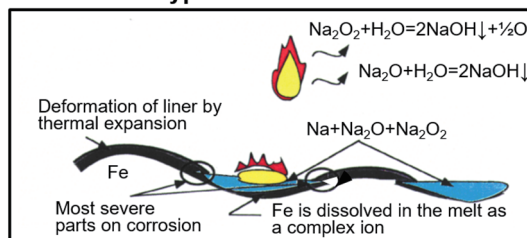
Fig.11-7 Corrosion mechanism of floor liner by leaked sodium

a mechanism in which complex oxides are produced by the reaction between sodium oxide and iron. This corrosion actually occurred on the floor liner during the Secondary Sodium Leak Accident. On the other hand, the molten salt type corrosion, which occurred in the reproduction experiments, is induced by a mechanism through which peroxide ions melted in sodium hydroxide under the specific condition of the experiments. The corrosion rate of the molten salt type is about five times larger than that of the Na-Fe complex oxidation type.

(Sodium oxide reacts with floor liner (Fe) to make iron compounds. The corrosion progresses when the temperature is higher than 700°C and the iron compounds are dissolved in the melt.)

(Peroxide ions in the sodium hydroxide corrode floor liner as a strong oxidizer. The corrosion progresses rapidly since the corrosion products are dissolved in the melt.)

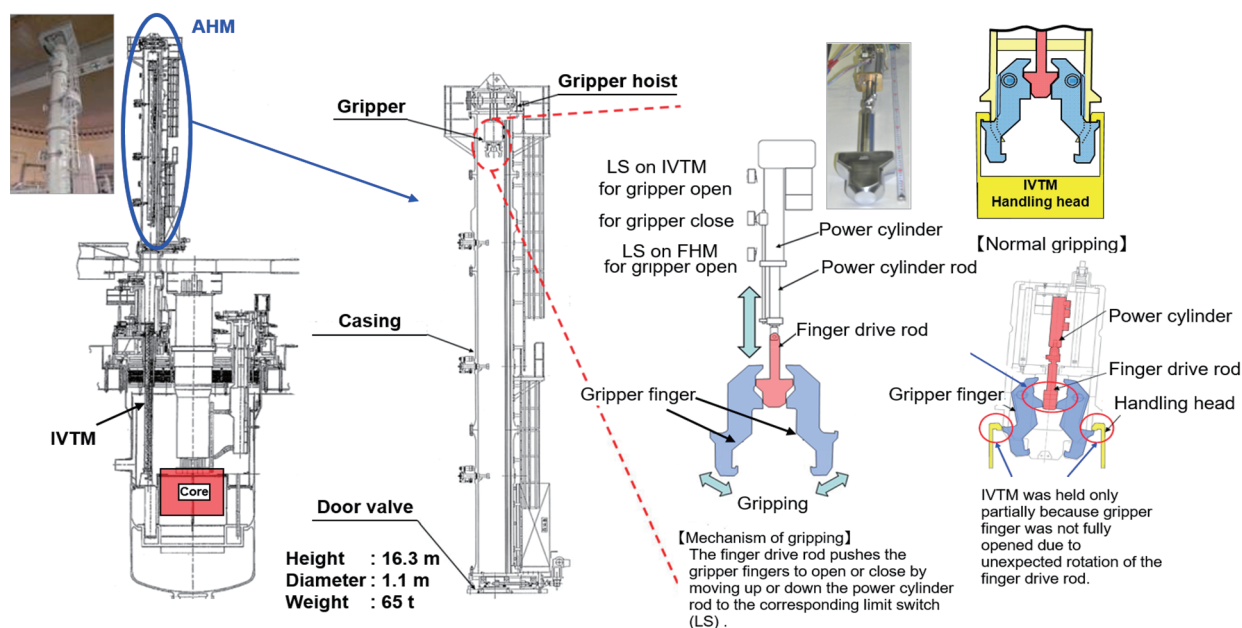
Fig.11-10 In-vessel transfer machine (IVTM) and Auxiliary handling machine (AHM)

The drop was due to the unstable holding of the IVTM with AHM gripper fingers, which were not fully opened to hold the IVTM. The AHM gripper finger drive rod is plane-shaped, and must be carefully designed, manufactured, and maintained in order to prevent rotation. However, the sufficient care to prevent rotation was not taken in replacing the power cylinder of AHM, resulting in the screws gradually becoming loose to induce the finger drive rod to rotate. As a countermeasure, the finger drive rod was changed to one with a welded structure that does not rotate, and the function was enhanced to detect an un-lifted condition.
