JAERI-M

MODIFICATION OF JRR-2

January 1978

Yasuhiko MIYASAKA et al

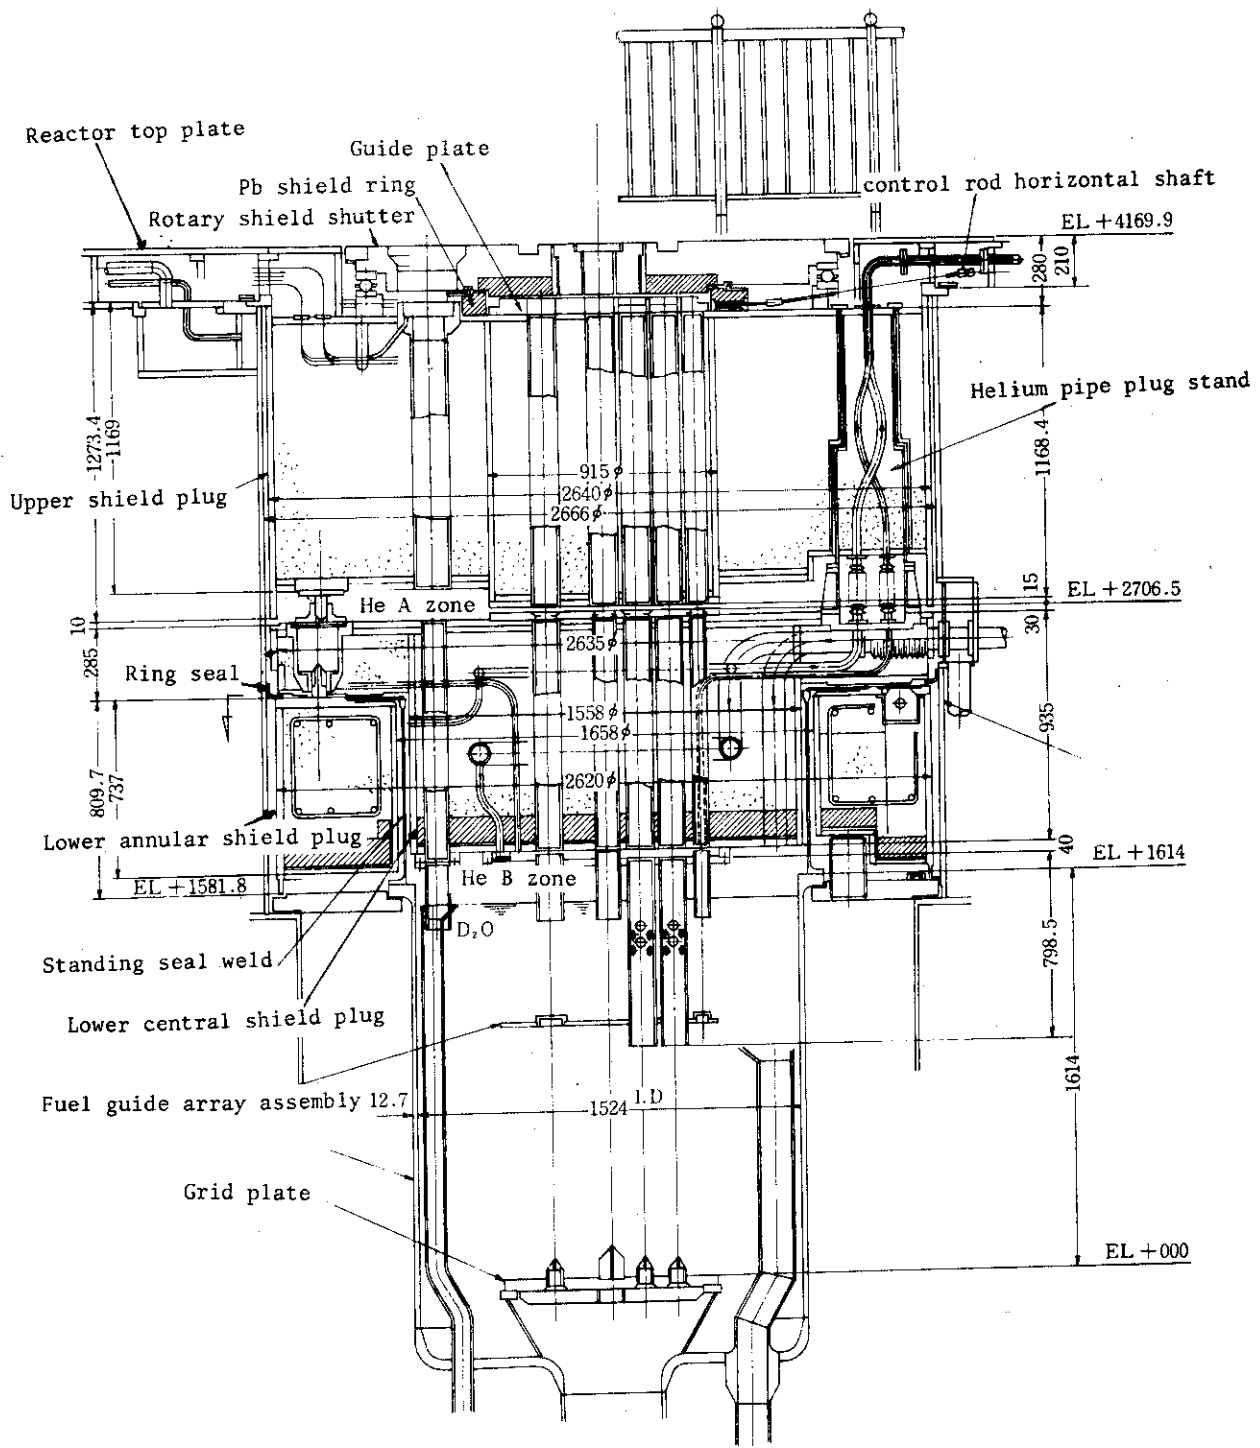
Fig. 1 JRR-2 cross section after modification

The heavy water concentration in the thermal shield light water increased gradually since the summer of 1971. Total amount of heavy water leakage into the thermal shield light water system since September 1971 till December 1973 was estimated to be about 520 kg. The repair works were planned to eliminate heavy water leakage trouble and to improve design of the reactor top shield at the same time. The "standing seal weld" for stopping heavy water leakage was carried out in June 1975 after the full size mock-up tests. The standing seal inserted between the lower annulus plug and the lower central plug was welded at the heavy water tank flange as shown in Fig. 1 and Fig. 2.

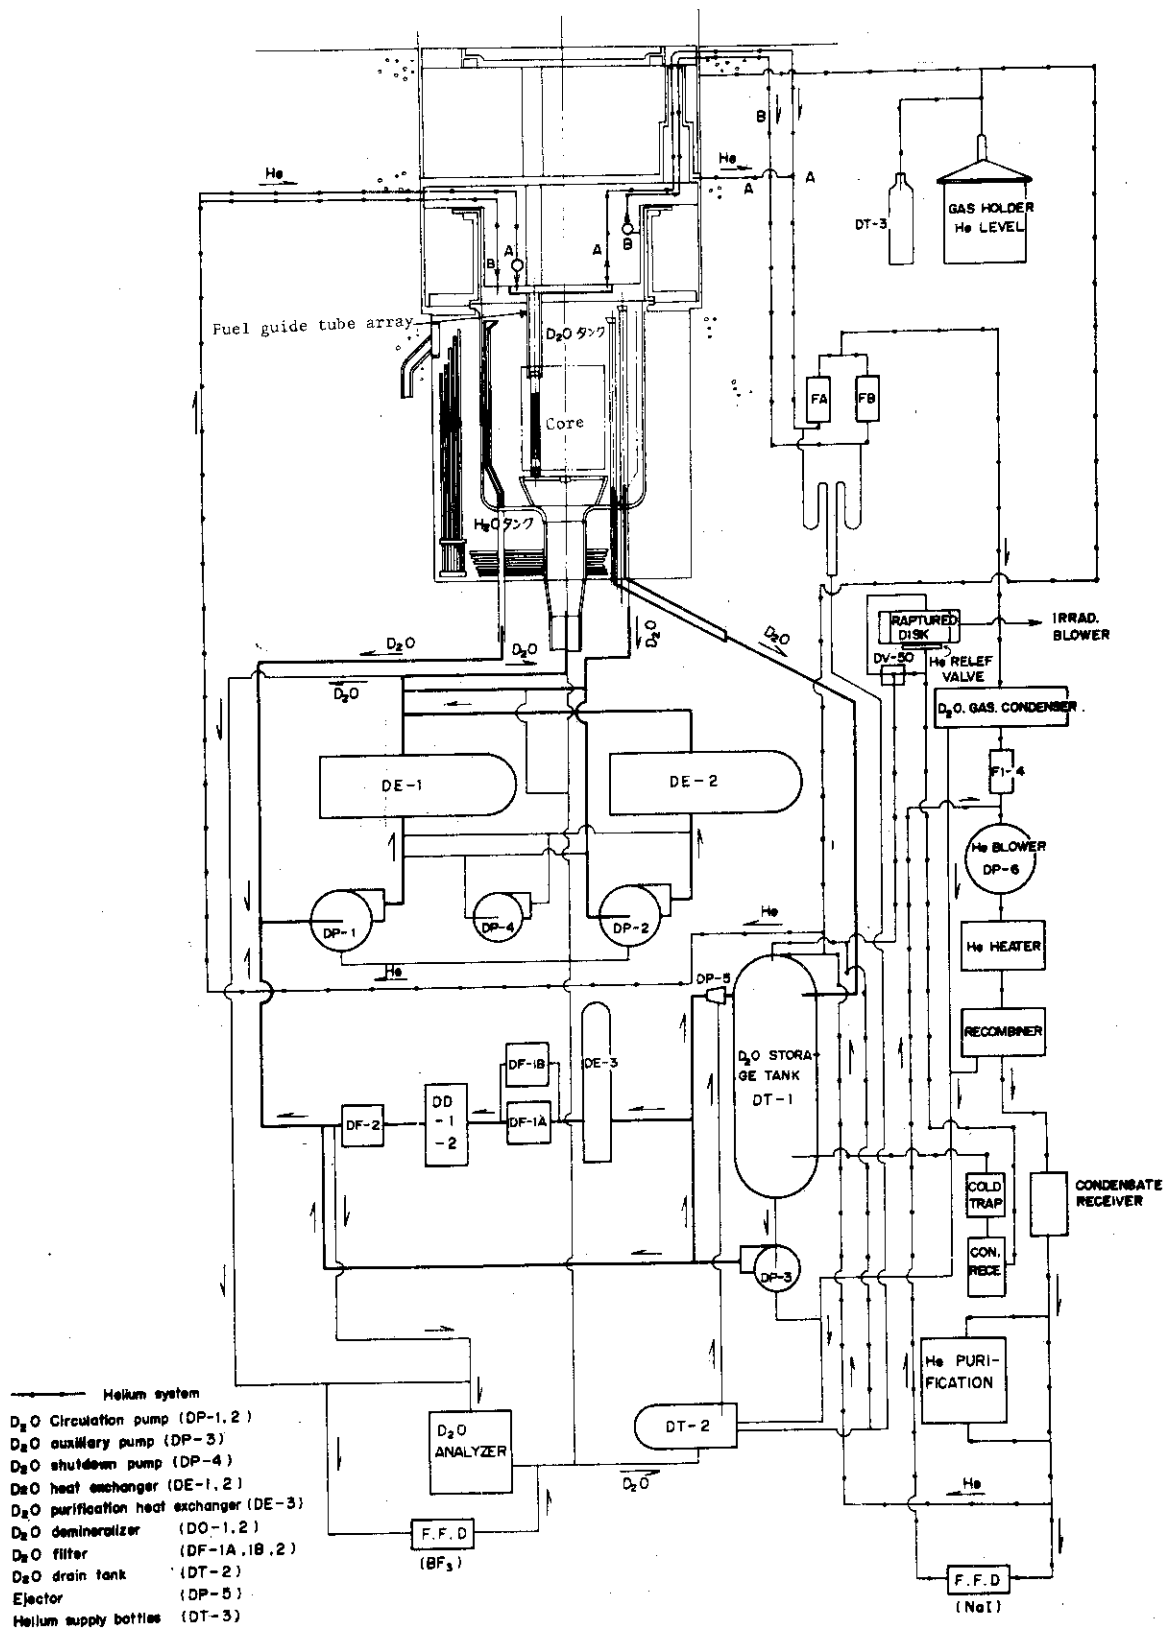
Fig. 3 JRR-2 heavy water cooling and helium system flow diagram after modification

The helium system flow diagram of JRR-2 after the modification is shown in Fig. 3. Helium gas above the liquid level in the heavy water tank is separated by the skirts of the guide tube array, so that the helium release in refueling is reduced to only about 500 ℓ (the volume inside the skirts). The total leak rate of the helium system at 10 MW was improved to about 2 ℓ/h after the modification. Heavy water dissociation rate was decreased to about (2 g D_2O/Mwh) $1/6$ of the value before the modification. Fig. 4 shows the D_2 and O_2 gas concentration in the helium circulating lines.

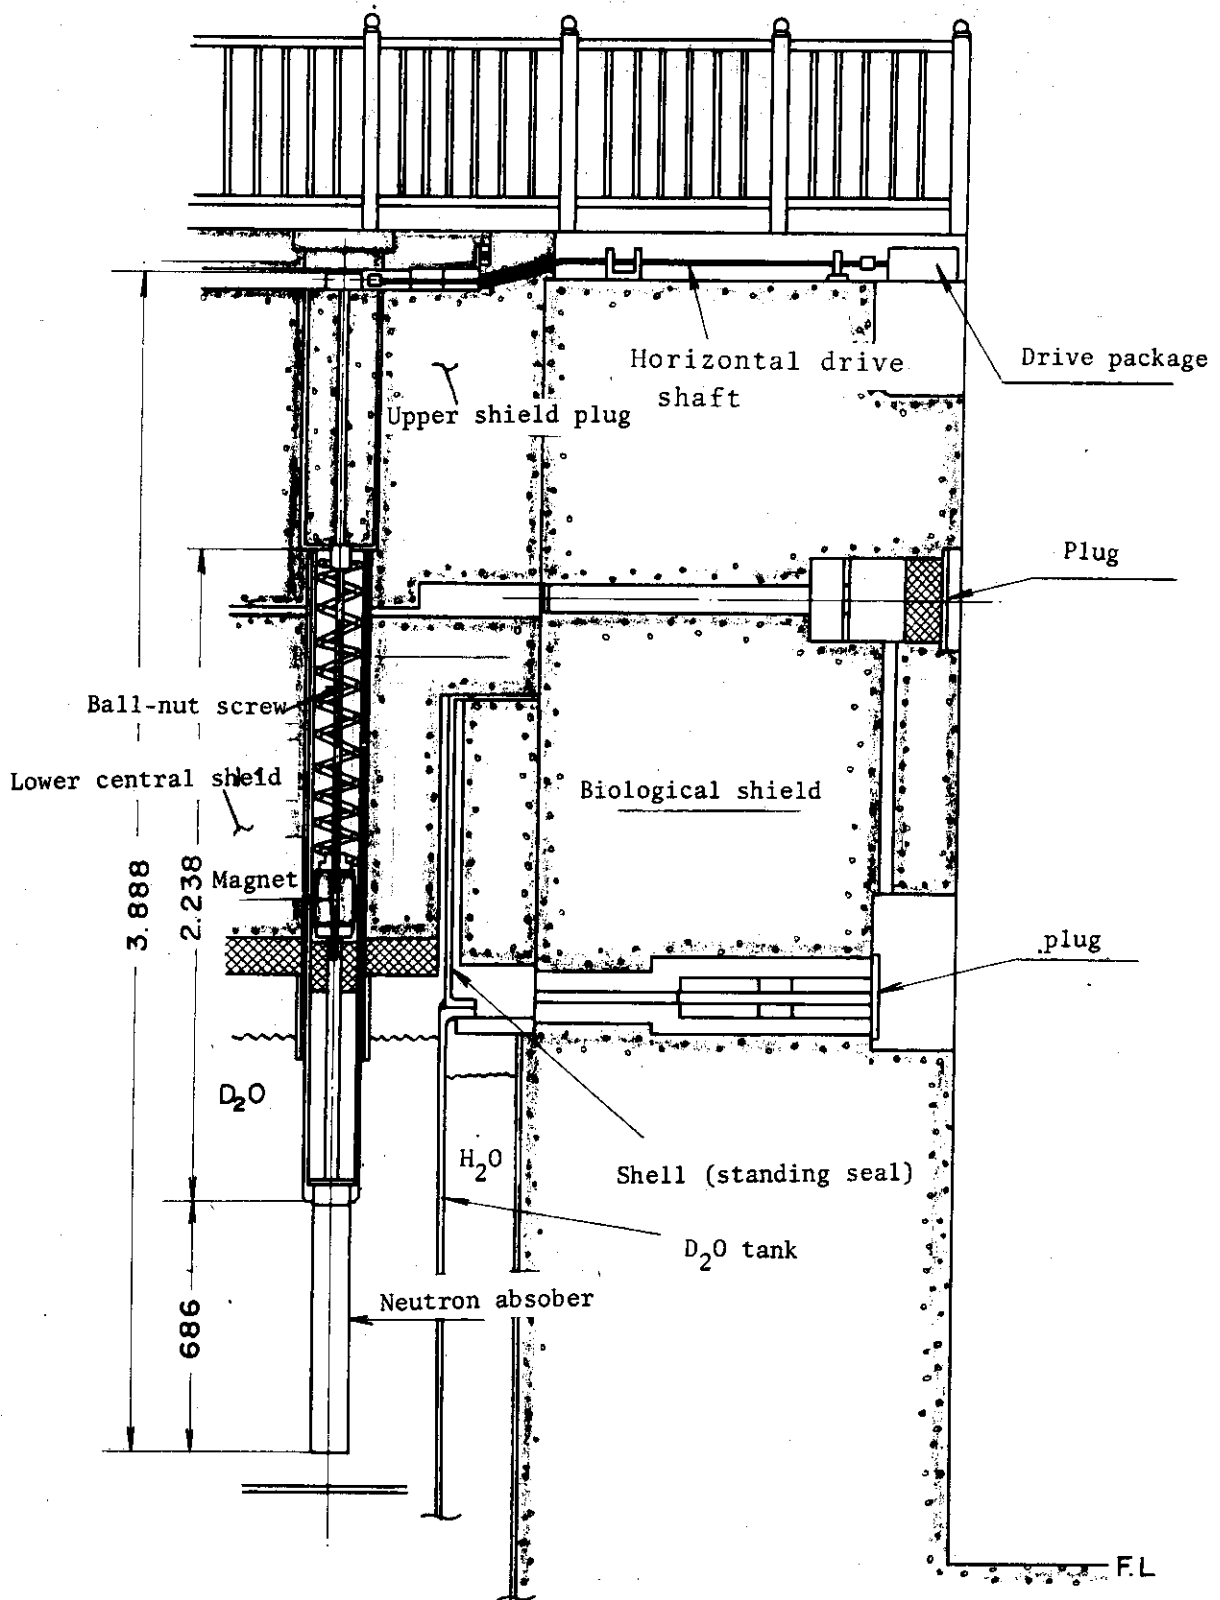
Fig. 6 Control rod drive system after modification

All the six control rod drive systems were replaced by the modified ones, in order to solve the problem mentioned above. Figs. 6 and 7 show comparatively the new system and the old control rod system. Major differences between are drive mechanism and location of the drive package. The drive mechanism consists of magnet and ball-nut screw instead of rack-pinion. The location of drive package is in the duct of the reactor top instead of the reactor wall.

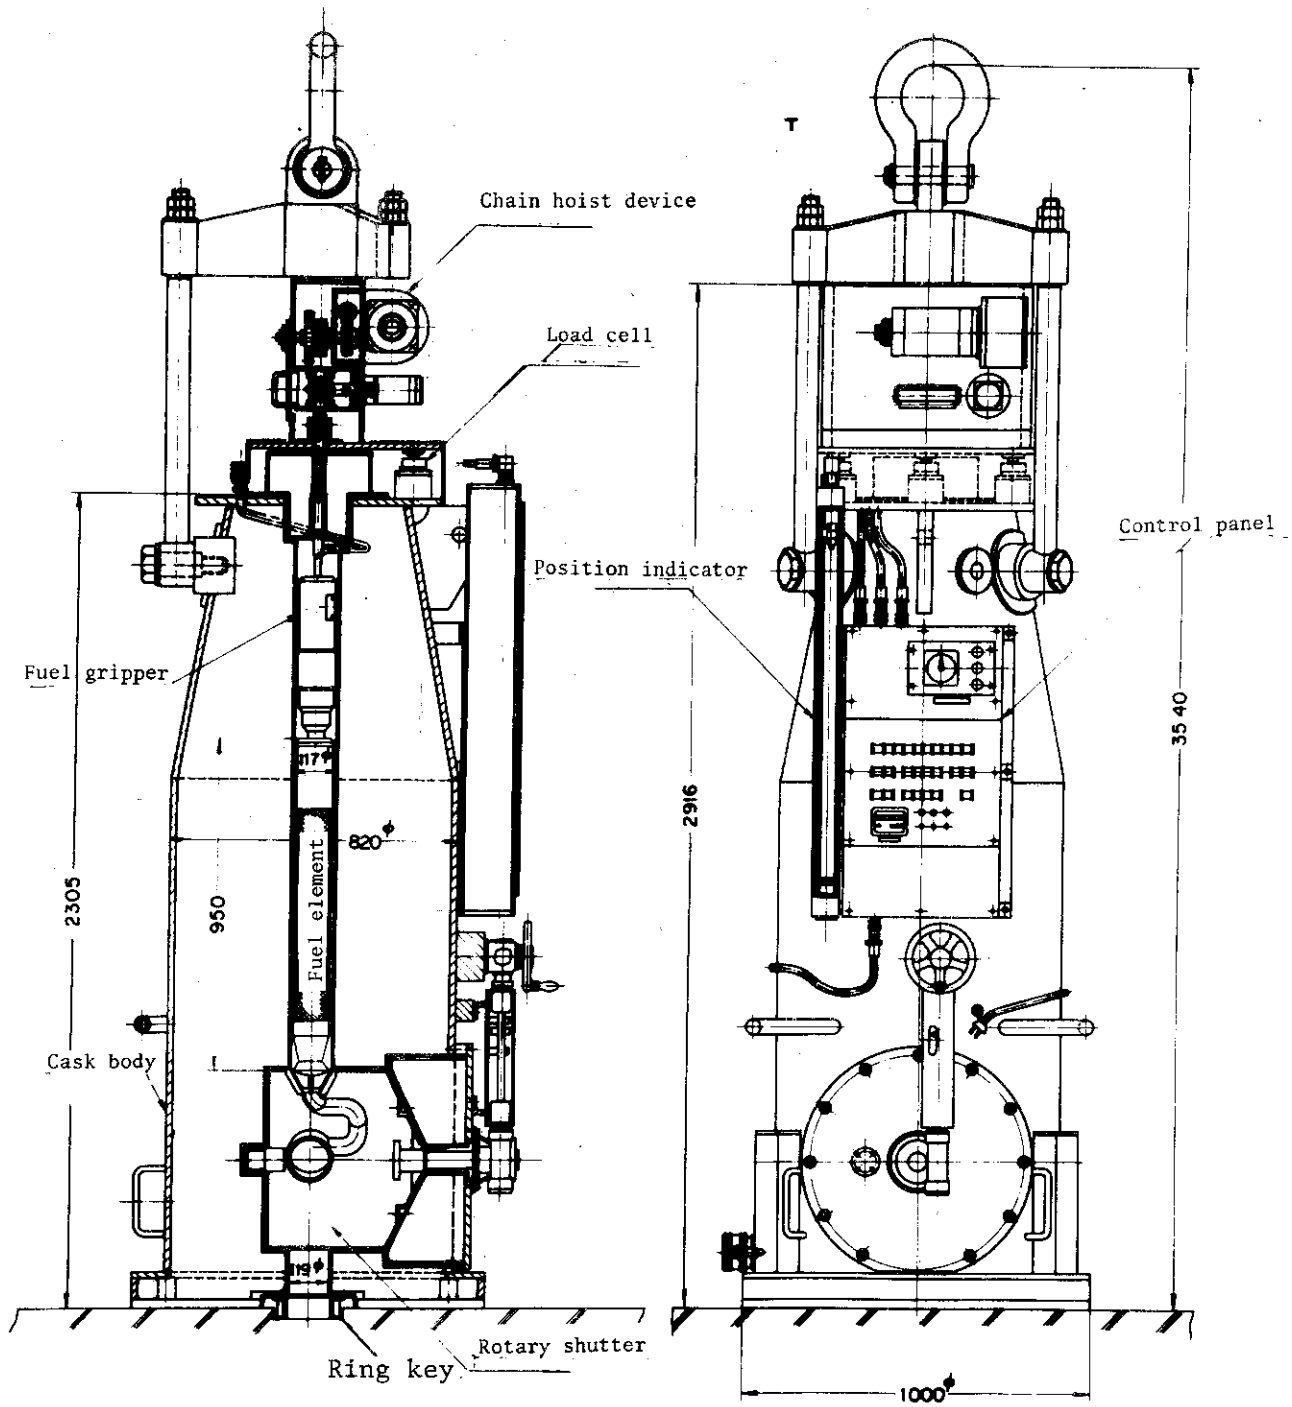
Fig. 8 Refueling cask

This cask was replaced with a modified one in the summer of 1975 to avoid some troubles concerning the old fuel cask such as shield gripper dropping or the rack disconnection by failure of stopper bolts etc.

A cross-section is shown in Fig. 8. A stainless steel tube of 117 mm inner diameter and about 2.3 m high is surrounded by an annular lead shield of 330 mm thickness. The weight is approximately 13 tons.

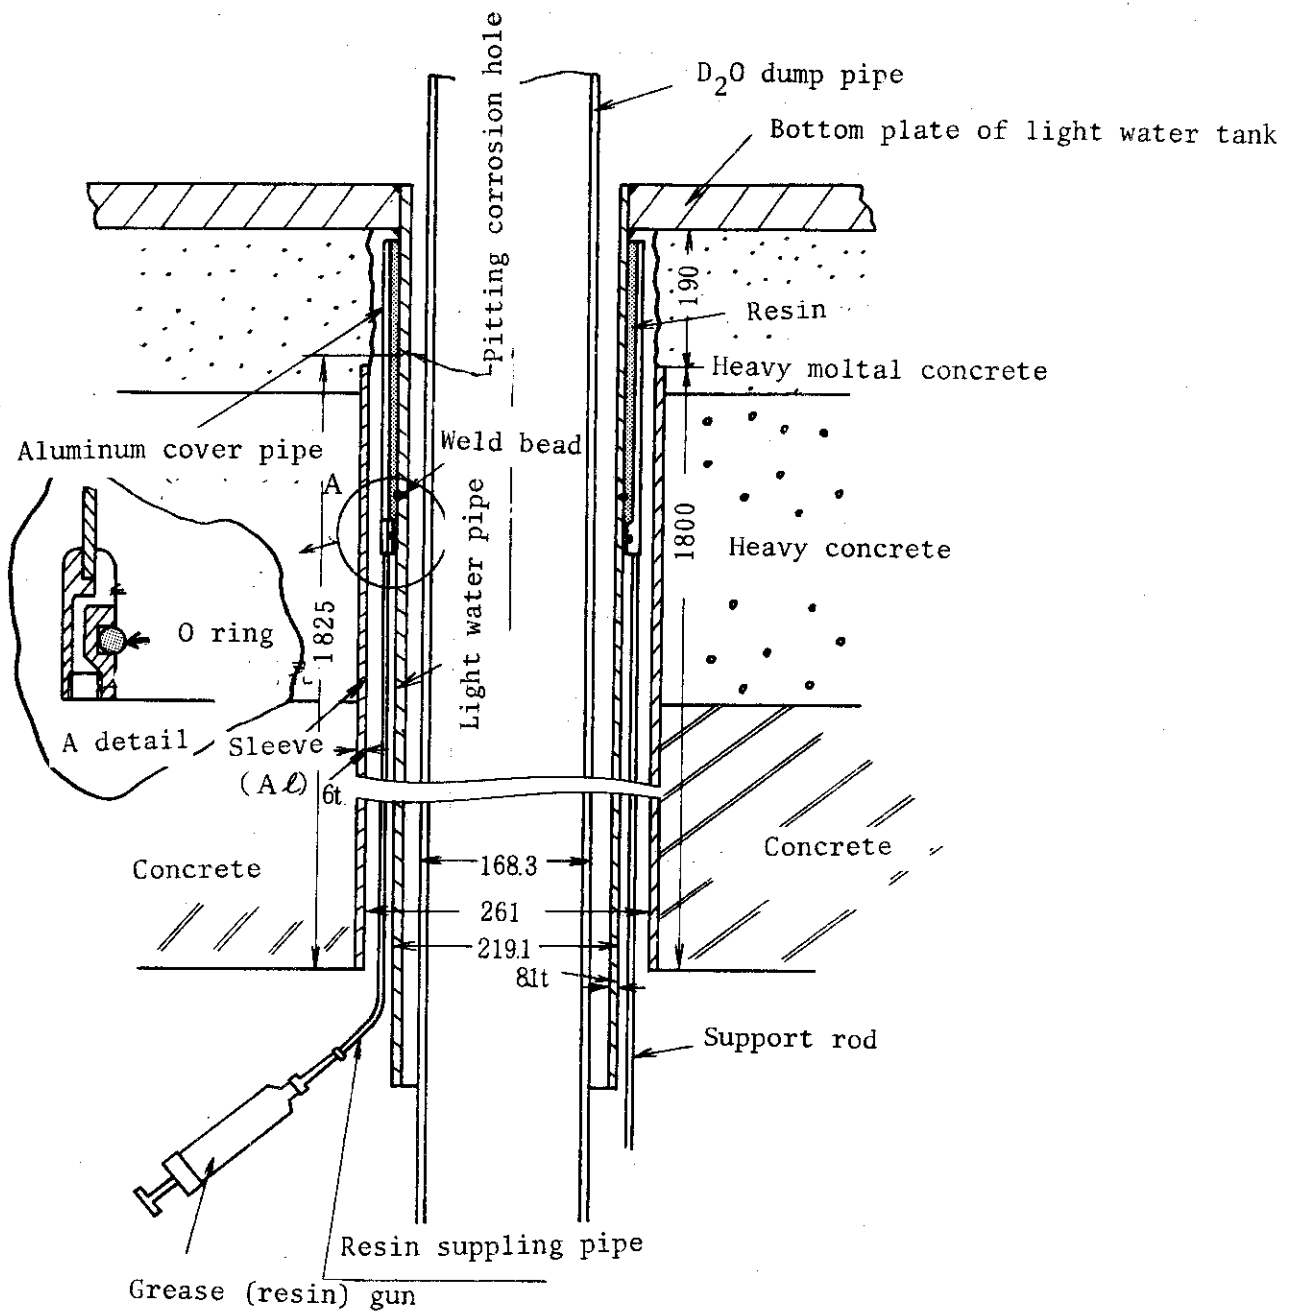
Fig. 12 Repair of light water leakage in stand pipe below the light water tank

Water leakage occurred in November 1975, in pitting corrosion of the aluminum pipe. The location was about 180 mm below the light water tank, along the heavy water dump line. Detailed examination was made with fibre scope and ^{192}Ir radiography.

The cause of the water leakage was presumed to be acidic pitting corrosion by analysis of corrosion products. Corrosion products were mainly chloride, aluminum hydroxide and Bayerite ($\text{Al}_2\text{O}_3 \cdot 3\text{D}_2\text{O}$). About $800 \text{ } \mu\text{g/g}$ of chlorine was also detected in the waste materials. The chlorine was supposed to be released by radiation damage of polyvinyl chloride sheets wrapping the aluminum pipe in inferior JRR-2 construction.

The repair works are outlined in Fig. 12. To stop the leakage, resin (Epikote 828) was packed into the gap between the light water pipe and the cover pipe about 350 mm long. The resin is estimated to have a life of about 10 years.

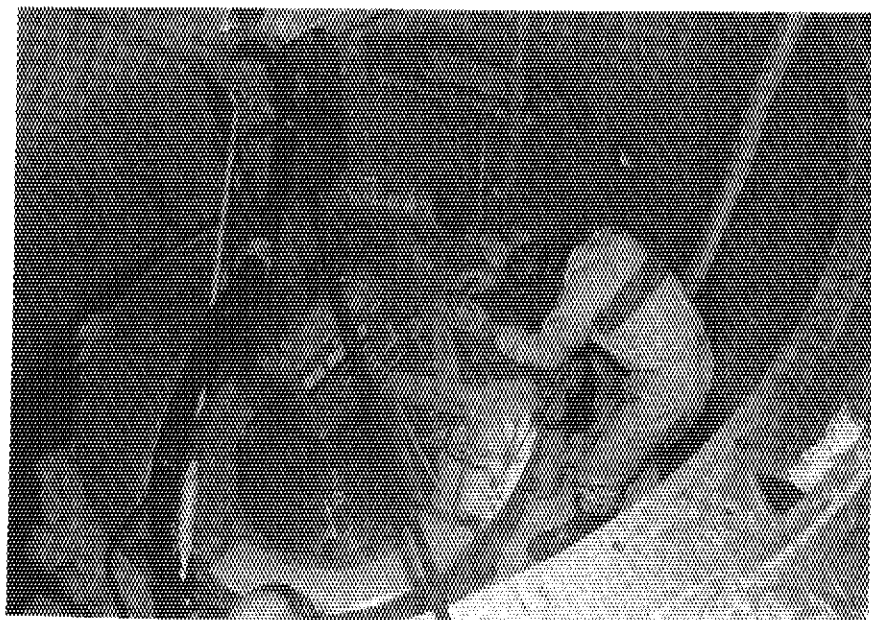
Photo 1. MIG Arc Automatic Welding at Position No. 1

The three-pass welding at the heavy water tank flange (position No.1) under high radiation level were performed by automatic MIG arc. The other four positions were welded in two passes by semiautomatic MIG arc. Inspection after the welding showed good results, including visual inspection, penetration test and helium leak test. Refer to photo No.1 and 2.

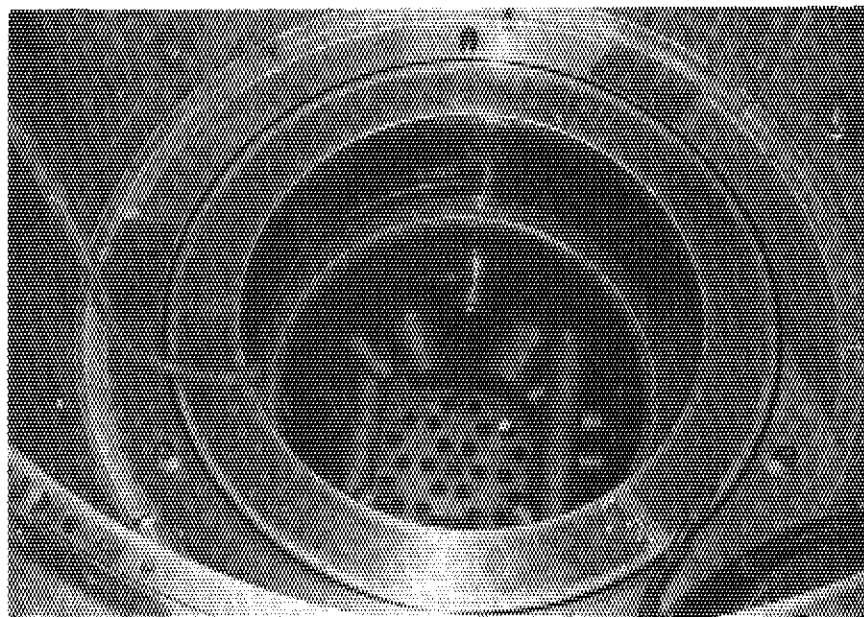
Photo 2. Standing Seal after Welding
(view of D₂O tank, horizontal beam tube and
grid plate)
