FATIGUE TEST RESULTS OF STRAIGHT
PIPE WITH FLAWS IN INNER SURFACE

January 1981

Katsuyuki SHIBATA, Toshihiro OBA, Takaichi KAWAMURA
Norio YOKOYAMA* and Shohachiro MIYAZONO

日 本 原 子 力 研 究 所
Japan Atomic Energy Research Institute

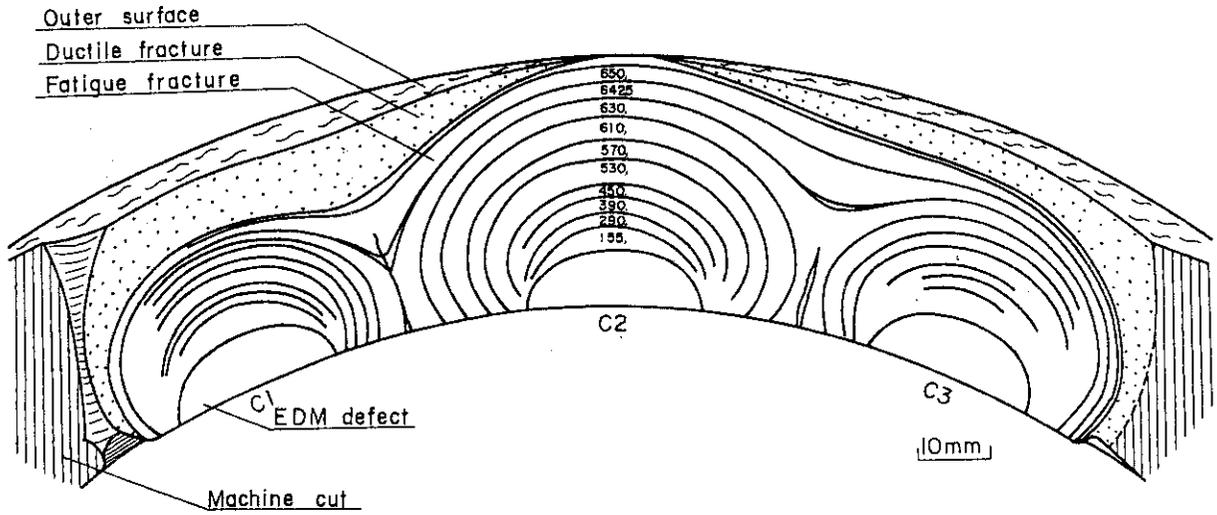
Fig. 5.1 Fracture surface appearance of ST-1 test pipe

However the crack depth and shape in the fracture surface of ST-2 test pipe could be almost recognized from the crack front marks obtained by the fatigue test. The appearances of the fracture surface are schematically depicted from their observation as shown in Figs.5.1 and 5.2.

The growth of C2 crack was most remarkable and C2 crack passed through the thickness. The crack initiated at the deepest point of the artificial defects, and crack front grew almost semi-circularly.

The crack front in the vicinity of the inner surface had a singular geometry, i.e., a convex shape, and there some delay of crack growth was always observed. This phenomenon seems to be caused by a difference of the stress state between the vicinity of the inner surface and the inside.

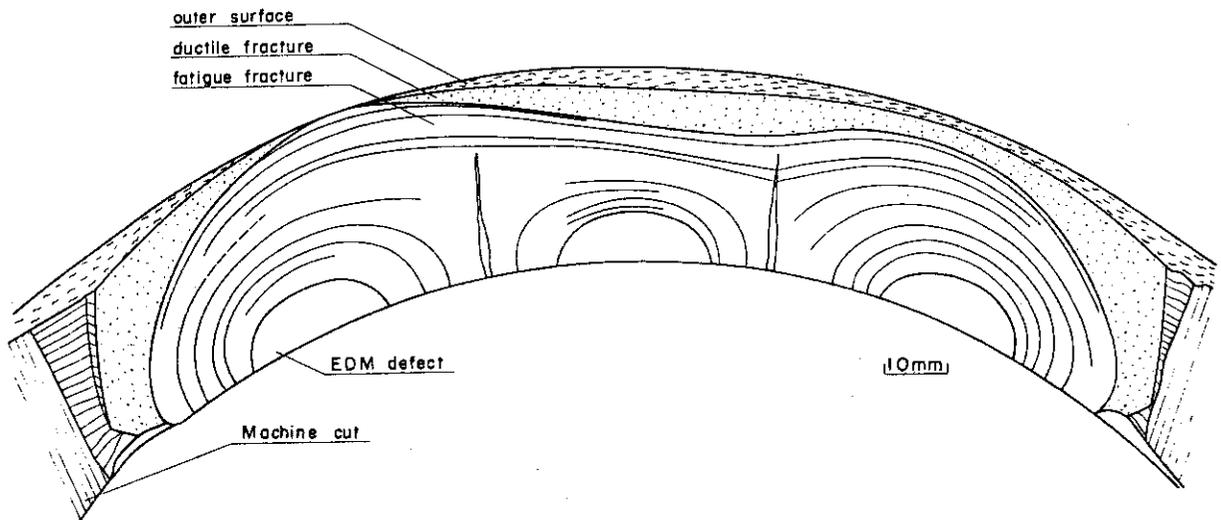
Fig. 5.2 Fracture surface appearance of ST-2 test pipe

In case of ST-2 test pipe, a particular crack growth behavior that C1 and C3 cracks grew faster than C2 is observed as shown in Fig.5.2 and Photo.5.2. The deepest points of C1 and C3 cracks tend to move from the center line of the artificial crack to C2 crack. The crack growth curves of ST-2 test pipe along the deepest point and the centerline (90° direction) are shown in Fig.5.5.

As shown in Fig.5.9, the relationship between da/dN and the crack depth, a , of ST-2 test pipe is somewhat different from that of ST-1. As shown in Fig.5.2, the crack growth of C1 and C3 cracks is larger than that of C2 crack. Consequently the crack growth behavior of ST-2 test pipe is different from that of ST-1 after three cracks coalesce.

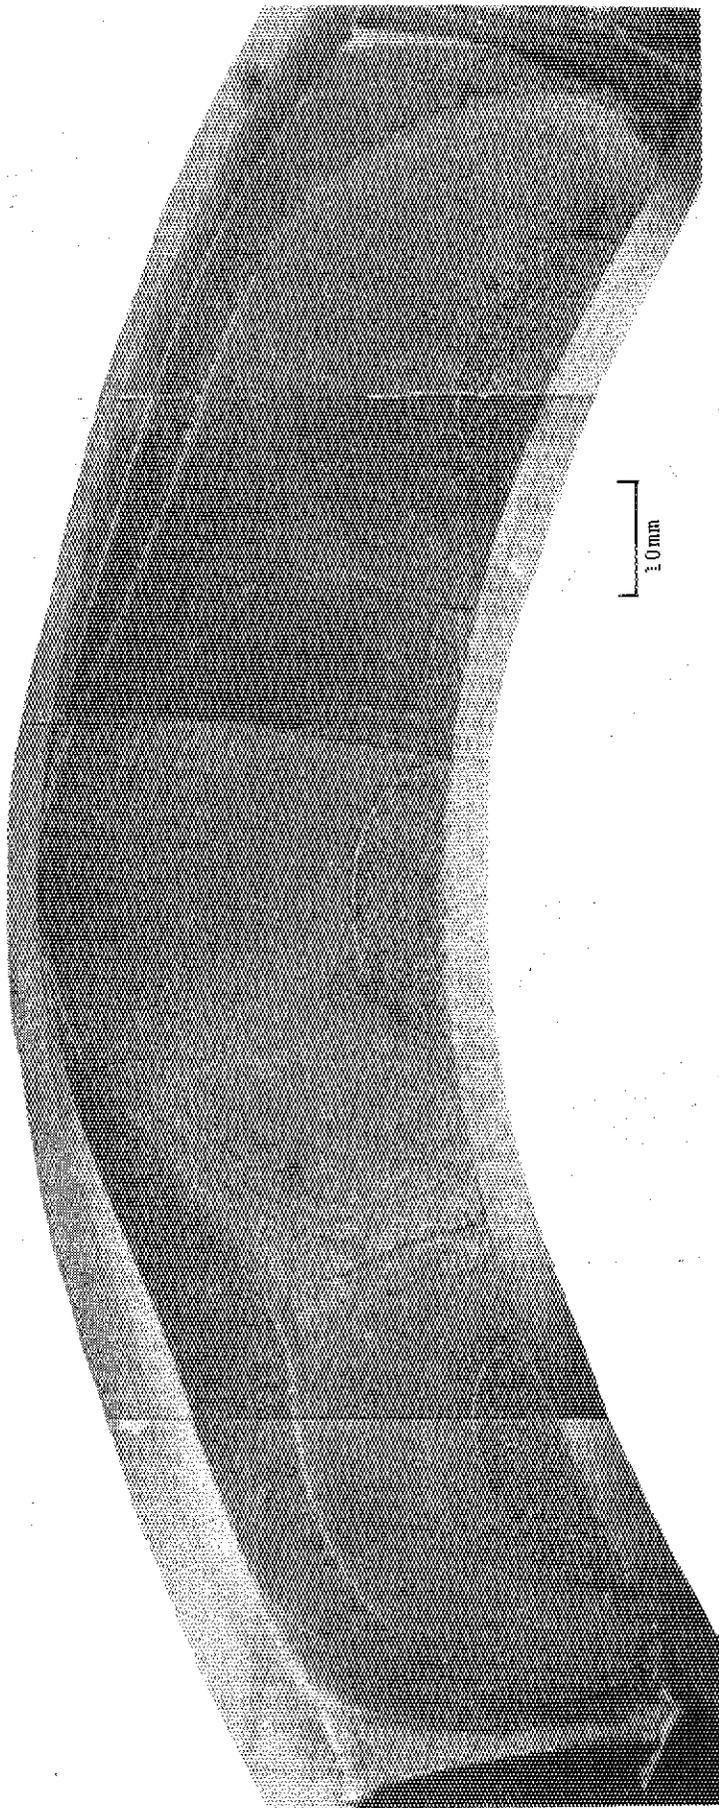
Photo. 5.1 Fracture surface appearance of the No.1 test pipe

Photos.5.1 and 5.2 show the fracture surface of ST-1 and ST-2 test pipe. The crack front marks of the fracture surface of ST-1 test pipe can be observed clearly, while those of ST-2 test pipe are not so clear.

Though the cracks did not grow to the exact symmetrical configuration, a large single internal crack was realized at the end of the fatigue tests as expected before the test.

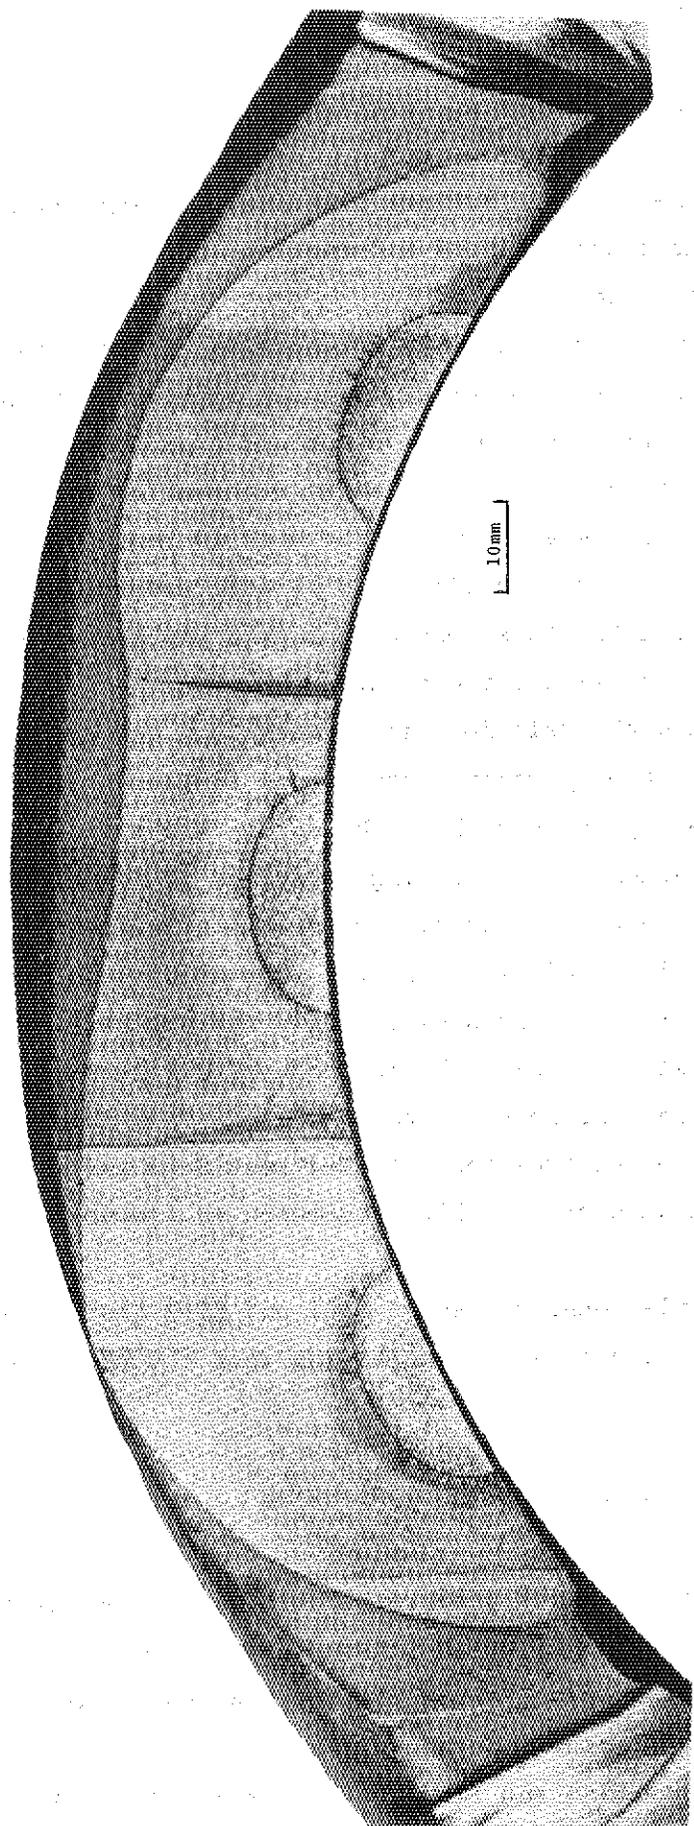
Photo. 5.2 Fracture surface appearance of the No.2 test pipe

The crack growth behavior of ST-2 test pipe was different from that of ST-1 test pipe as it was observed in those test results.

In the test of ST-2 test pipe, cracks initiated in order of C1, C3 and C2, and grew larger cracks in the same order. The crack penetration was caused at C3 after the coalescence of three cracks. As the crack extension of ST-2 test pipe in the circumferential direction is

- (1) As the weld beads of ST-2 test pipe exists close to the test section, the geometry and the stress distribution in the test section is different from that of ST-1 test pipe.
- (2) The cracks grow through the heat affected zone of the weldment, so that the crack growth behavior might be influenced by the change of the material properties.
- (3) The crack growth behavior might be influenced by the residual stress caused during welding.

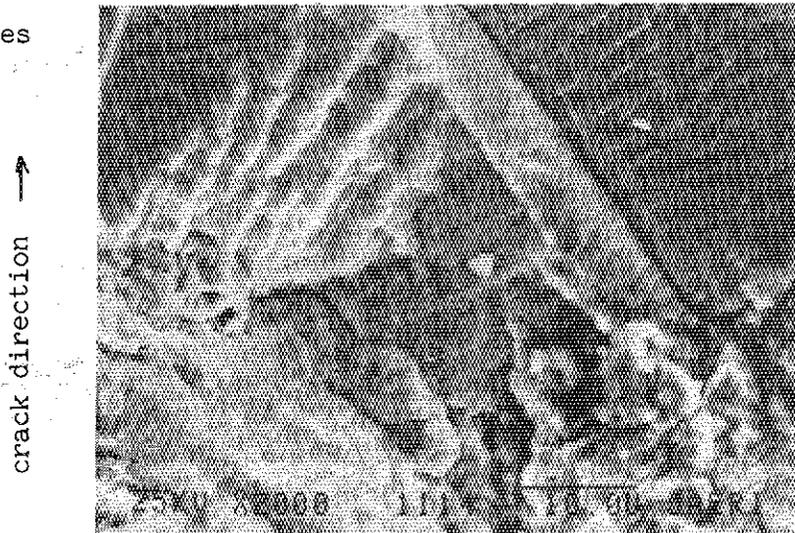
Photo. 7.1 Fractographs

The striation was not observed at low crack growth rate as shown in Photo.7.1. On the other hand, it was observed at high crack growth rate as shown in Photo.7.1.2. A fair correspondence between striation spacing (2.8×10^{-4} mm/cycle) and optical measurement of the crack growth rate (2.3×10^{-4} mm/cycle) was obtained from Photo. 7.2.

The fractographic observation of ST-1 and ST-2 test pipes was almost the same.
