# 「常陽」MK-II炉心燃料(PFD001)の 照射後試験(2)

燃料要素の組織観察及び機器分析  
(Vol. 2 データ編)

技術資料コード	
開示区分	レポートNo.
T	N9410 87-189 Vol.2

動力炉・核燃料開発事業団  
大洗工学センター

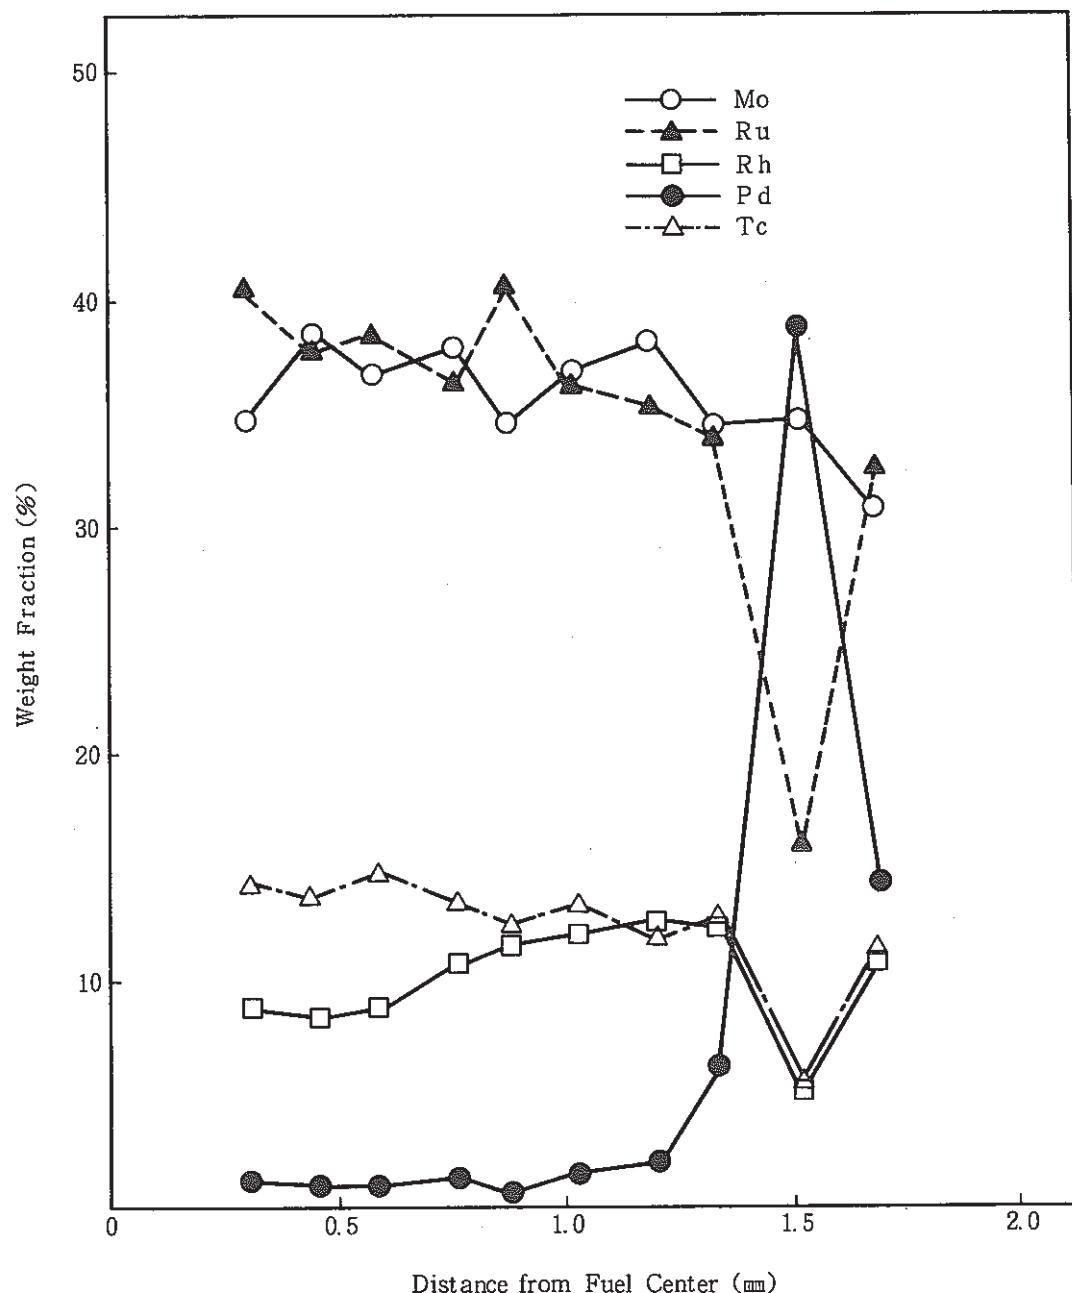
Fig. 23 Radial Distribution of Mo, Ru, Rh, Rd, and Tc Contents in Metallic Inclusion (Specimen No. 815244)

金属析出物中の各元素の標準試料(Pure Mo, Ru, Rh, Pd)に対する強度比を求め、これを燃料径方向位置に対応してプロットした関係をFig.23に示す。

金属析出物の主成分は、Mo, Ruであることがわかる。

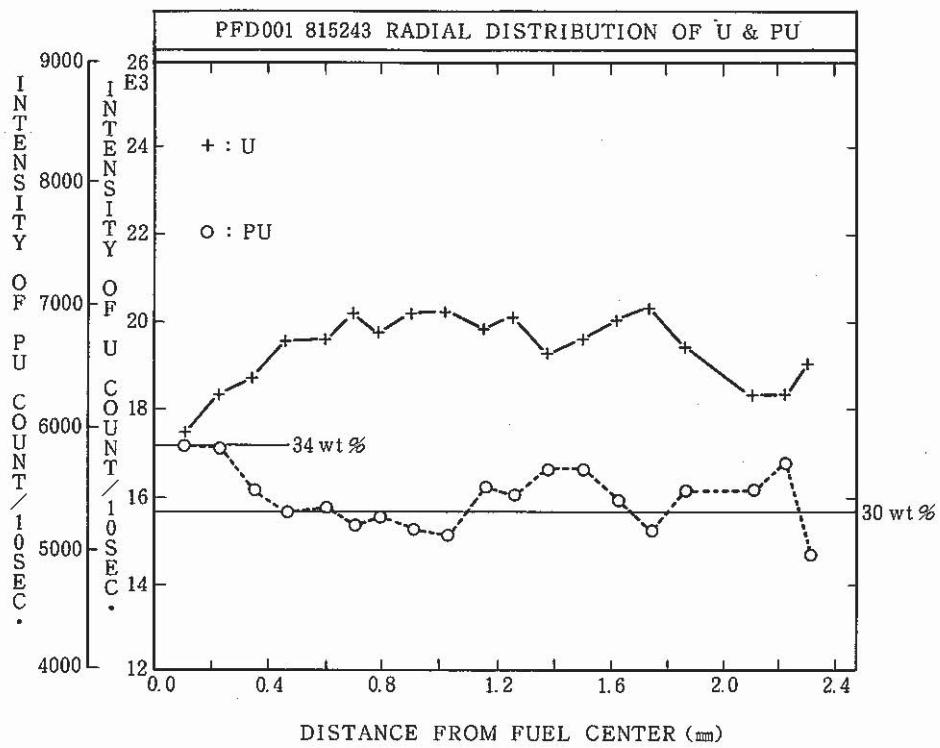
Fig. 24 Radial Distribution of Pu-M $\beta$  and U-M $\alpha$  in the Fuel  
(Specimen No. 815243)

U, Puについて中心部より被覆管方向へ定点測定を実施（20点）した結果をFig.24に示す。柱状晶及びガスバブル領域において明瞭なU, Puの再分布が認められ、中心空孔の近傍では、Pu濃度が増加し、U濃度が減少していることがわかる。

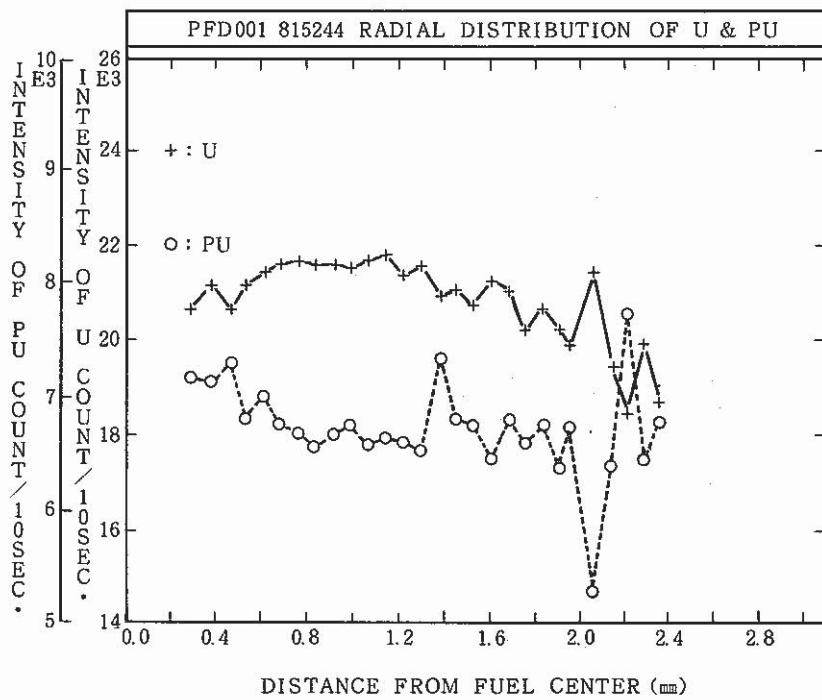
Fig. 25 Radial Distribution of Pu-M $\beta$  and U-M $\alpha$  in the Fuel  
(Specimen No. 815244)

U, Puについて、中心部より被覆管方向へ定点測定を実施（28点）した結果をFig.25に示す。本試料も中心空孔が認められた試料であり、柱状晶、ガスバブル領域でPu濃度の増加、U濃度の減少が認められる。

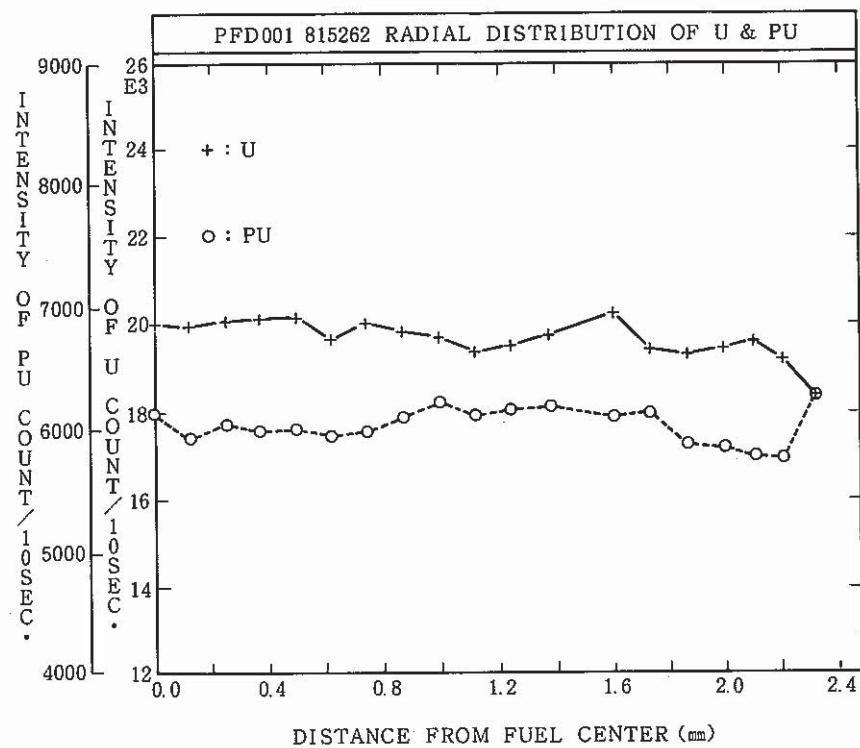
Fig. 26 Radial Distribution of Pu-M $\beta$  and U-M $\alpha$  in the Fuel  
(Specimen No. 815262)

U, Puについて、中心部より被覆管方向へ定点測定を実施（20点）した結果をFig.26に示す。本試料には、中心空孔、柱状晶は認められず、U, Puの再分布も生じていない。

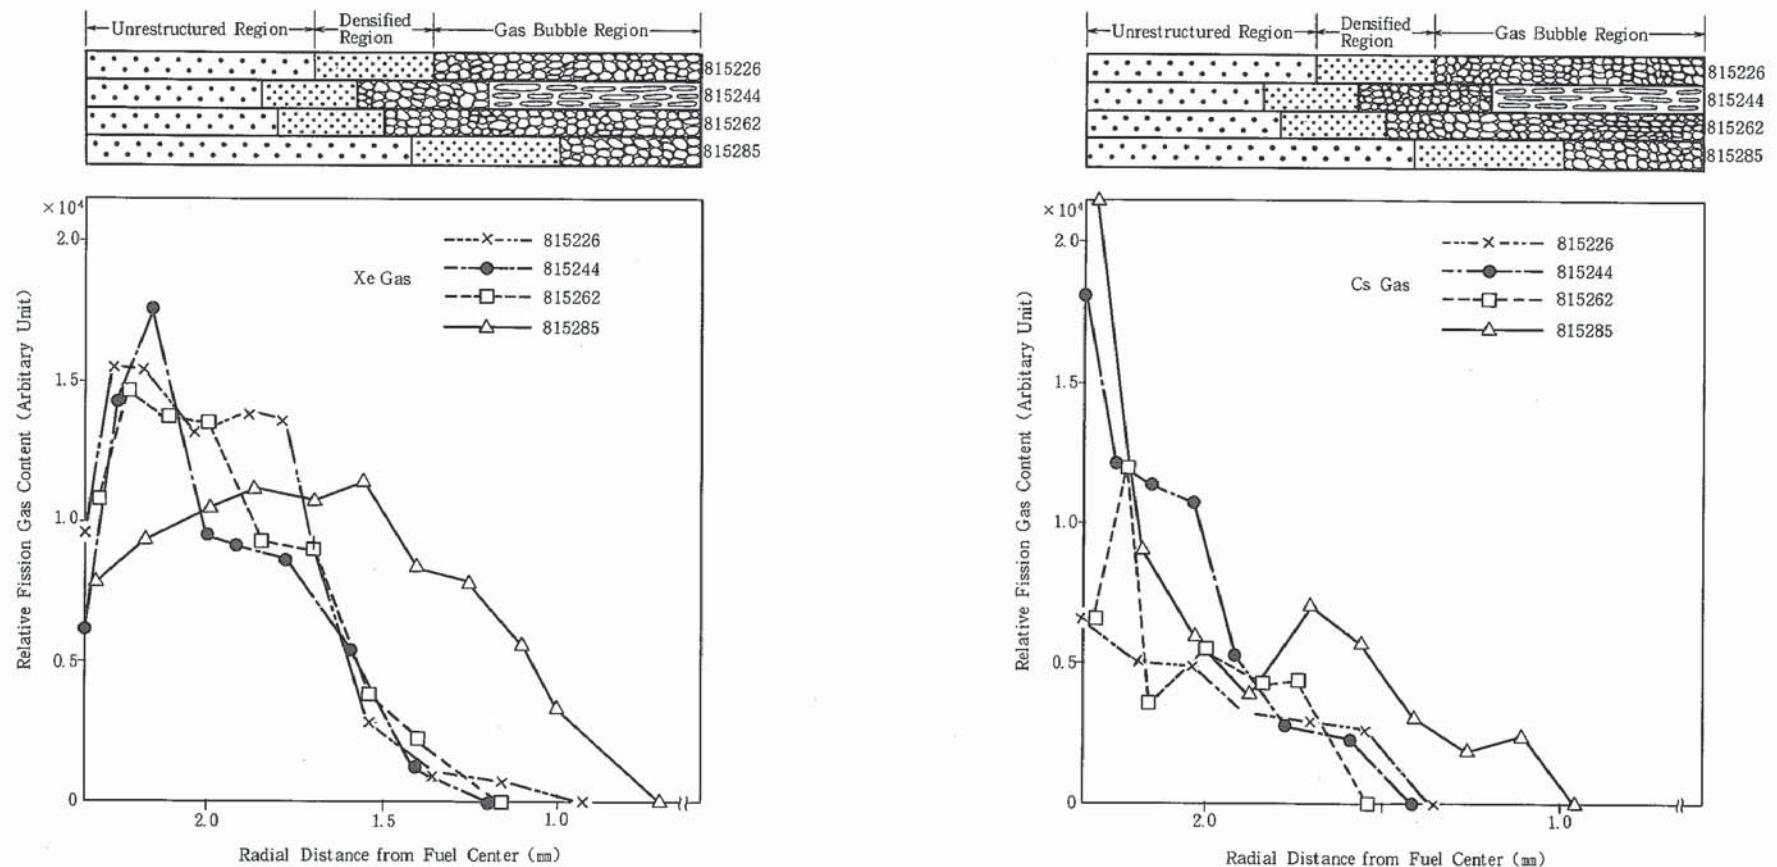
Fig. 27 Radial Profiles of Retained Xe, and Cs (PFD001)

試料No. 815226, 815244, 815262, 815285につき測定したXe強度のペレット径方向分布をFig.27に示す。Xe強度と燃料組織変化には、明瞭な対応があり、全試料とも高密度化領域で急激なXe強度の減少が認められる。

Csは、ペレット外周部で強度が高く、これは燃料との反応生成物が形成されているためと考えられる。ペレット内の径方向分布はXeと同様、高密度化領域で検出限界以下まで強度が低下していることがわかる。

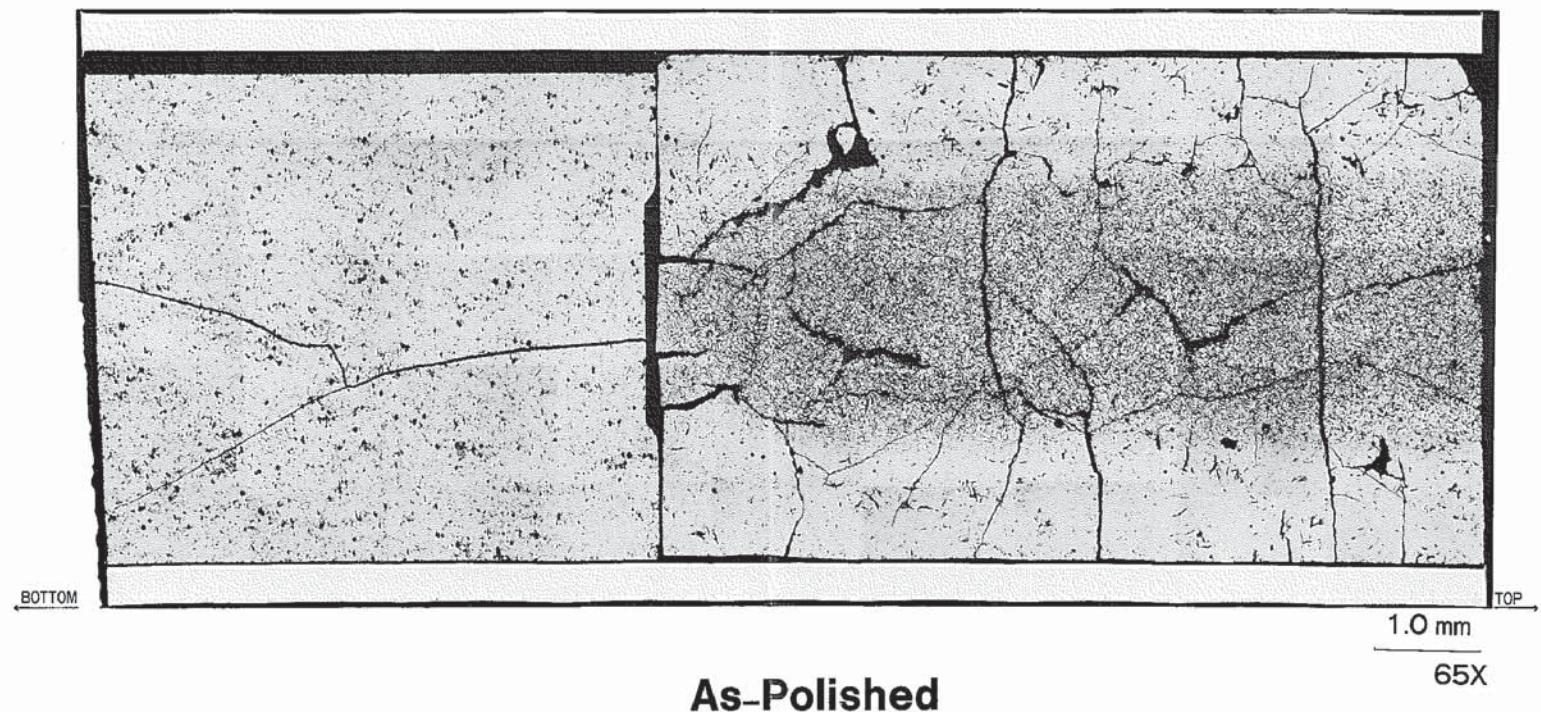
Photo.0-2 Optical Micrograph of the Longitudinal Section of the Core  
and Blanket Fuel Pin (Specimen No. 815223) As-Polished

本試料は, 下部インシュレータペレットを含む縦断面試料であり, Photo. 0-2, 3 に As-Polished 状態における光顕写真を示す。インシュレータペレットは, 軸方向に長いクラックが入っているが燃料組織は, 製造時とほとんど変化がなく, ディッシュ部もそのまま観察される。炉心燃料ペレットは, FP ガスバブル領域, 高密度化領域, 製造時領域の三層に区分される。また被覆管についても内外面共に異状は認められない。

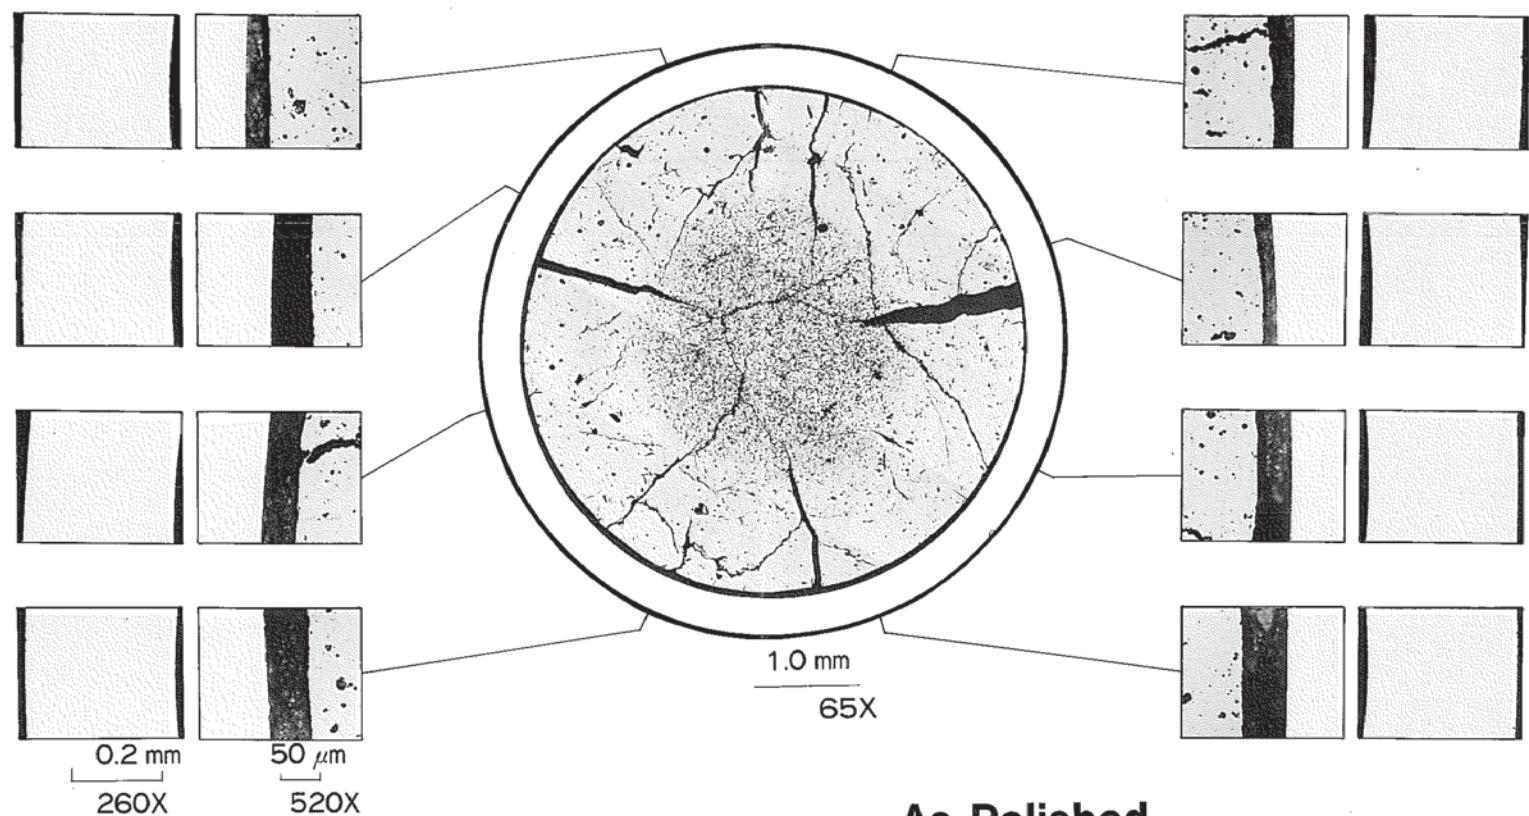
Photo.0-4 Optical Micrograph of the Transverse Section of the Core Fuel Pin (Specimen No. 815226) As-Polished

本試料は, 炉心燃料下端部の輪切り試料であり, As-Polished 状態及び Etched 状態における光顕写真をそれぞれ Photo. 0-4, 5 と Photo. 0-15, 16 に示す。燃料組織は, ピン中央から FP ガスバブル領域, 高密度化領域, 製造時領域からなる。クラックは, 外周部で広く, 中心部で狭いクサビ形である。

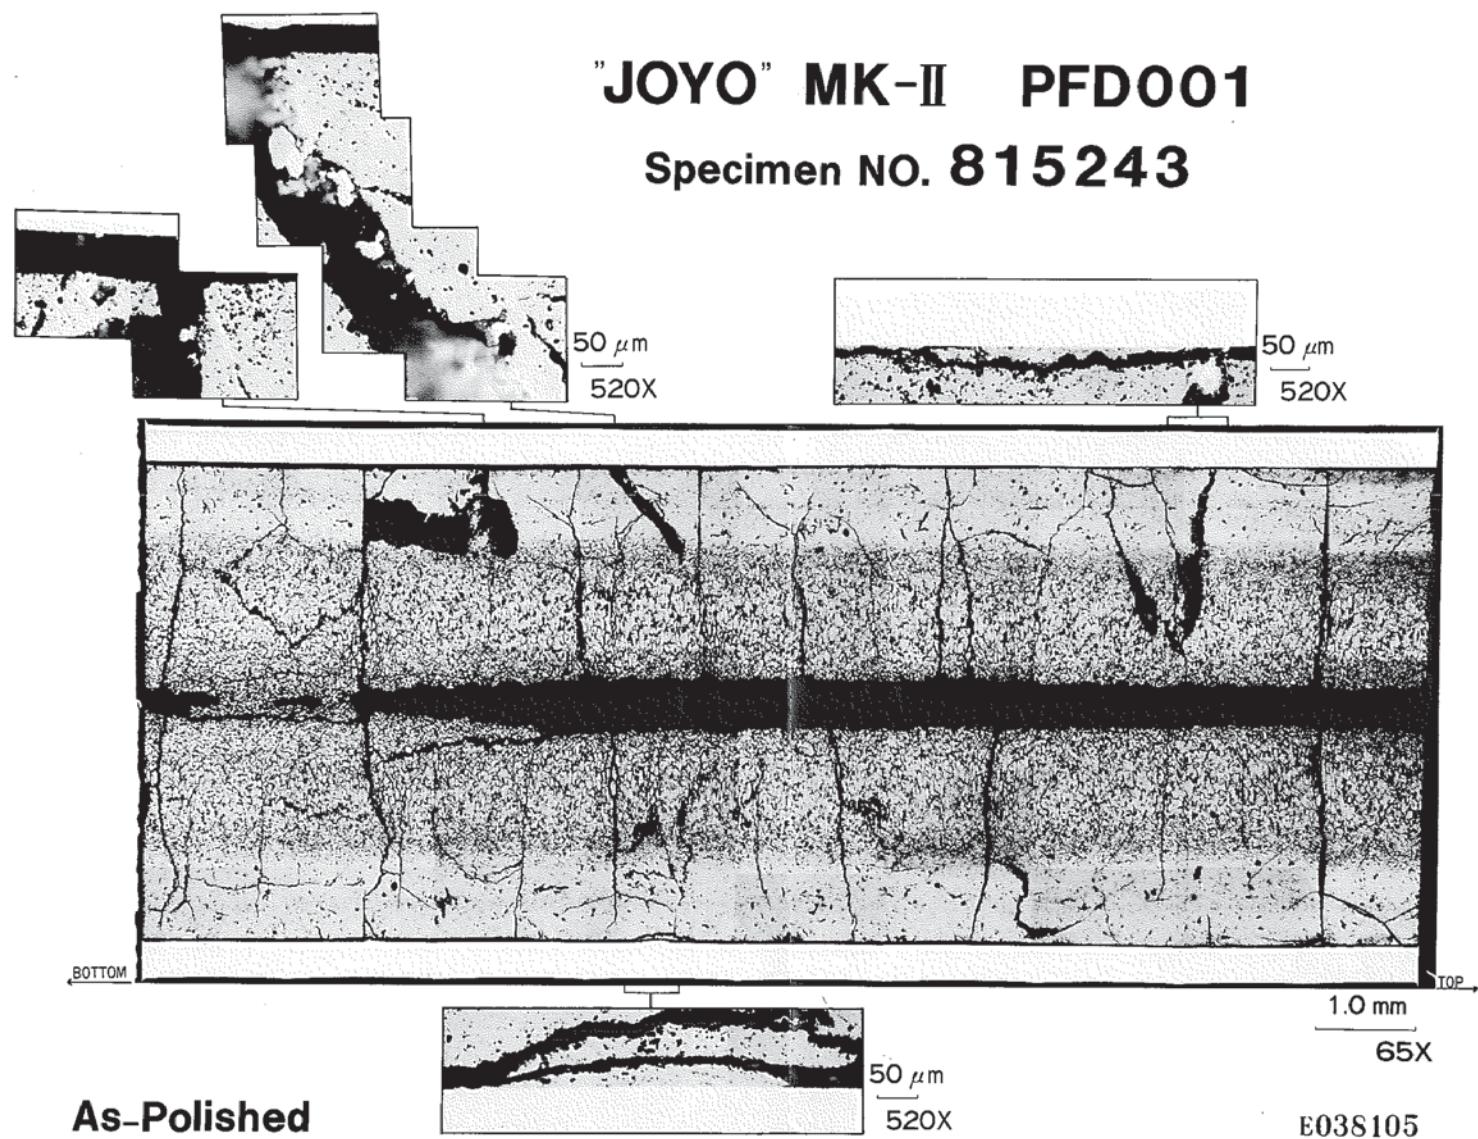
Photo.0-6 Optical Micrograph of the Longitudinal Section of  
Core Fuel Pin (Specimen No. 815243) As Polished

Photo. 0-6, 7 に As-Polished 状態における光顕写真を示す。燃料組織は, 中心空孔, 柱状晶領域, FP ガスバブル領域, 高密度化領域, 製造時領域の五層から成っている。Bottom 側で中心空孔が細くなり, 本試料において中心空孔の軸方向下端が現われていることがわかる。ペレット-ペレットの境界部が 2ヶ所観察され, 境界部付近の被覆管には, 若干の腐食と FP 等が観察される。白色析出物は, 中心空孔内壁から柱状晶, 高密度化領域に多く観察され, 製造時領域では, ほとんど見られない。

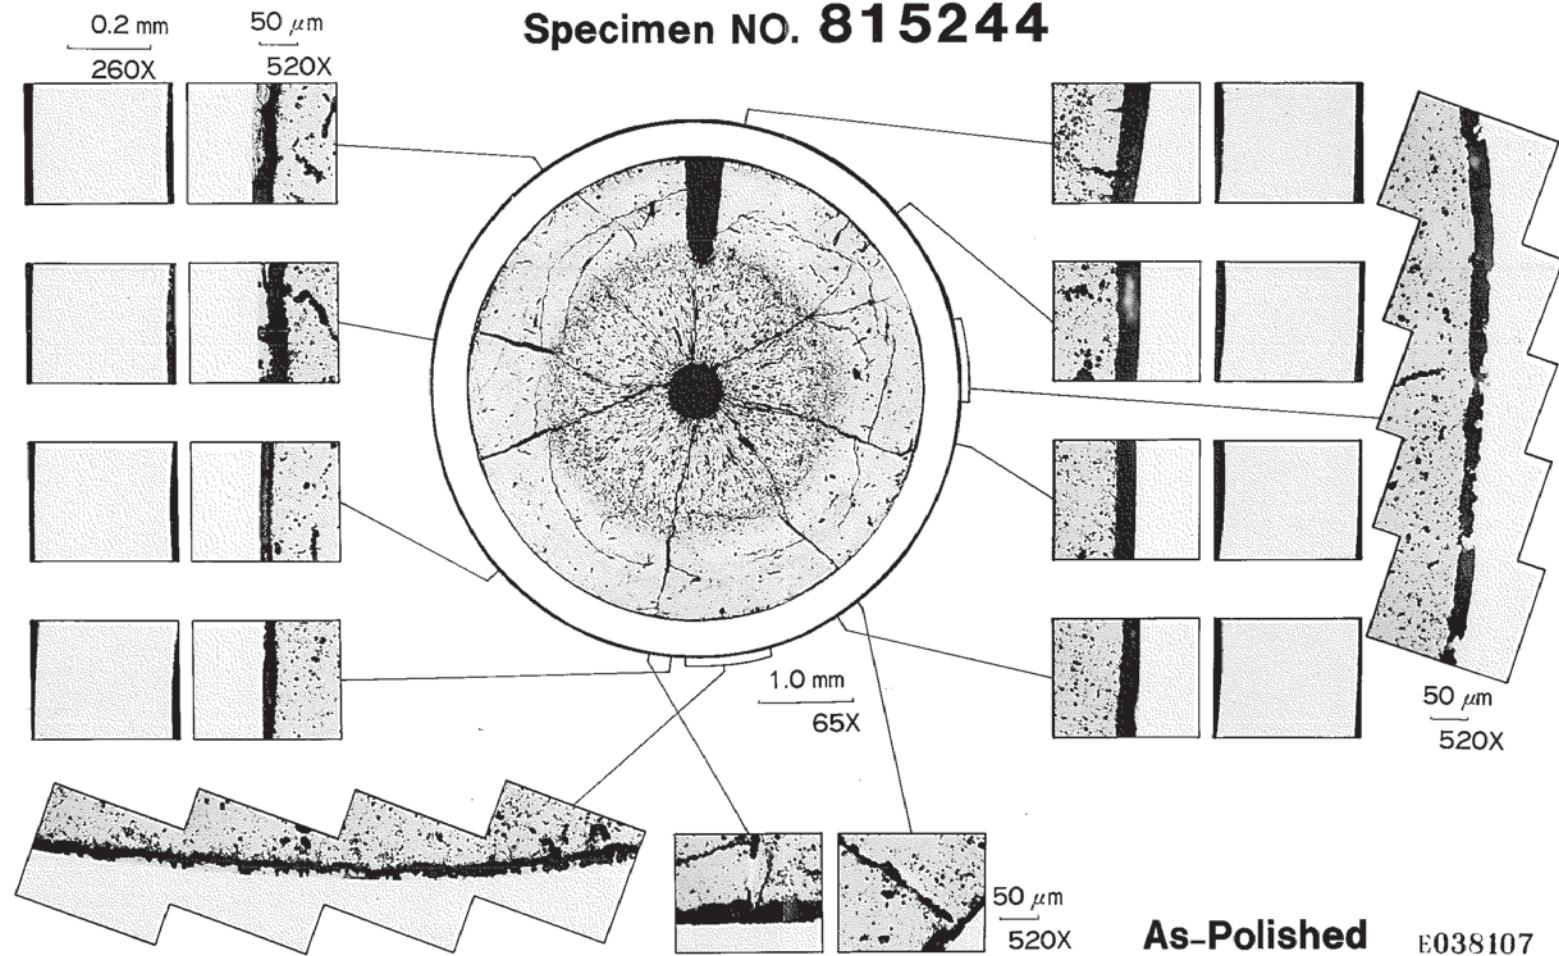
Photo.0-8 Optical Micrograph of Transverse Section of the Core Fuel Pin (Specimen No. 815244) As-Polished

本試料は, 炉心燃料部軸方向中心部の輪切り試料であり, その As-Polished 状態及び Etched 状態における光顕写真をそれぞれ Photo. 0-8, 9 と Photo. 0-17, 18 に示す。燃料組織は試料 No. 815243 と同様で, それらの領域はほぼ同心円状になっている。中心空孔の大きさは, 直径約 0.56mm で PFD003 の 0.43mm より成長している。また, 柱状晶長短軸比は, PFD003 の 3.3 : 1 に対し, 本試料では, 6.9 : 1 と約 2 倍になっている。白色析出物は, 中心空孔内壁から高密度化領域にかけて多く観察され, 中心ほど粒径が大きい。また燃料-被覆管ギャップ内に局部的に FP 等が観察され, 一部全面腐食も観察される。

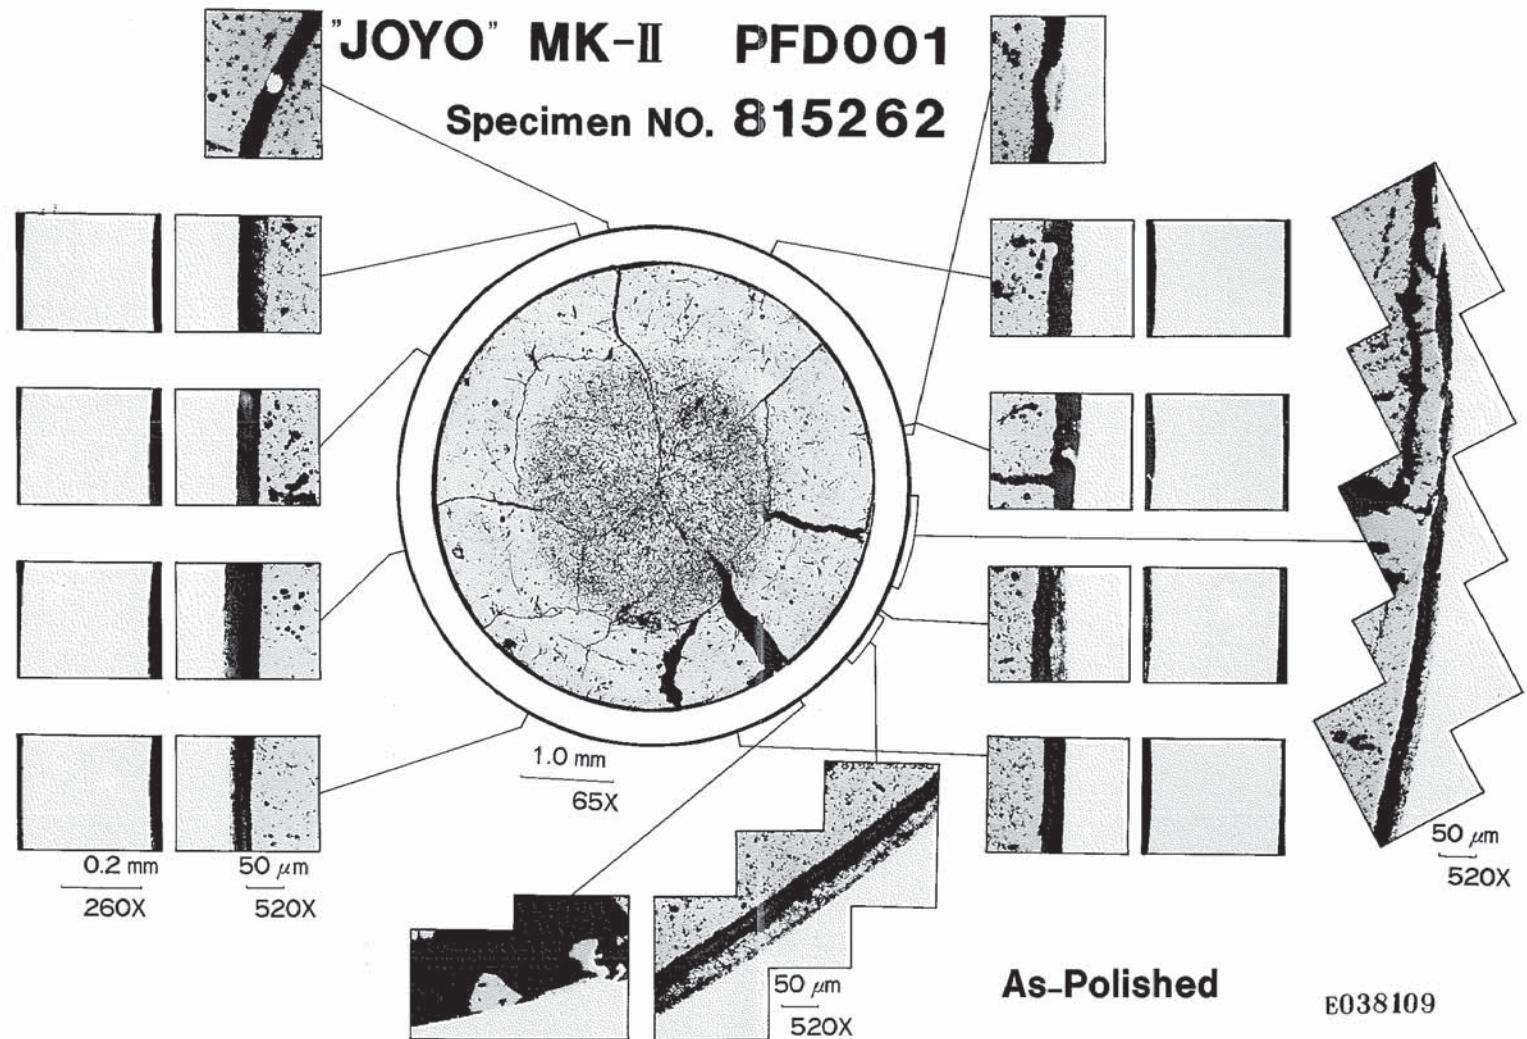
Photo.0-10 Optical Micrograph of the Transverse Section of the  
Core Fuel Pin (Specimen No. 815262) As-Polished

顕写真をそれぞれ示す。燃料組織は、試料No.815226とほぼ同様であるが、FPガスバブル領域の中央部付近では、結晶粒の成長がおこり、若干細長くなっている。燃料-被覆管ギャップ内には、FPと被覆管構成元素から成る反応層が観察され、局的に全面腐食型の被覆管内面腐食が認められる。また、クラック内開口部の被覆管内面に金属状FPの析出が観察される。

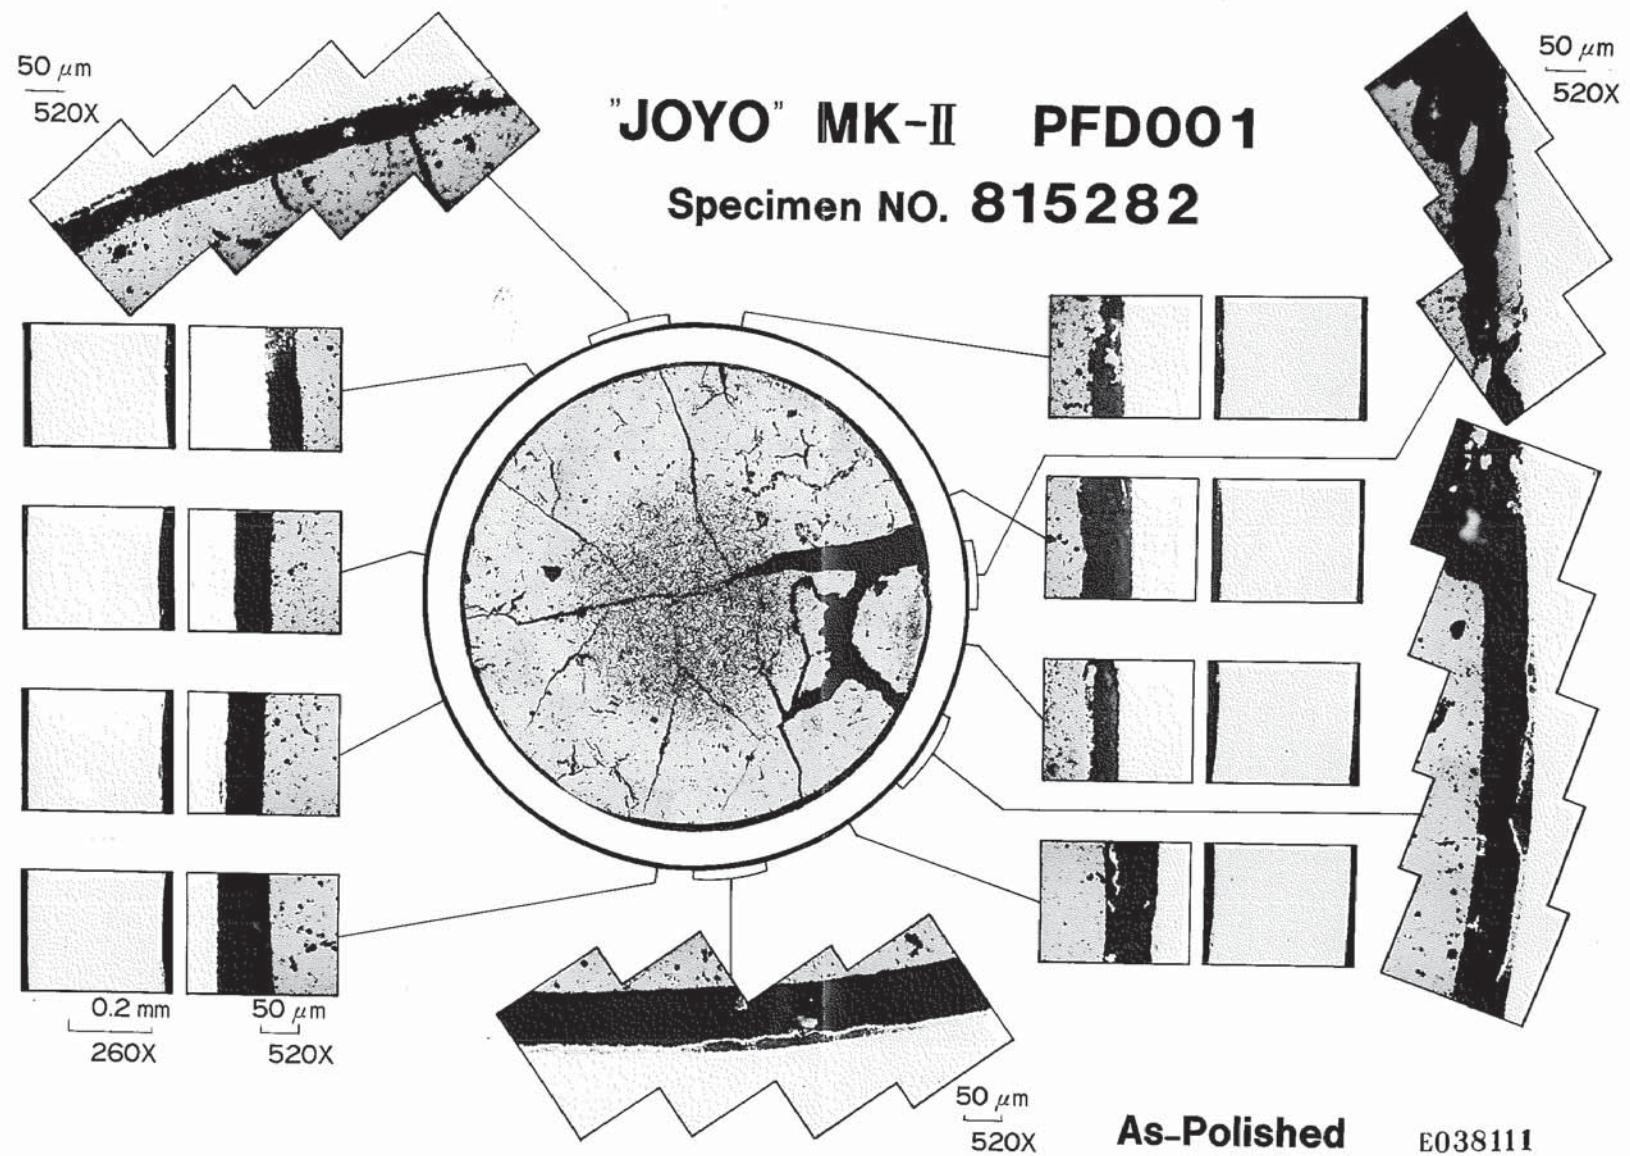
Photo.0-12 Optical Micrograph of the Transverse Section of the Core Fuel Pin (Specimen No. 815282) As-Polished

本試料は、炉心燃料上端部の輪切り試料であり、As-Polished及びEtched状態における光顕写真をそれぞれPhoto.0-12, 0-13とPhoto.0-21, 0-22に示す。燃料組織、白色析出物は、試料No.815226とほぼ同様である。被覆管内面は、ほぼ全面に渡り剥離（全面腐食）し、特にギャップ幅が広い所及びクラック開口部付近は剥離が著しい。またクラック開口部付近には、FPが多く観察される。

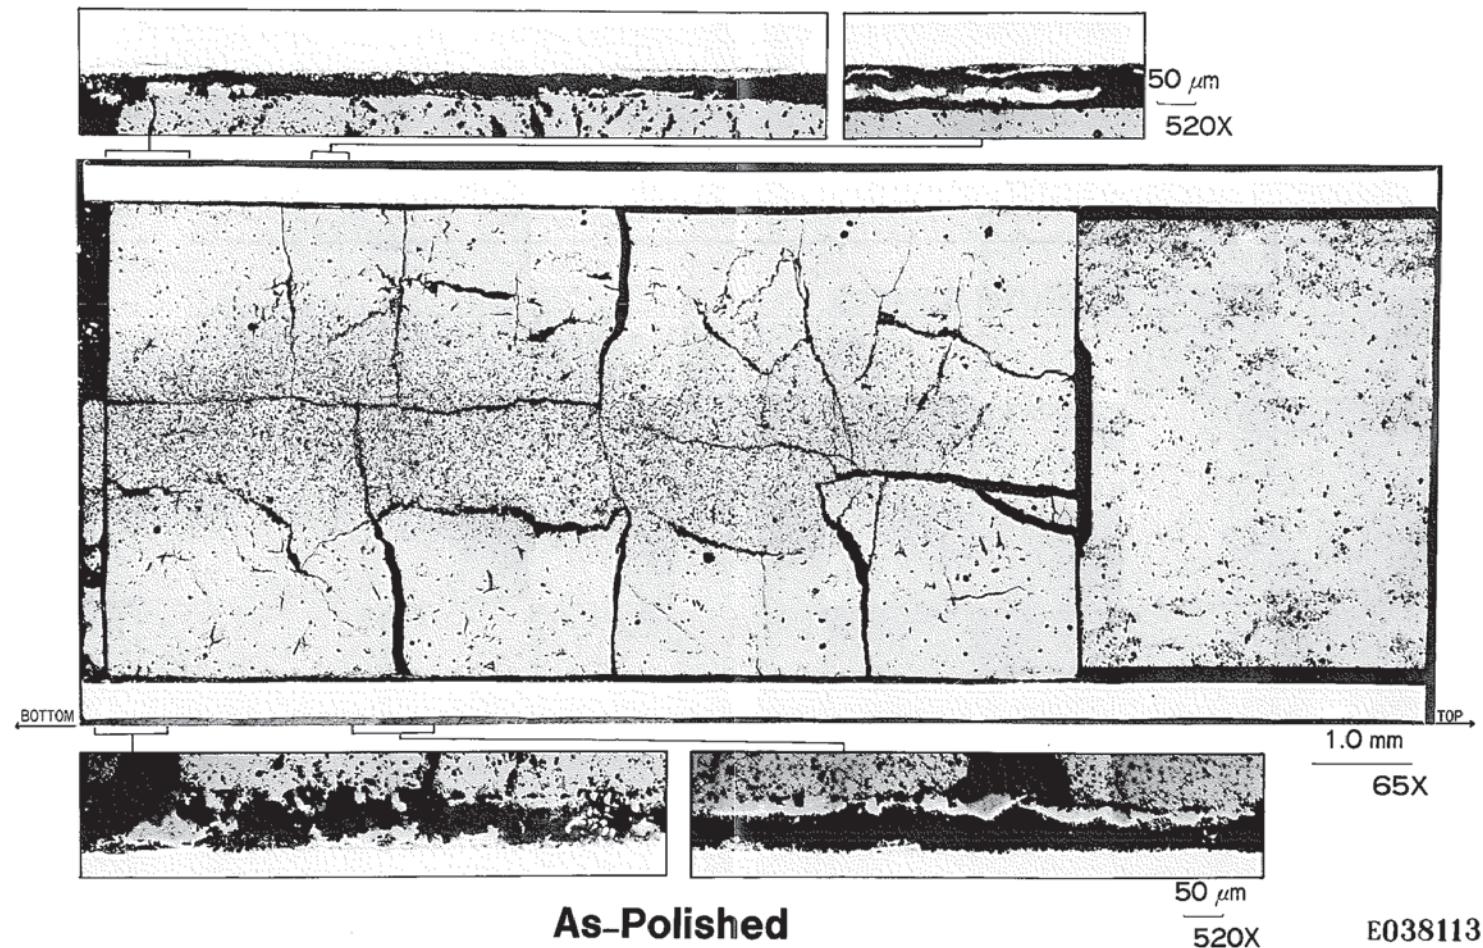
Photo.0-14 Optical Micrograph of the Longitudinal Section of the Core  
and Blanket Fuel Pin (Specimen No. 815285) As-Polished

本試料は、炉心燃料と上部インシュレータ境界部を含む縦割り試料でありPhoto.0-14にそのAs-Polished状態の光顕写真を示す。燃料組織は、試料No.815282とほぼ同様である。被覆管内面は、剥離が見られインシュレータ境界には、全面腐食も認められる。インシュレータペレットには、組織変化及びクラックは見られず、製造時の状態を保持している事がわかる。

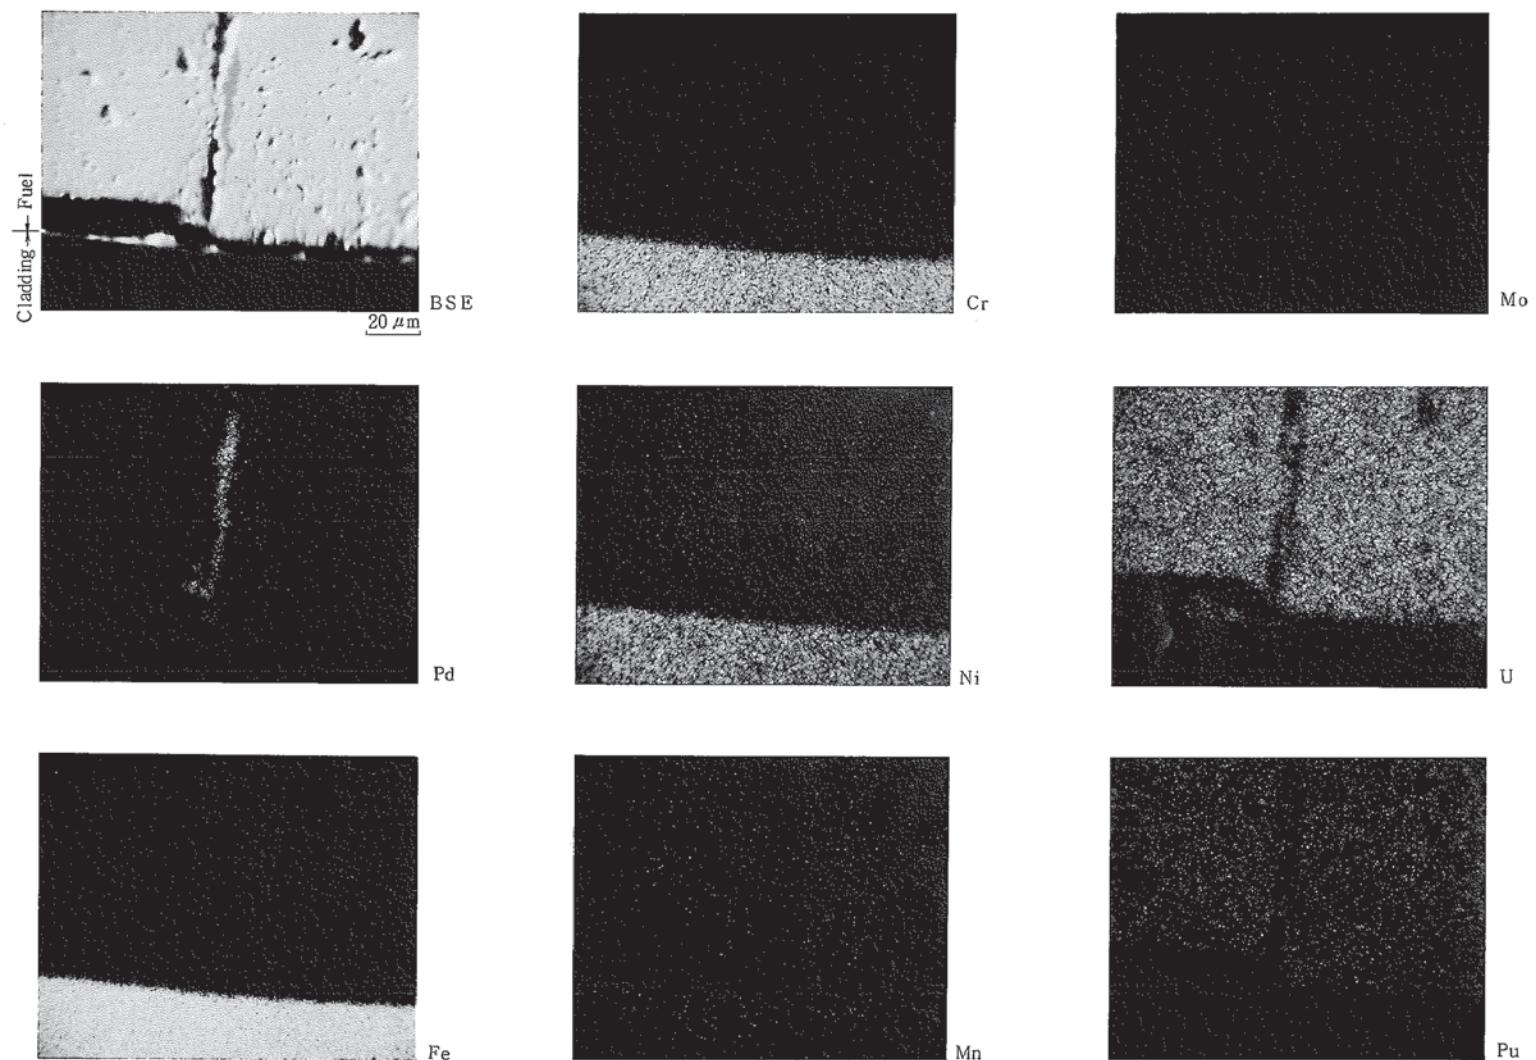
Photo. E-1 Various X-ray Images of the Metallic Inclusion  
in the Crack (Specimen No. 815244)

ピン最高線出力位置の横断面試料No.815244の燃料内F・P分布を調べた。燃料内には、Pd相とMo, Ru, Rh, Tc, Pd相の2種の金属状FP析出物が観察される。Pd相の観察される位置は、燃料クラック内であり、その面分析結果をPhoto.E-1に示す。

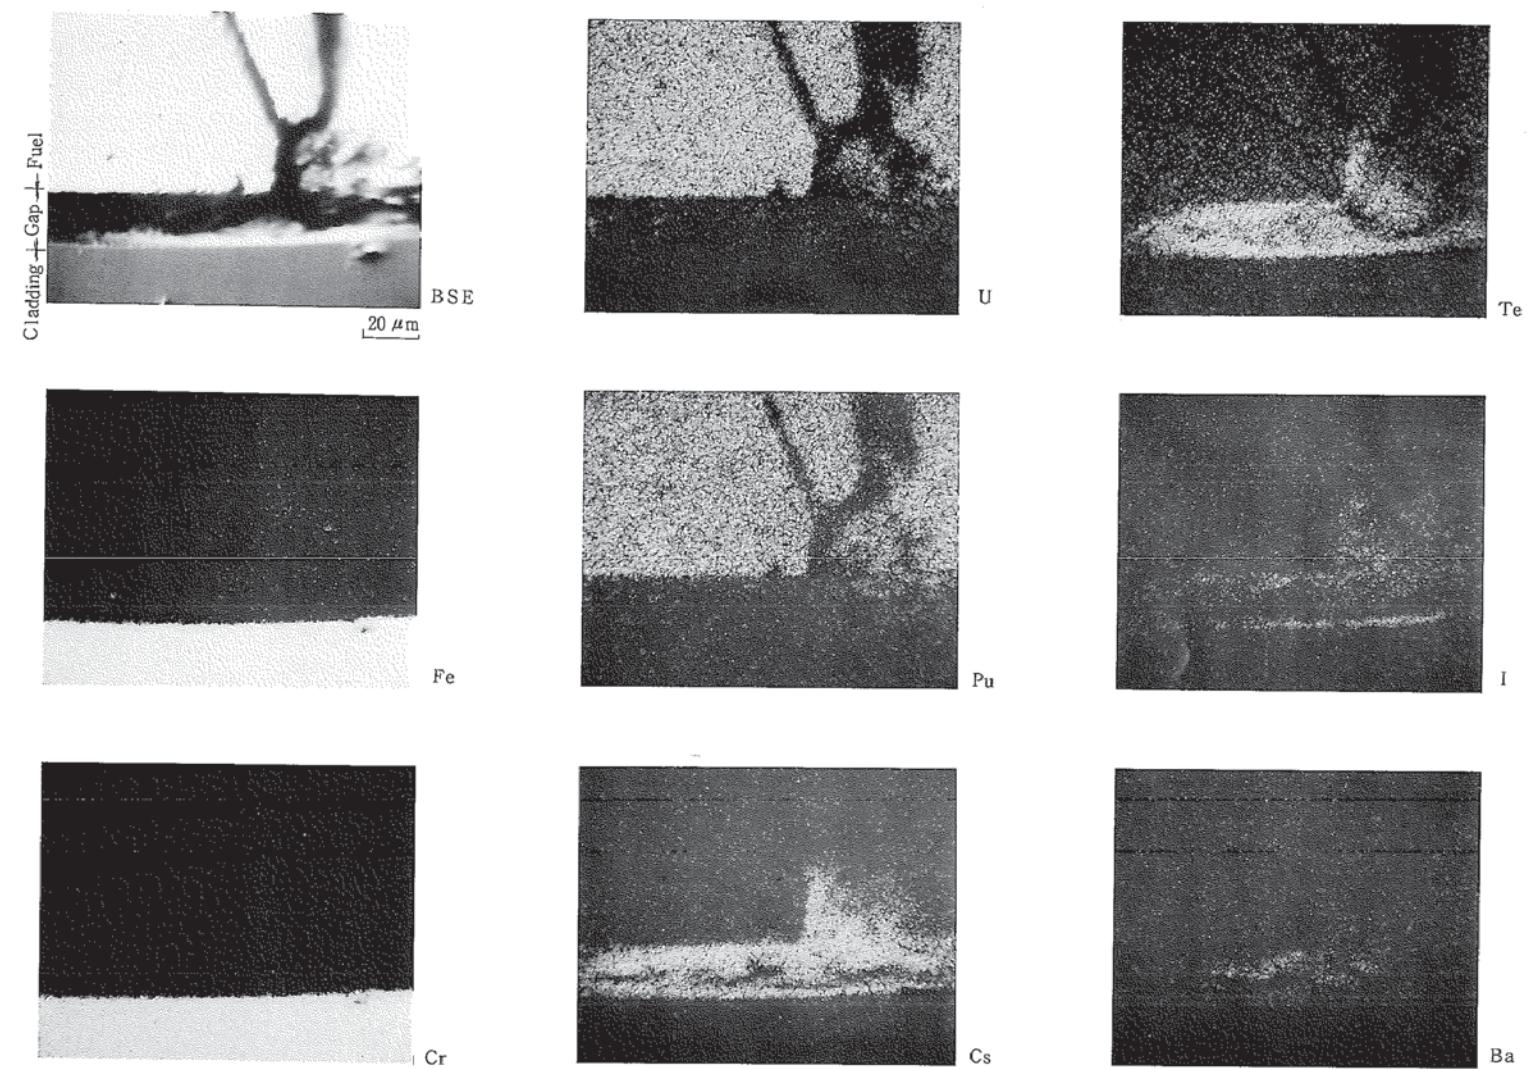
Photo.E-2 Various X-ray Images of the Gas Part between the Core Fuel and Cladding (Specimen No. 815226)

Photo.E-2, 3に面分析結果を示す。ギャップ内にCs, Te, Ba, Iの揮発性FPが蓄積しているものの、被覆管構成元素の溶出は、まったく認められない。

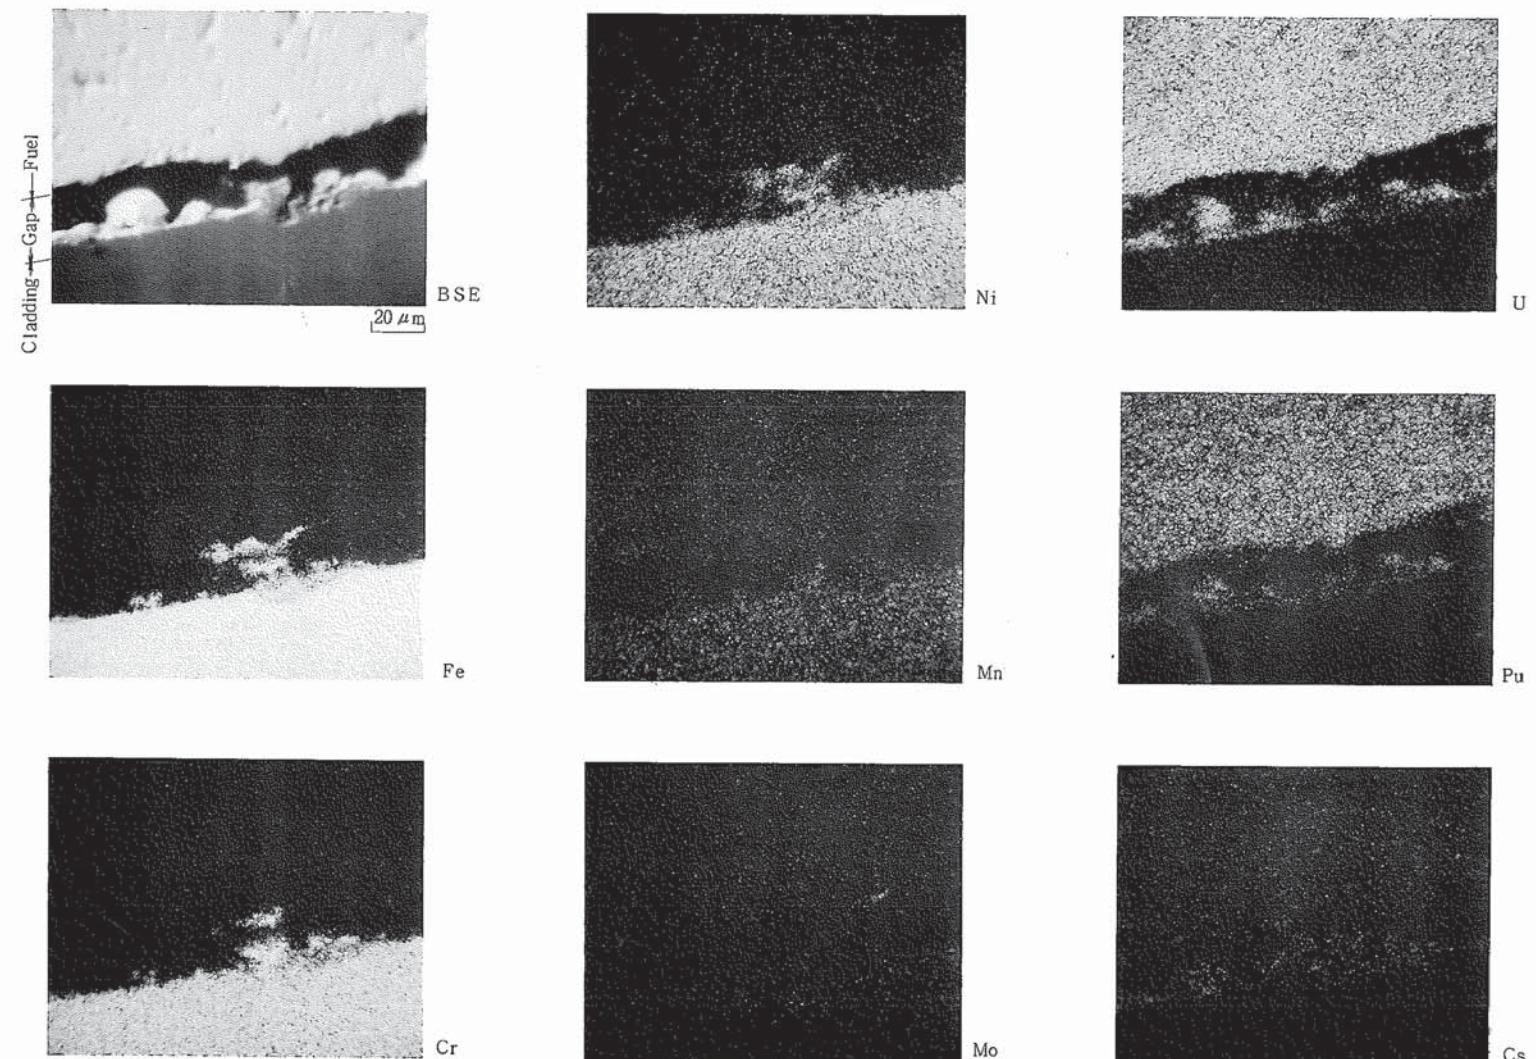
Photo.E-4 Various X-ray Images of the Gap Part between the Core Fuel and Cladding (Specimen No. 815244)

Photo.E-4, 5に面分析結果を示す。ギャップ内にCs, Te, Pd, Ba, IのFPが存在し、U, Puも同時に認められるが被覆管構成元素の溶出は、ほとんど認められない。

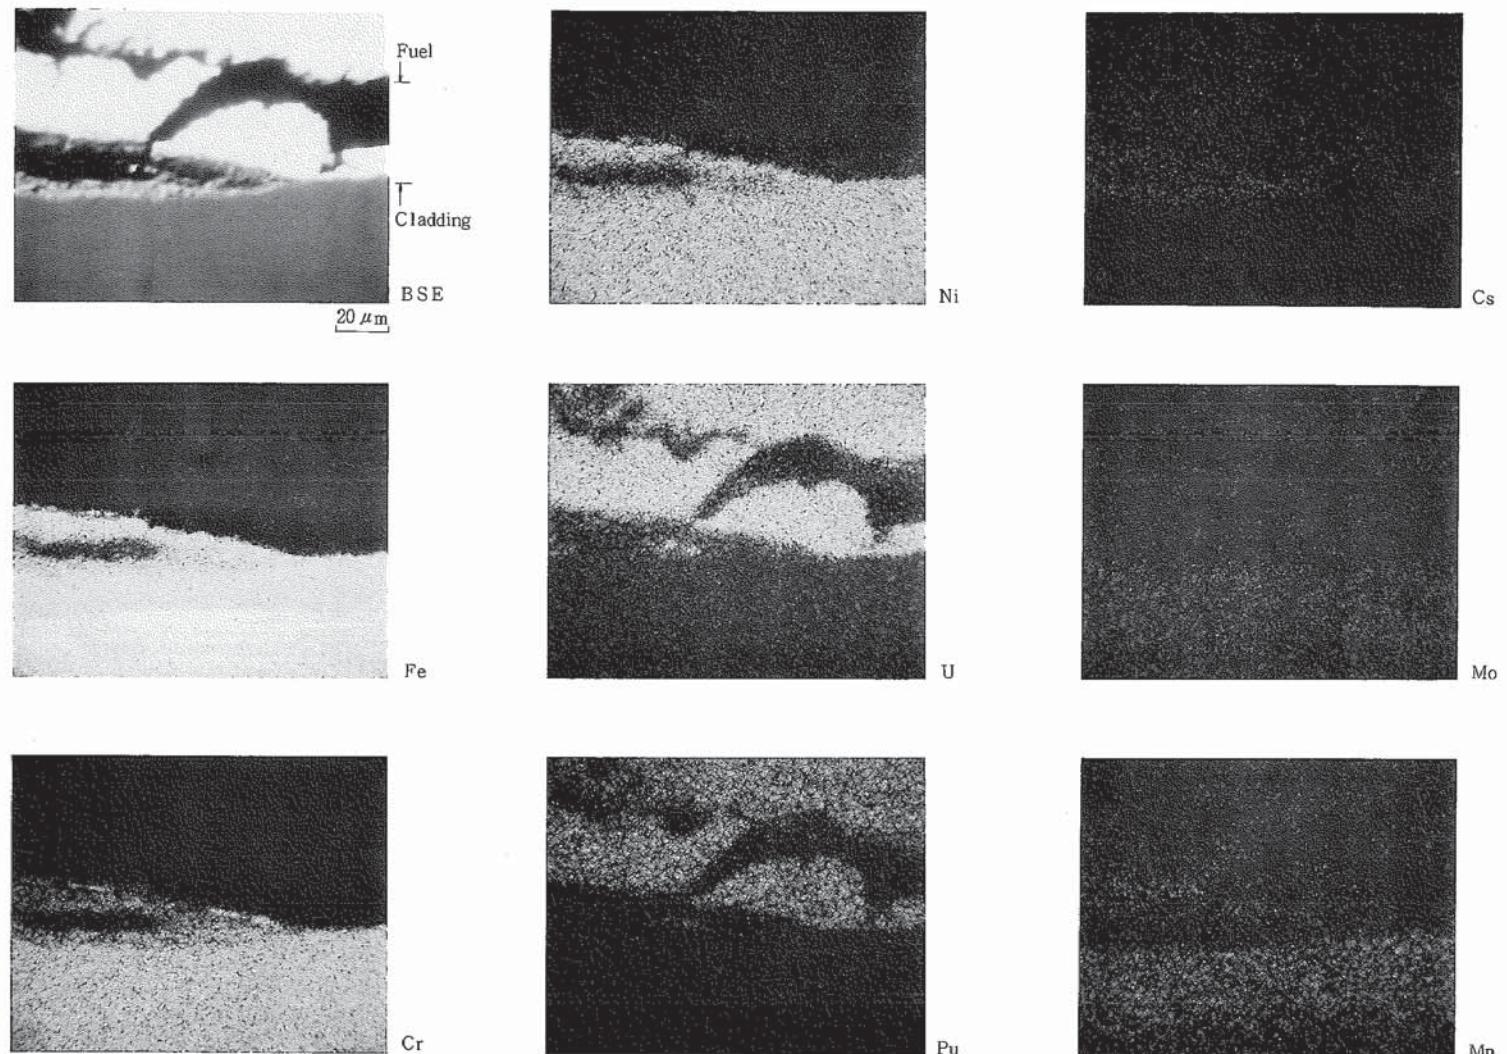
Photo.E-6 Various X-ray Images of the Gap Part between the  
Core Fuel and Cladding (Specimen No. 815262)

Photo.E-6に面分析結果を示す。被覆管構成元素(Fe, Cr, Ni, Mn)の一部剥離が観察される。
