# 「常陽」MK-II炉心燃料(PFD001)の 照射後試験(2)

燃料要素の組織観察及び機器分析  
(Vol. 2 データ編)

技術資料コード	
開示区分	レポートNo.
T	N9410 87-189 Vol.2

動力炉・核燃料開発事業団  
大洗工学センター

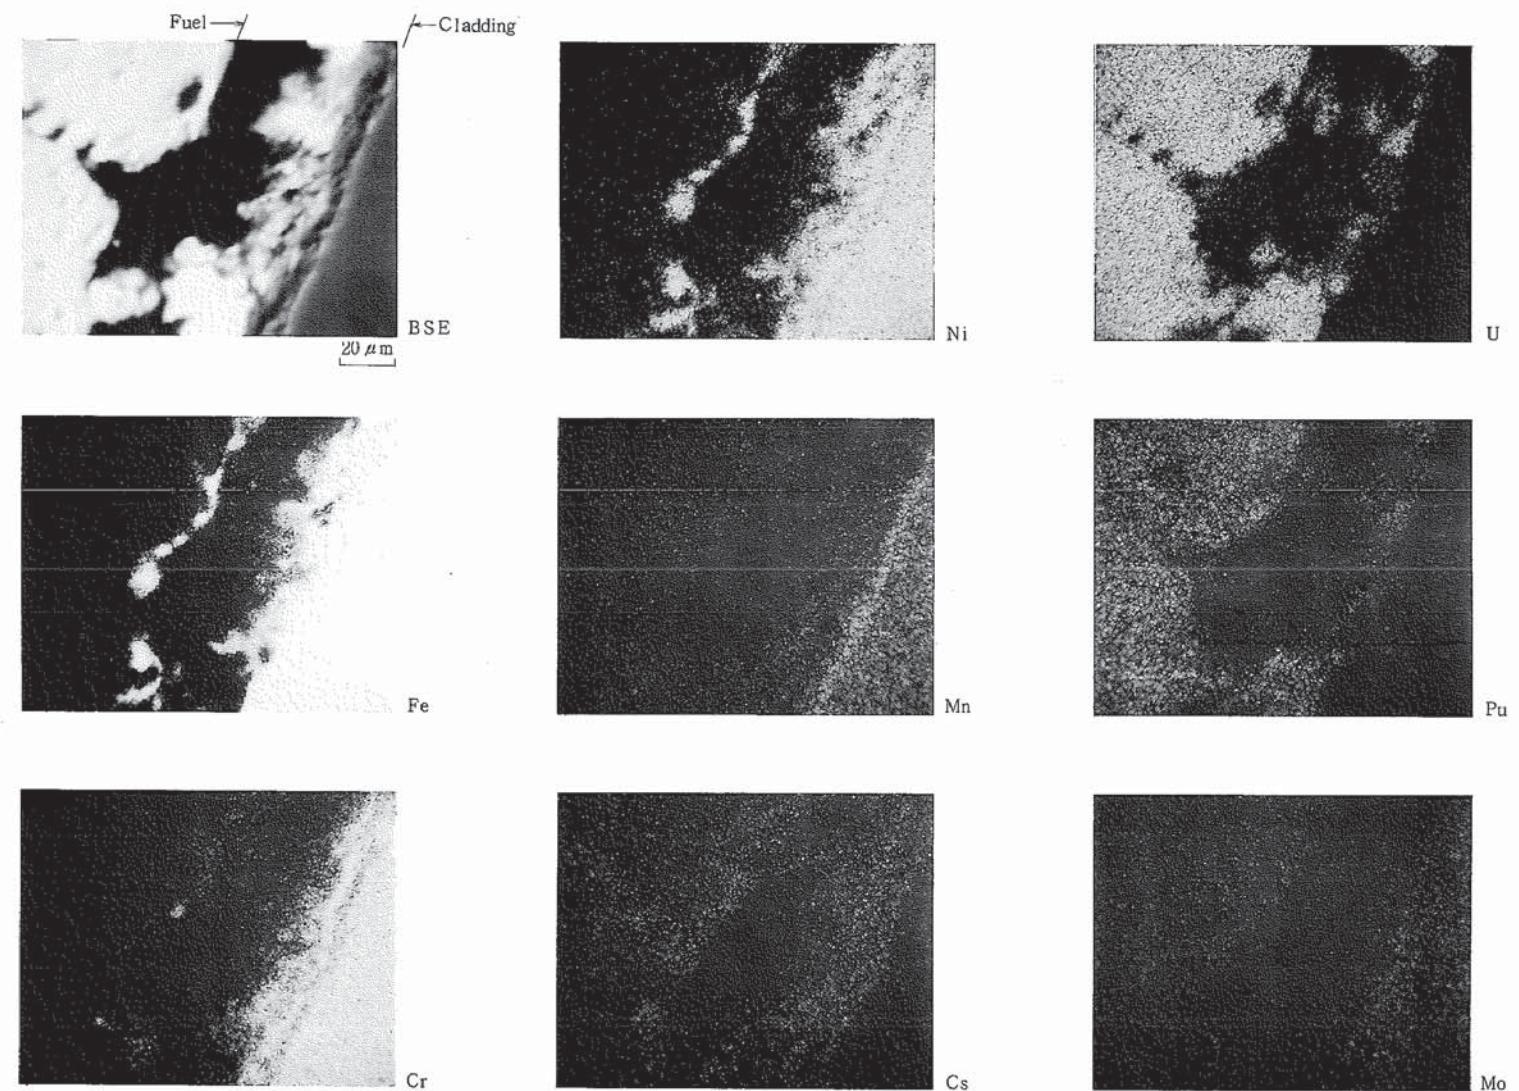
Photo.E-7 Various X-ray Images of the Gap Part between the Core Fuel and Cladding (Specimen No. 815285)

本試料は、被覆管内面温度が最も高い炉心燃料上端部の試料であり、そのギャップ部の面分析結果をPhoto.E-7, 8に示す。ギャップ中へのCsの蓄積と被覆管構成元素(Fe, Cr, Ni, Mn)の溶出が顕著に認められる。また、Photo.E-9にインシュレーター炉心燃料境界部を含むギャップ部のCs分布測定結果を示す。Csは、インシュレーター炉心燃料境界部及びインシュレーター側のギャップ部にも存在している事がわかる。

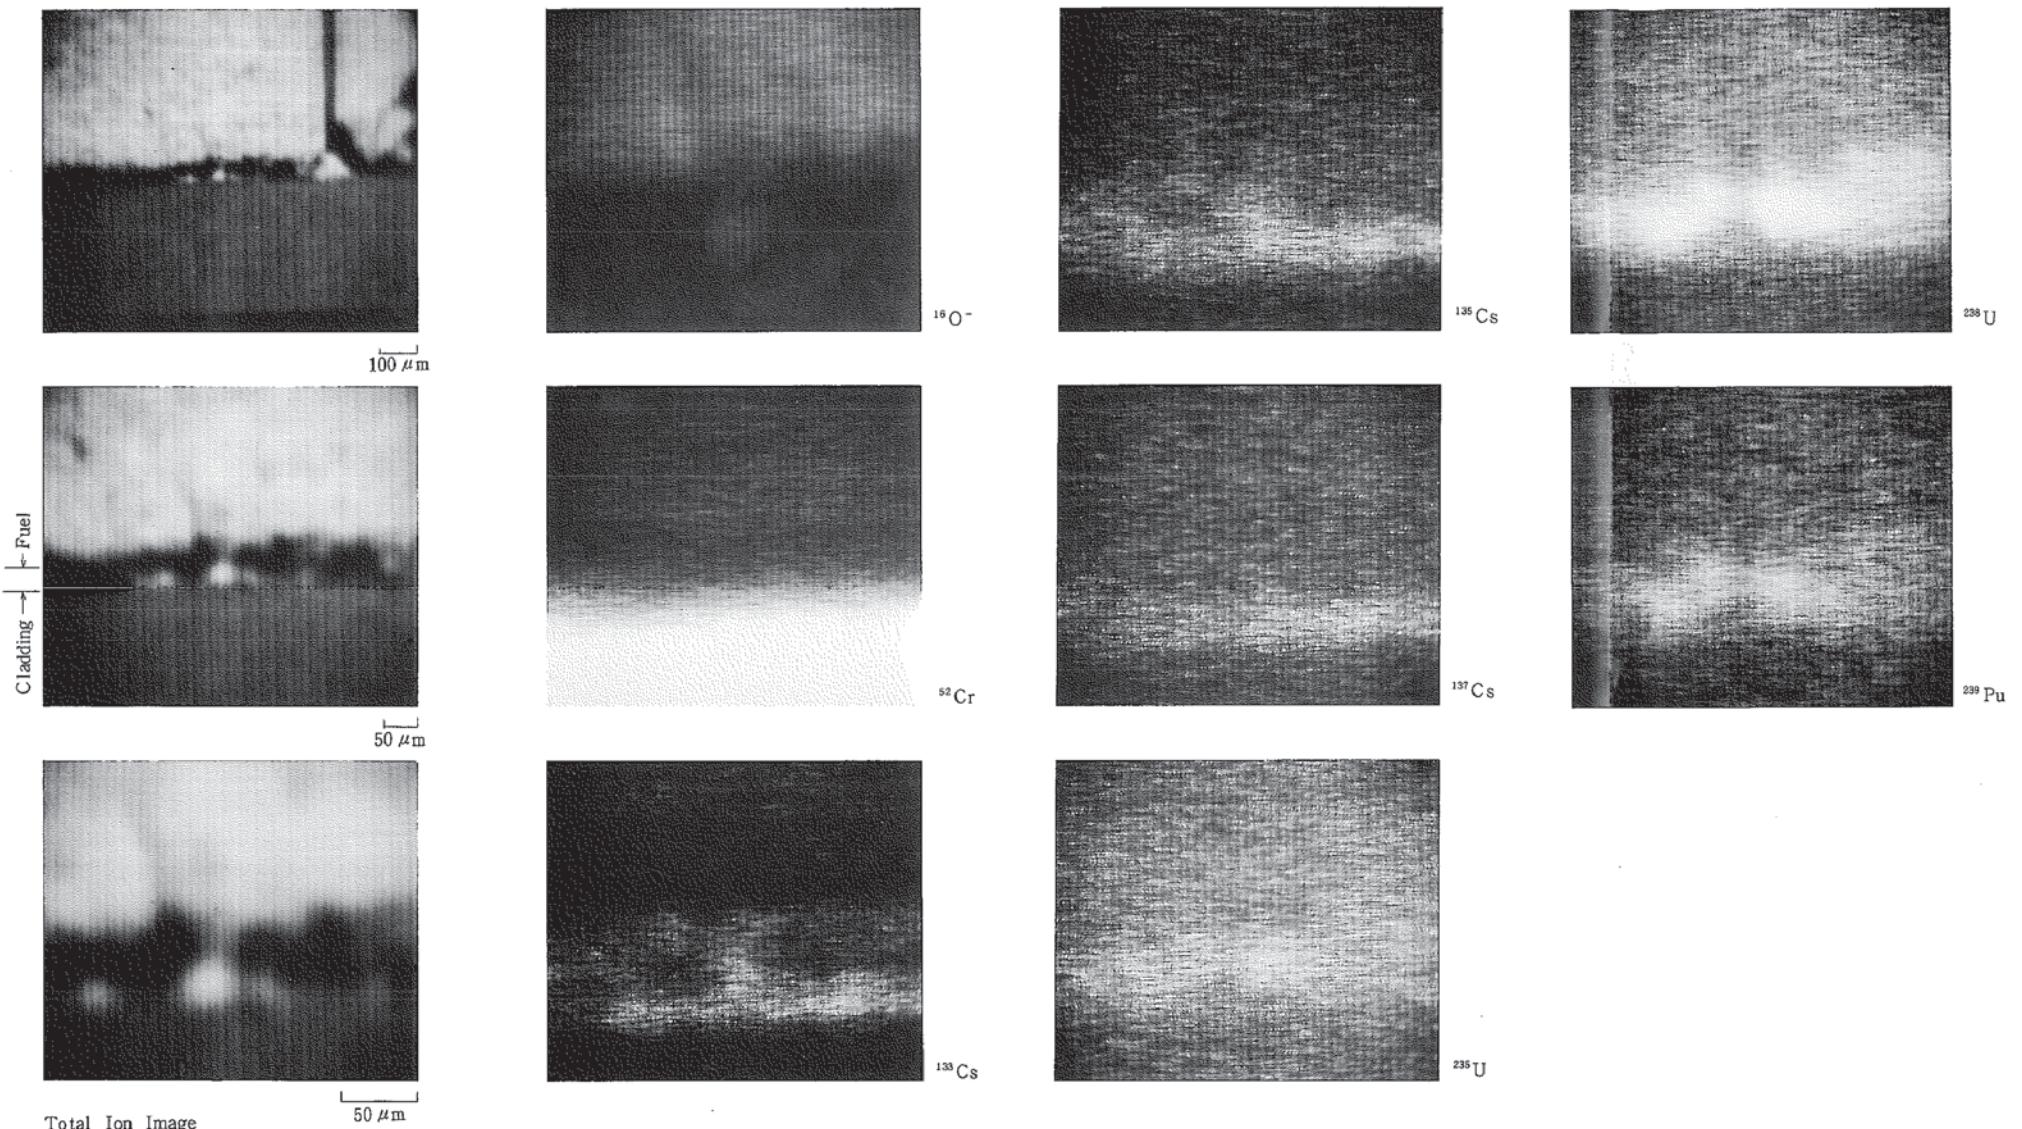
Photo.I-1 Ion Images of the Gap Part between the Core Fuel  
and Cladding (Specimen No. 815285)

燃料上端部 (No. 815285) の燃料 - 被覆管境界部の面分析結果を Photo. I-1, 2 に示す。ギャップ部には、 $^{133}\text{Cs}$ ,  $^{135}\text{Cs}$ ,  $^{137}\text{Cs}$  が観察され、これらの各核種は、被覆管内面及び燃料外周部に蓄積していることがわかる。酸素の強度は、燃料外周部で強くなっている。
