## Investigation on Integrity of Heat Exchanger and Tanks in Primary Cooling System of JMTR

Ryuji ONOUE, Hiroyuki EBISAWA, Akitomi FUKASAKU and Tsuyoshi KUSUNOKI

Department of JMTR Operation  
Neutron Irradiation and Testing Reactor Center  
Oarai Research and Development Center

December 2010

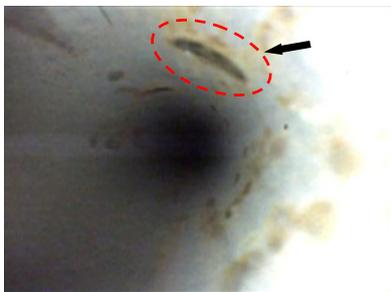
According to the result of eddy current testing, we observed tube surfaces using an endoscope, and confirmed color change and pitting corrosion. Some observed results are shown in figure 5. It is observed that there are minor corrosion, color change, pitting corrosion, deformation and separation of oxide film ((a) ~ (d) in figure 5). Photo (c) shows a pipe in which ETC probe could not insert. Photo (e) shows a step part of inner surface. Photo (f) shows a sample of reference specimen which is adjusted to the thinning rate at 30%. We evaluated that there is no significant corrosion and decrease of tube thickness from the result of the comparative testing using some reference specimens.

(a) No.1 Corrosion color change in outlet side straight pipe

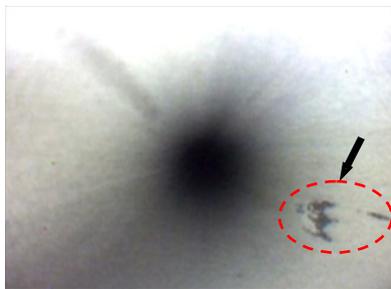
(d) No.2 Separation of oxide film from outlet side straight pipe

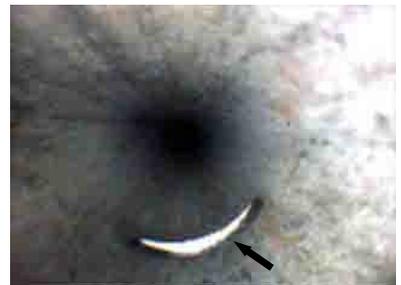
(f) Reference specimen (thinning rate at 30%)

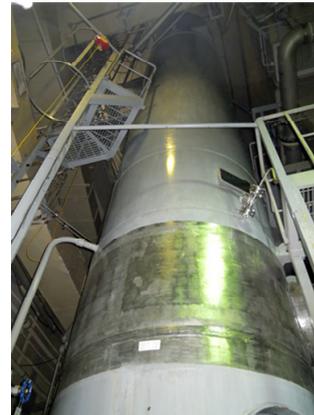
- The inside tube walls of primary coolant system heat exchangers are prevent from rusting and SCC.
  - Because ;
    - the tubes are made of austenite stainless steel
    - the quality of primary cooling water is kept
    - the temperature of water is low (below 49 degrees C)
- On the other hand, it has possibility of pitting corrosion or SCC by chloride ion
  - Because :
    - hypochlorite is used as sterilizer in the secondary cooling water.
- But degree of corrosion is inhibited by an anticorrosion additive in the secondary cooling water.
- It has a potential for thinning of baffle plates with fluid oscillation.
- We carried out following investigations to identify the integrity of heat exchangers for the reason stated above.

- (1) Eddy current testing for heat exchanger tubes
- (2) Visual observation using endoscope
- (3) Penetration test of tube plates
- (4) Thickness measurement of the main body

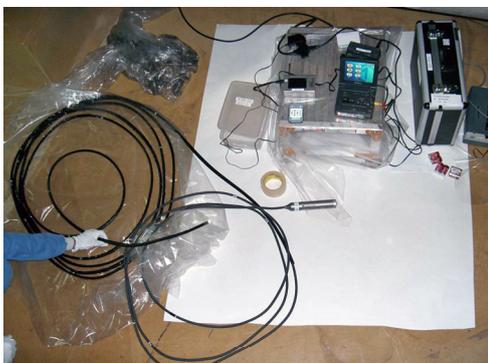
Whole apparatus

- Visual observation was carried out.
- Using an endoscope for the heat exchanger tubes .
- Target ;
  - Evaluated part as the thinning of the thinning rate 20% or more according to the eddy current testing
  - Part that had not been measured by eddy current testing.

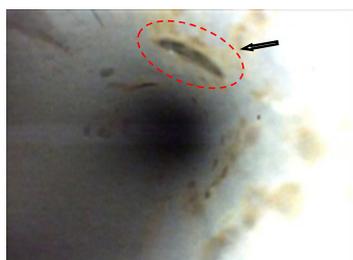
No.1 Outlet side strait pipe corrosion, color change

- According to the result of eddy current testing, we observed surface of these tubes using an endoscope. Some observed results are shown here.
- We evaluated that there is no significant corrosion and decrease of tube thickness

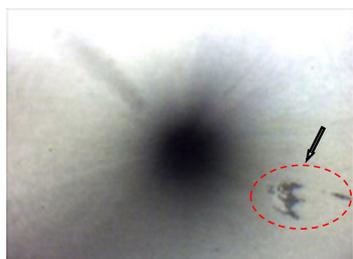
No.2 Outlet side strait pipe separation of oxide film

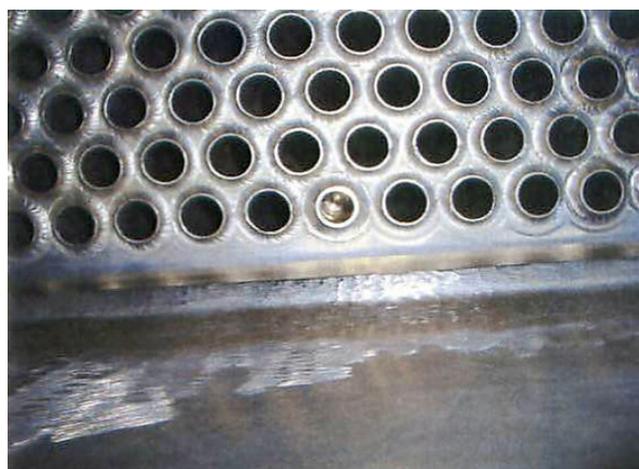
- Penetration test was carried out for the depressed portion
- that had been observed by photography of surface of the tube plate.

- No defect indication was found at the positions that depressed portion had been observed by photography of surface of the tube plate.

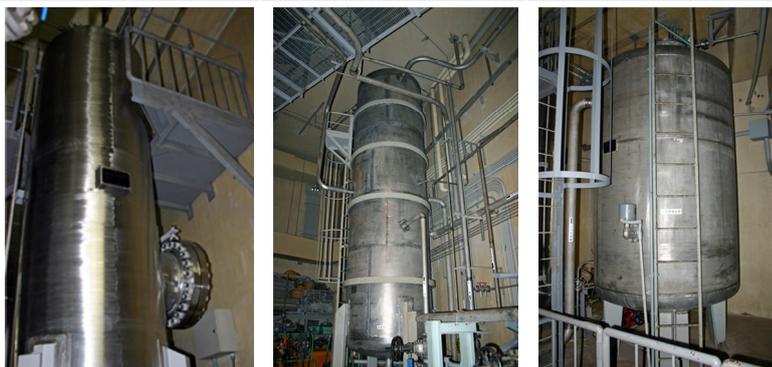
## 13. Investigation items for tanks

surge tank	degas tank	purify water tank
Visual Inspection	O	O	O
penetration testing	-	O	O

- Though the surge tank was replaced in 1997, visual inspection was carried out for the inner surface in order to confirm that it is able to use the tank over the long term.
- The degas tank and the purify water tank have been used for about 40 years.
- Visual inspection and penetration testing for welding region were carried out for the degas tank and the purify water tank to confirm their integrity.
