FUEL FAILURE BEHAVIOR OF PCI-REMEDY FUELS UNDER
THE REACTIVITY INITIATED ACCIDENT CONDITIONS

May 1980

Tsutao HOSHI, Koji IWATA, Tomio YOSHIMURA^{*}
and Michio ISHIKAWA

Division of Reactor Safety, Tokai Research Establishment, JAERI

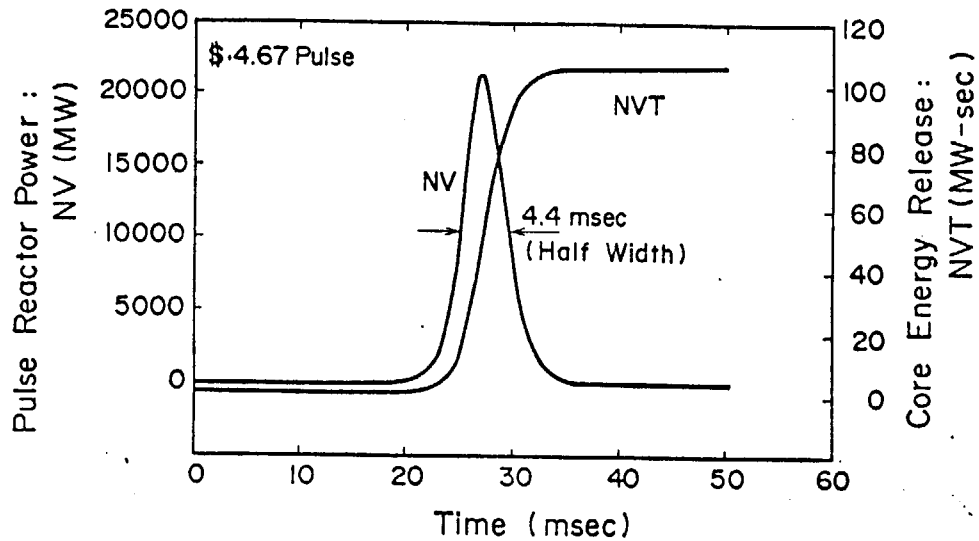
Fig. 3 Histories of reactor power and core energy release in case of maximum reactivity insertion

Pulsing power is realized by quick withdrawal of transient rods and the maximum reactor capabilities in pulse operation are the peak reactor power of 21,000 MW, total energy release of 117 MW-sec with the pulse width of 4.4 msec as shown in Fig. 3. The major characteristics of the NSRR is shown in Table 1.

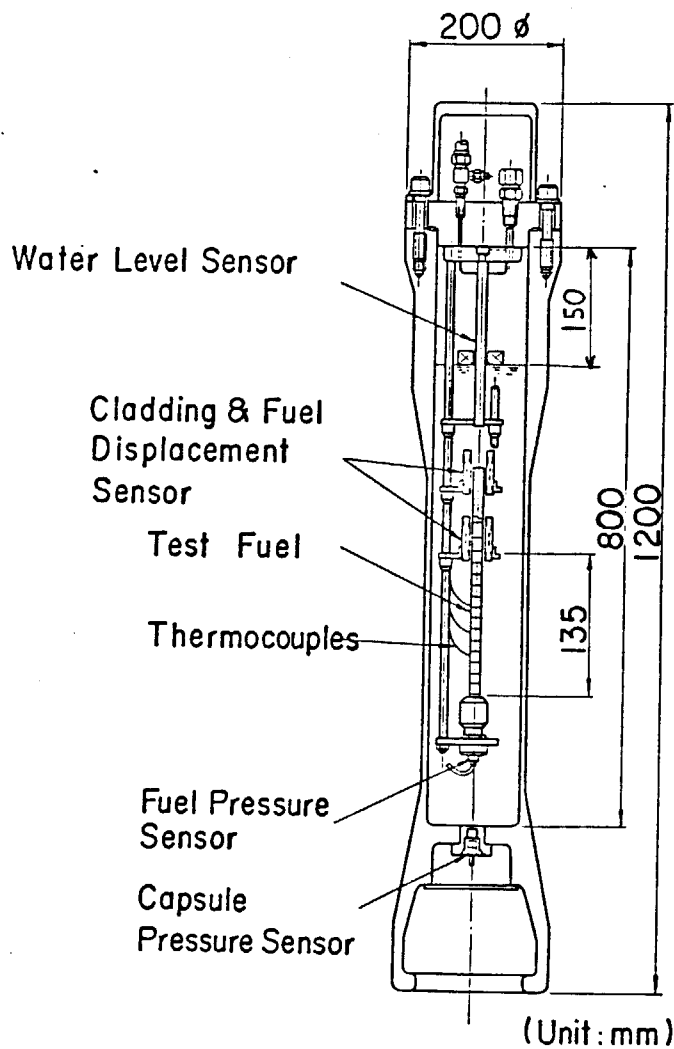
Fig. 4 Standard water capsule

In these experiments, the NSRR standard water capsule was used. Fig. 4 shows the capsule in which the test rod is supported at the center. Cooling water is filled up to 22 cm below the top of capsule flange.

Major instrumentations in the capsule are indicated in Fig. 4.

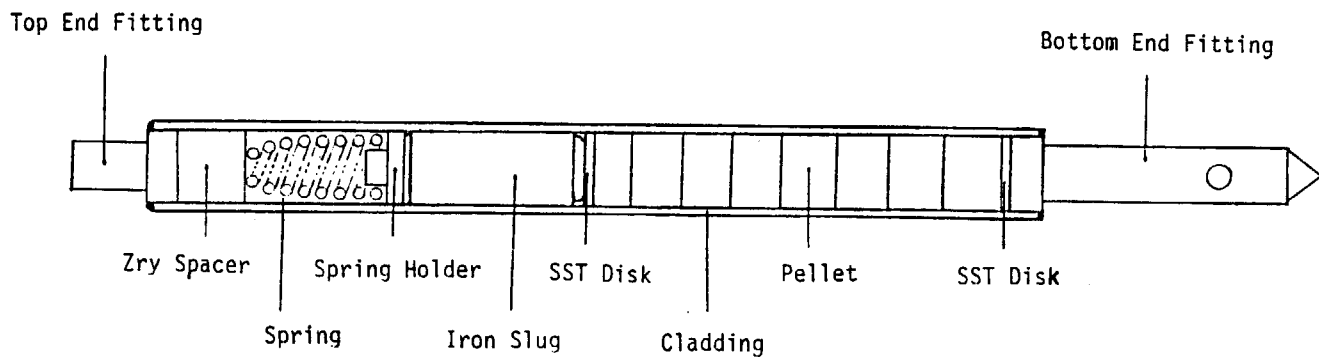
Fig. 5 GE fuel element

Zr-lined cladding fuel rod has a zircaloy cladding with a metallurgically bonded layer zirconium ($\sim 75 \mu\text{m}$) on the inner surface, and Cu-barrier cladding fuel rod has a zircaloy cladding with a very thin layer ($\sim 5 \sim 10 \mu\text{m}$) of copper plated on the inner surface. Schema and design summary of fuel rods tested are given in Fig. 5 and Table 2.

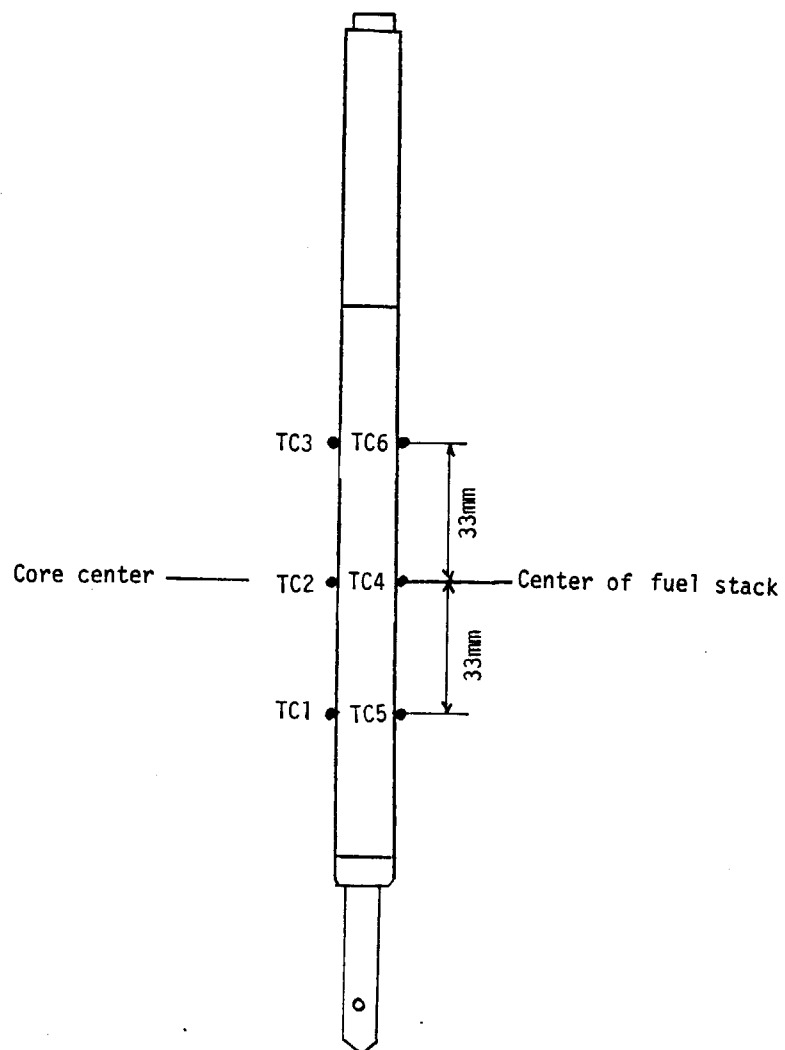
Fig. 6 Location of thermocouples for cladding surface temperature

Characteristics of the sensors are summarized in Table 3 and the location of the cladding surface thermocouples is shown in Fig. 6.

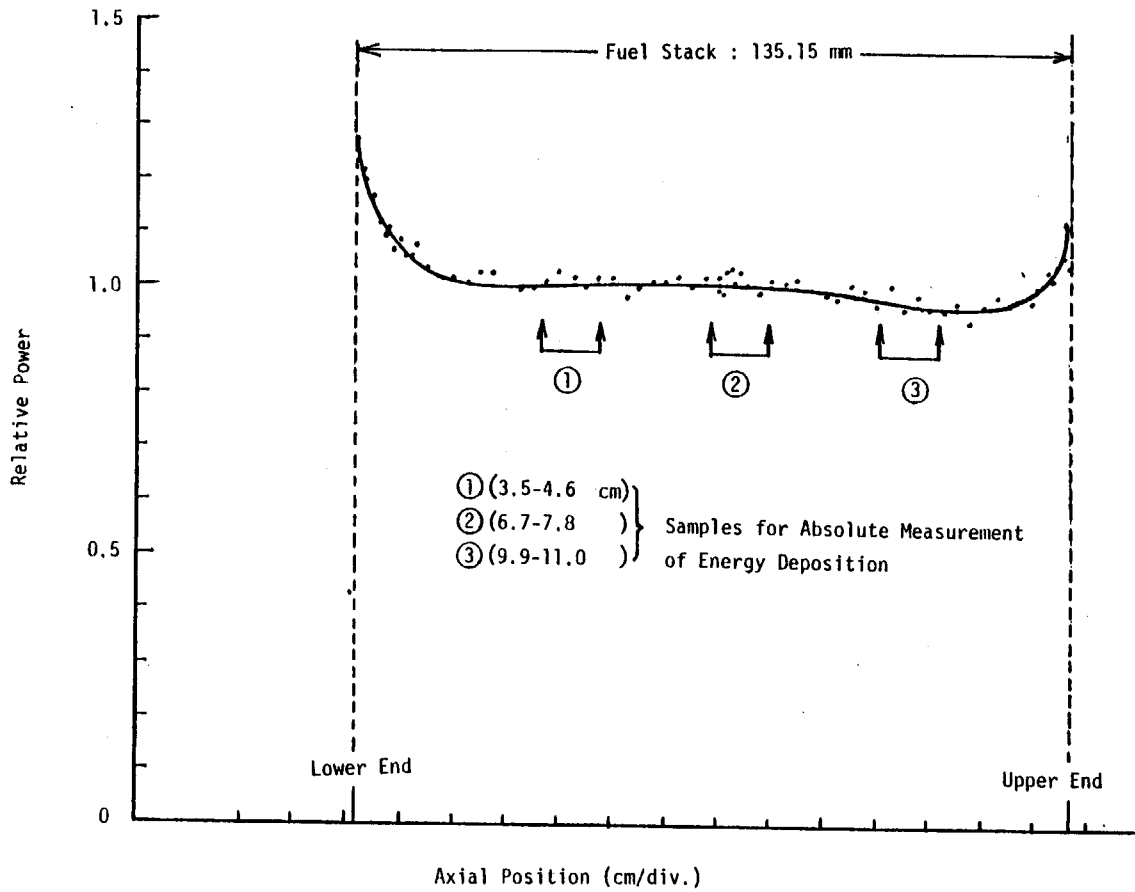
Fig. 7 Axial power distribution : Test No. 501-1

Axial power distribution measured by r-scanning and radial power

distribution calculated are shown in Figs. 7 and 8, respectively.

The core release energy in Test No. 501-1 was 49.6 MW-sec, then the radially averaged energy deposition at axial center position to the GE-fuel rod was $4.21 \text{ cal/g} \cdot \text{UO}_2\text{-MW-sec}$.

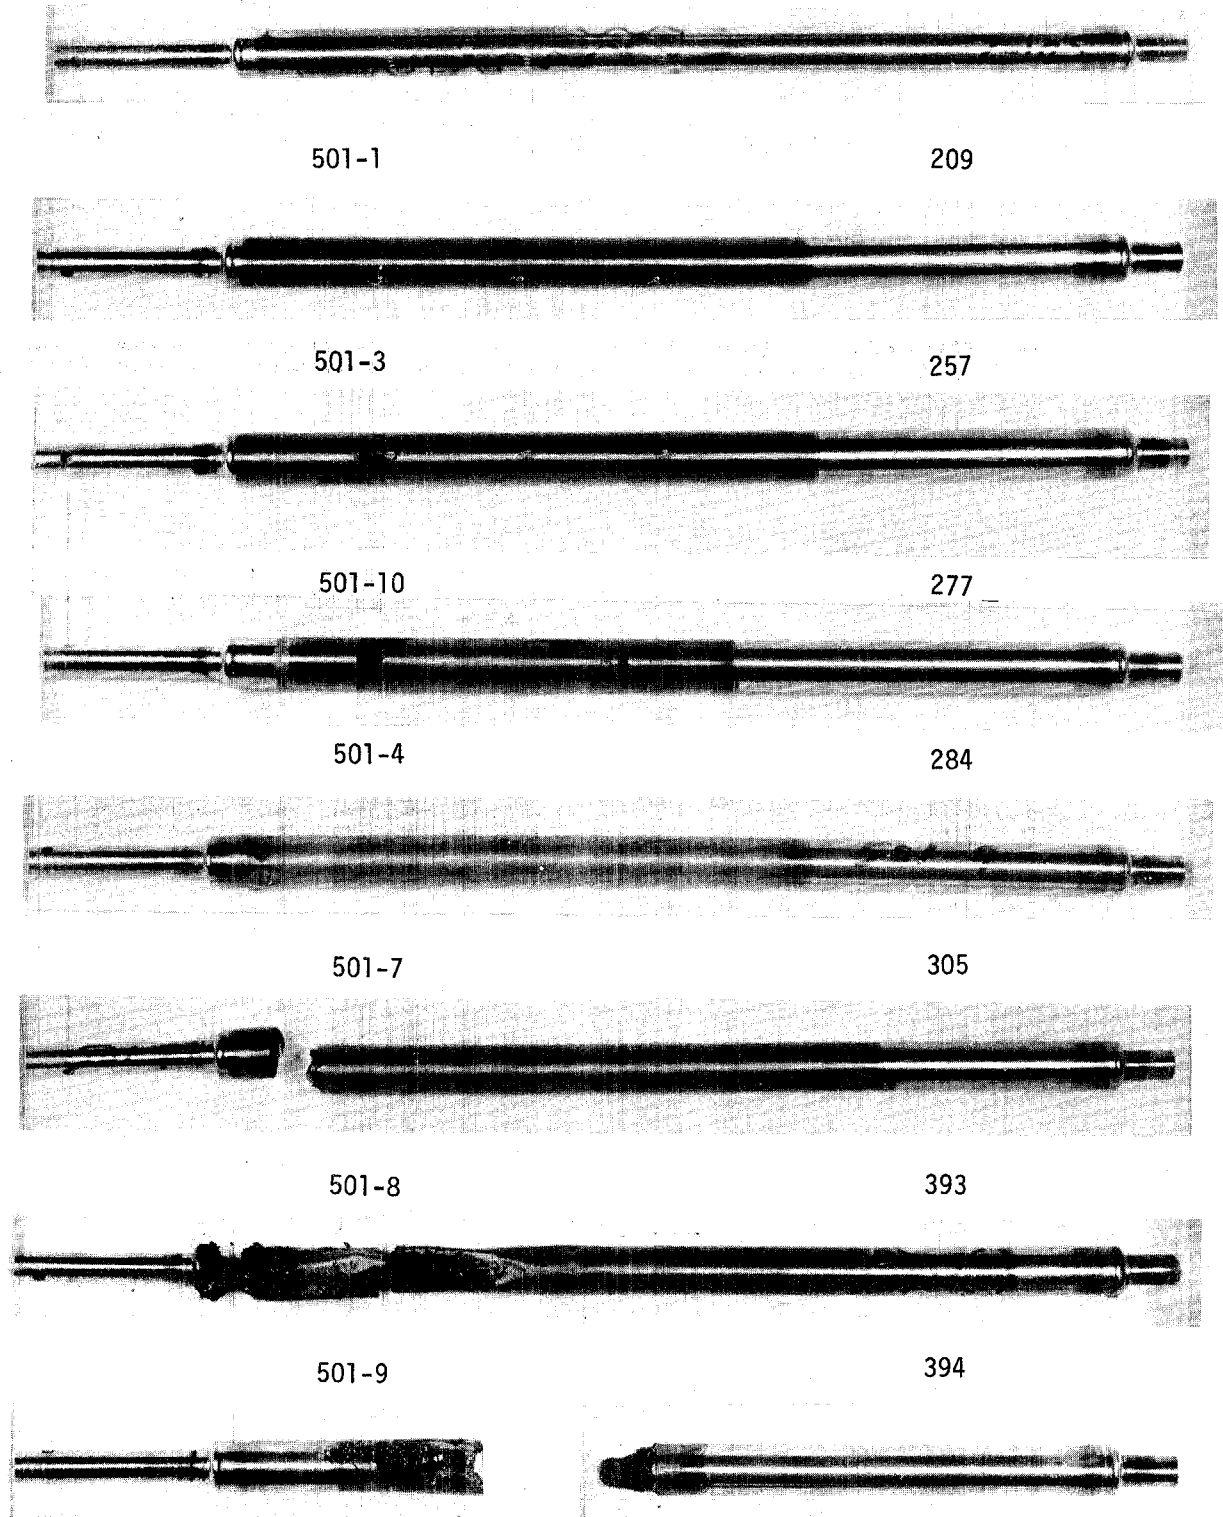
Fig. 9 (1) Post-test photographs of Reference fuel rods

The appearance, X-ray photographs and neutron radio-graphs of irradiated fuel rods are shown in Figs. 9, 10 and 11 and magnified view for the typical portion of failed fuel rods are shown in Appendix A.

The figure consists of eight horizontal photographs of fuel rods, each corresponding to a row in the table above. The rods are dark, cylindrical, and have various components at their ends, including what appear to be electrical connectors or cladding. The rods are arranged vertically, one above the other, with some showing signs of wear or damage at the ends.

Reference type fuel (Test series 501): Reference type fuels were tested at energy deposition of 169 cal/g·UO₂ (Test No. 501-2), 209 (501-1), 257 (501-3), 277 (501-10), 284 (501-4), 305 (501-7) and about 390 cal/g·UO (501-8 and 501-9).

In Test No. 501-2, (169 cal/g·UO₂), the cladding was partially oxidized and it is concluded that the DNB condition just occurred.

The fuel rod in Test No. 501-1 (209 cal/g·UO₂) was fully oxidized and, in Test No. 501-3 (257 cal/g·UO₂) and 501-10 (270 cal/g·UO₂) oxide flakes were observed in both rods, but neither of the fuel rods failed.

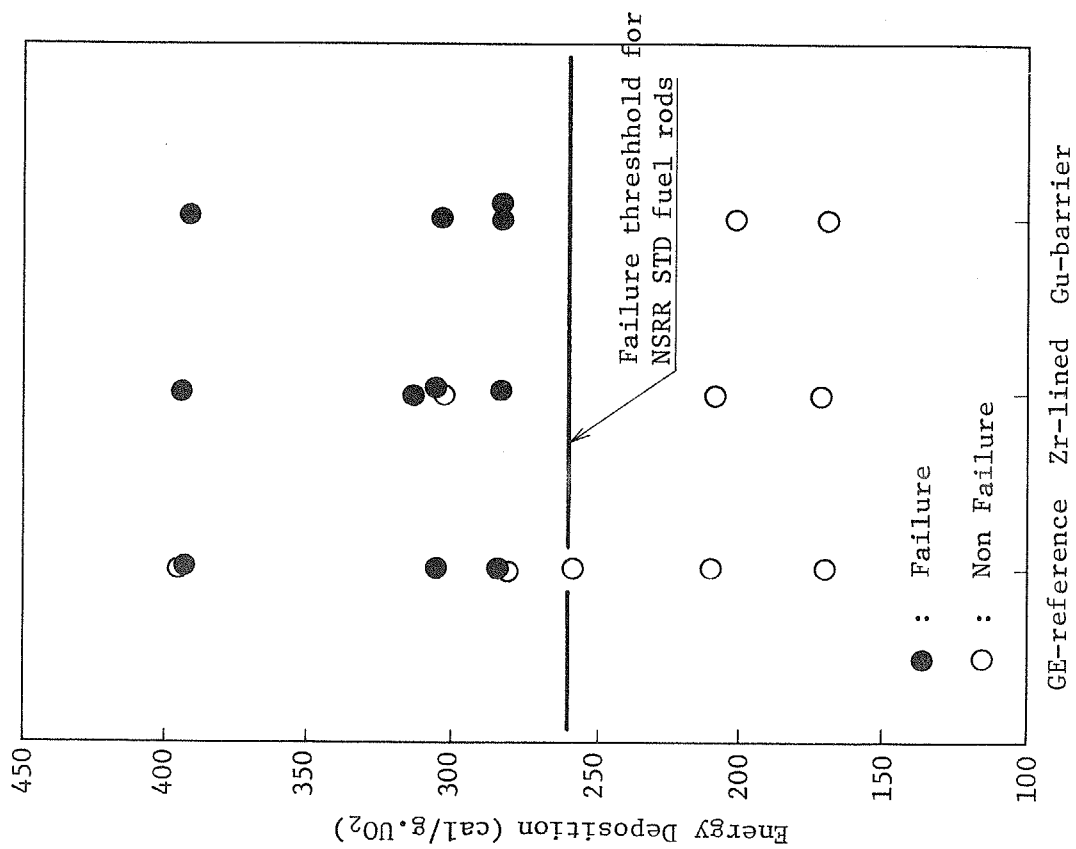
Fig. 12 Comparison of failure threshold for GE fuel rods

Failure thresholds for each type of fuel rod are compared in Fig. 12 with that for the NSRR standard fuel rod.

The failure threshold energy for the reference fuel rod and both the remedy fuel rods is 260 to 280 cal/g·UO₂ which is equal to or a little higher than that for the NSRR standard fuel rod. A single exception is that a Zr-lined rod did not fail at 300 cal/g·UO₂ as described in the preceding section.

- (1) Failure threshold energy of GE-reference fuel rod is 260 to 280 cal/g·UO₂ which is equal to or a littler higher than that of NSRR standard rods.

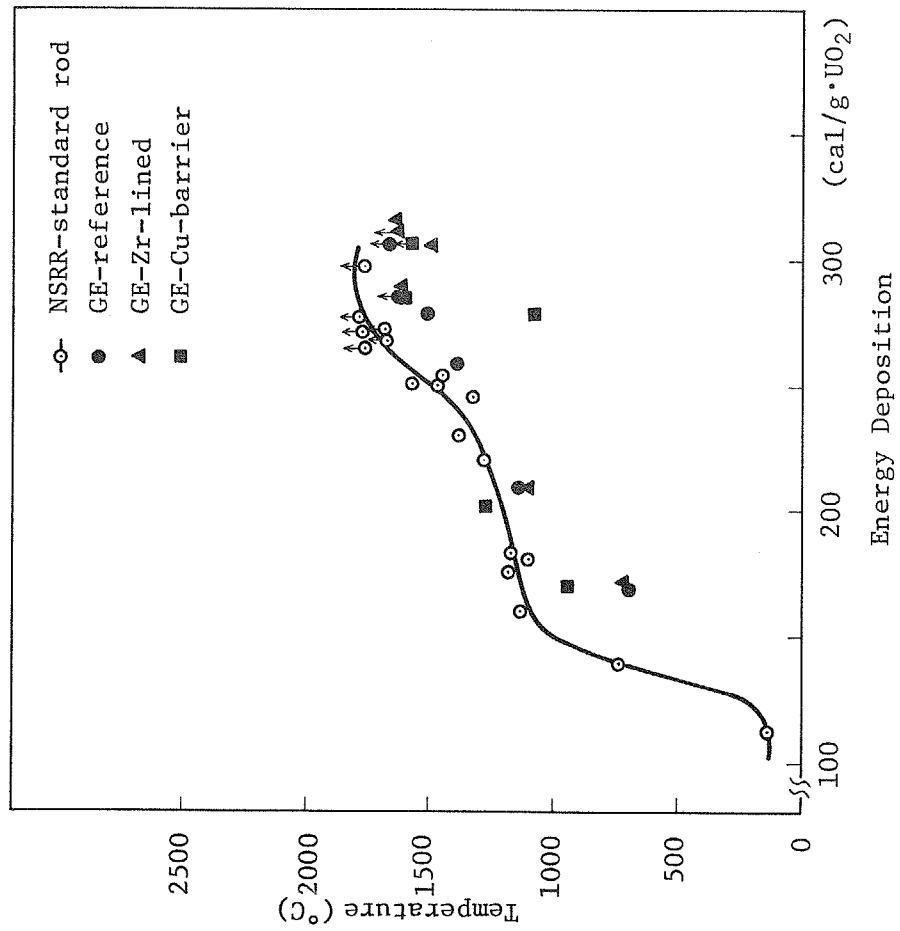
Fig. 13 Max. cladding surface temperature at axial center

The cladding surface temperatures at an energy deposition of 170 cal/g·UO₂ indicate DNB condition occurred in each case.

effect disappeared at high energy depositions, because the zircaloy base reached melting temperature promptly at the energy of near failure threshold.

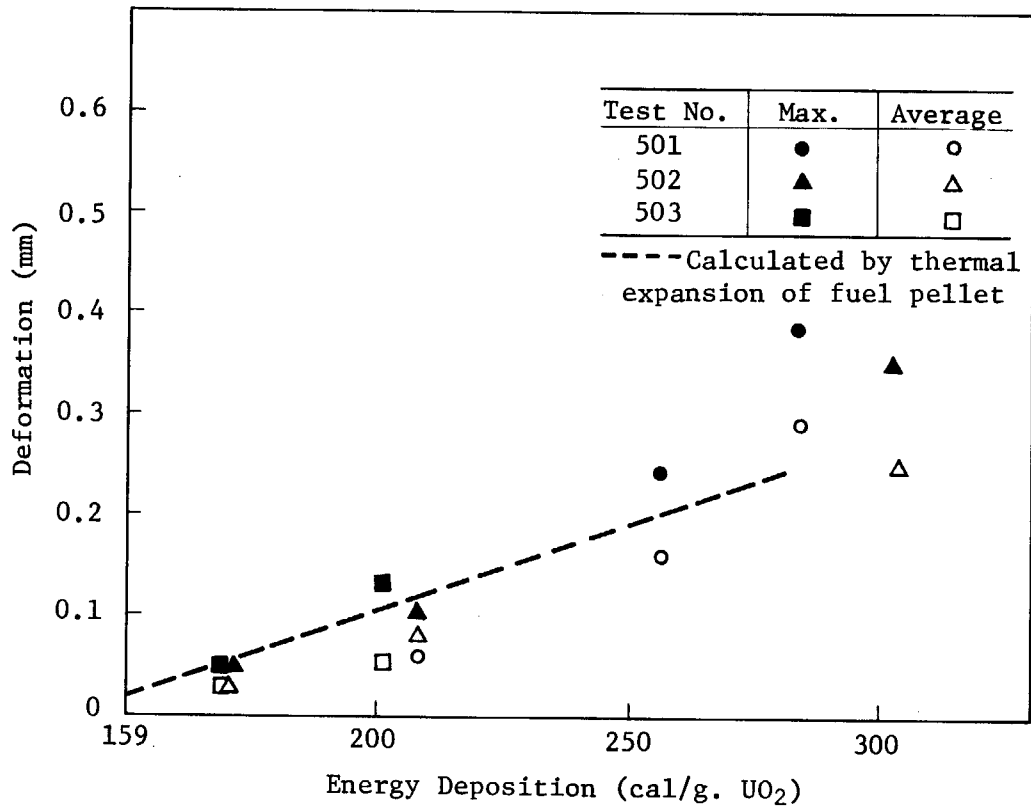
Fig. 14 Max. and averaged radial deformation of fuel rods at axial center of the rod.

Fig. 14 shows the maximum and average deformation at the axial center of fuel rod. Permanent deformation increases with increasing energy deposition and is supposed to be caused by the thermal expansion of the fuel pellet since the deformation measured agrees with the value calculated by the thermal expansion of fuel pellet.

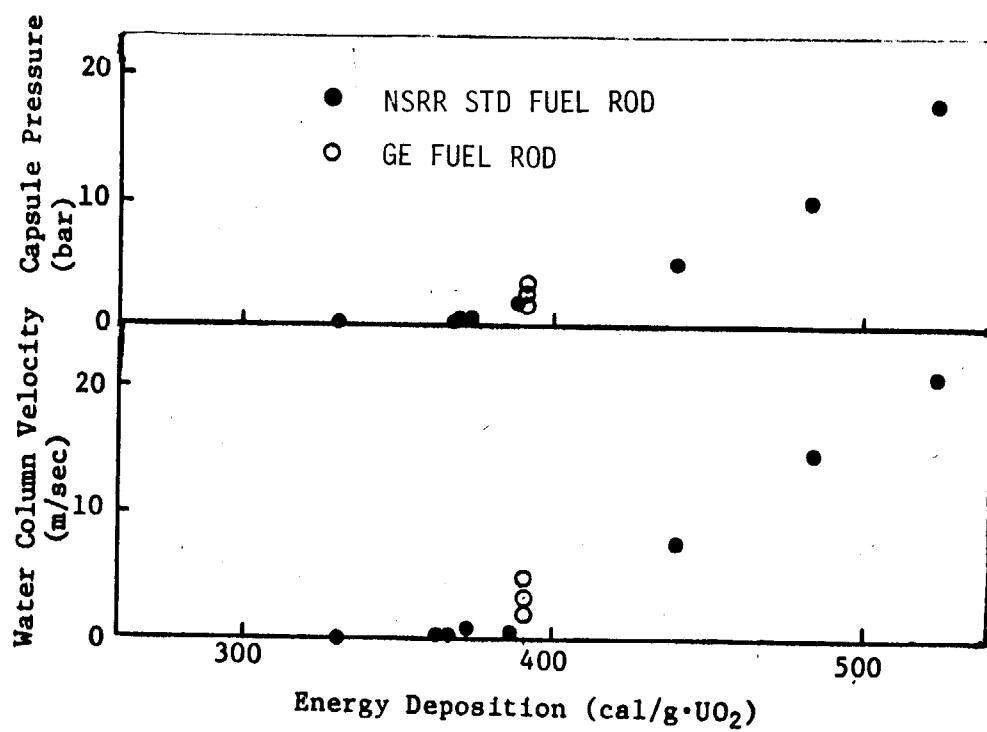
Fig. 16 Energy deposition vs. average water column velocity and max. capsule pressure

If it is assumed that the water column moves upward essentially as a solid body, the mechanical energy generated by the fuel failure can be evaluated by adding the two components, i.e. the kinetic energy of the water column and the energy imparted to the air contained in the top part of the capsule by compression since the potential energy of water column and the strain energy contained within the capsule wall are negligible.

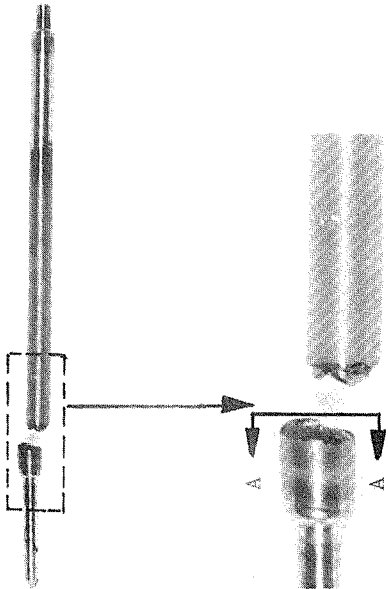
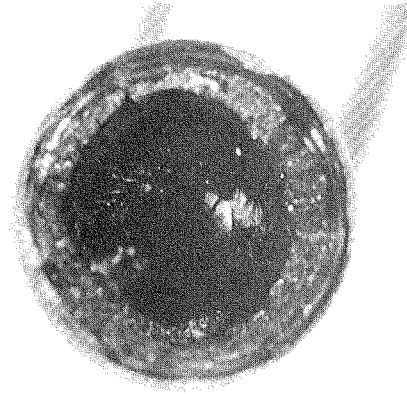
A-2 Photographs of the failed portion of a fuel rod in Test No. 501-7 (GE-reference, 305 cal/g·UO₂)

The fuel rod in Test No. 501-7 (305 cal/g·UO₂) was broken into two pieces by the embrittlement of cladding during disassembling. Some void space was observed in the fuel at the fractured portion (Appendix A-2). In the X-ray photograph and the neutron radiography (Fig. 10(1) and Fig. 11(1), extensive movement of fuel pellets was found

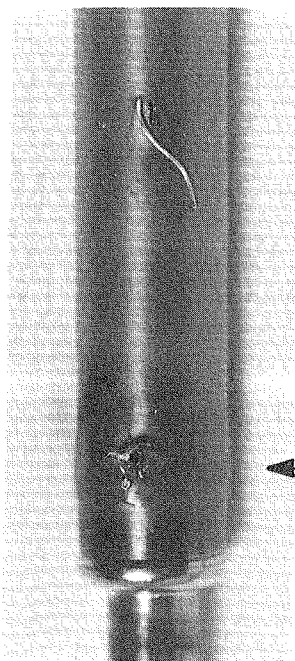
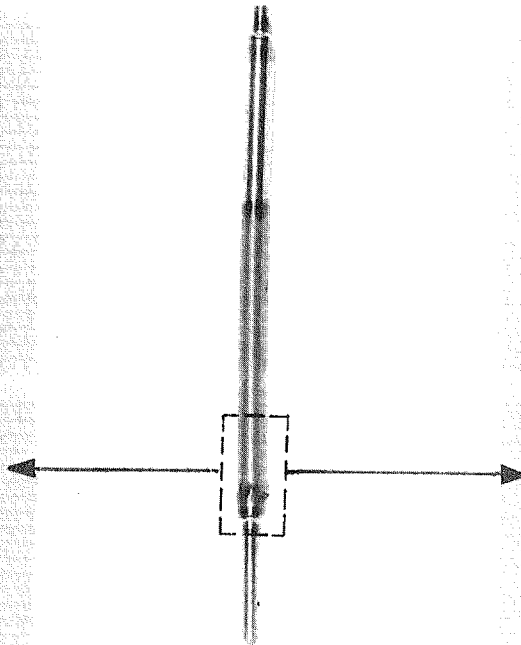
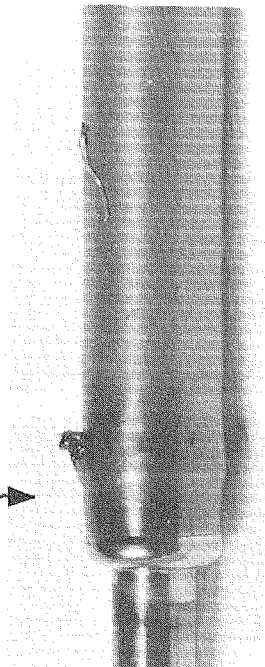
A-1 Photographs of the failed portion of a fuel rod in Test No. 501-4 (GE-reference, 284 cal/g·UO₂)

In Test No. 501-4 (284 cal/g·UO₂), melted cladding / or fuel was pushed out from the cladding at the lower portion of the rod (Appendix A-1). Relatively large ballooning of the cladding was observed at the lower portion of the rod and several holes were at the thermocouple locations.

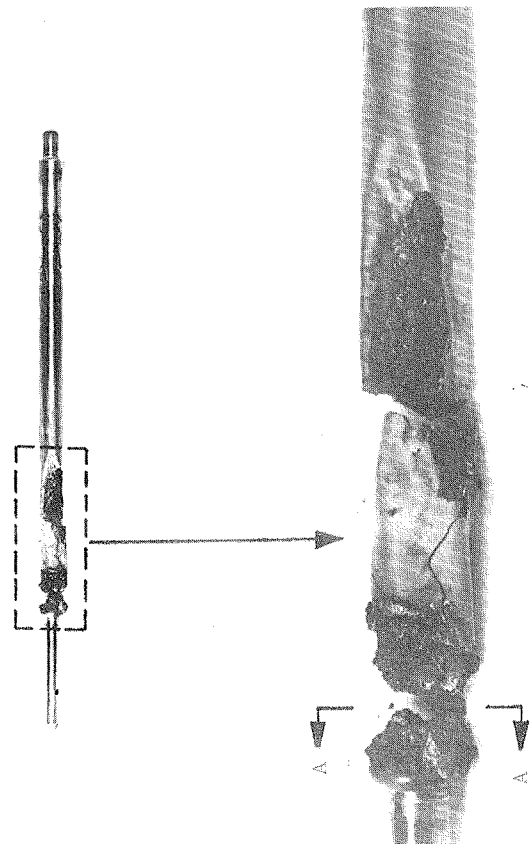
A-3 Photographs of the failed portion of a fuel rod in Test No. 501-8 (GE-reference, 393 cal/g·UO₂)

In Test No. 501-8 (393 cal/g·UO₂), the cladding had extensively melted. The fuel rod was fractured into three pieces during disassembling. Melted fuel had adhered to the lower failed portion of the rod, but almost all of the fuel was expelled from the rod as seen in the neutron radiography (Fig. 11(1) and fragmented. Extensive oxidation of cladding at the fuel plenum portion and shortening of the spring were observed (Fig. 10(1) and 11(1).

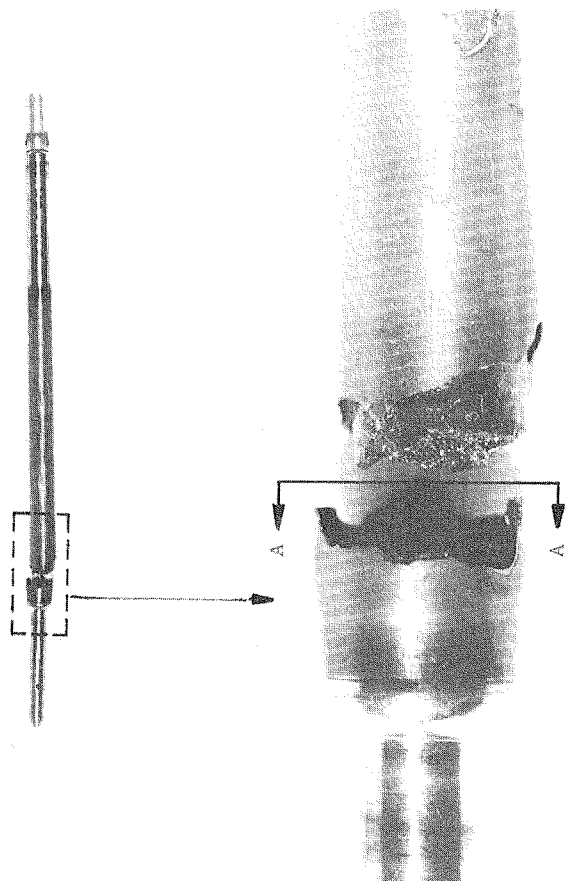
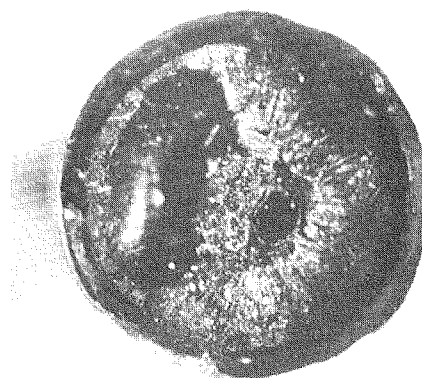
A-6 Photographs of the failed portion of a fuel rod in Test No. 502-4B (Zr-lined, 309 cal/g·UO₂)

Test No. 502-4b was the reproducibility test of Test No. 502-4. The irradiation condition was the same as that of Test No. 502-4, but the fuel rod failed. The state of failure was almost similar manner to that of the reference type fuel rod in Test No. 501-7 which was subjected to the same energy deposition.

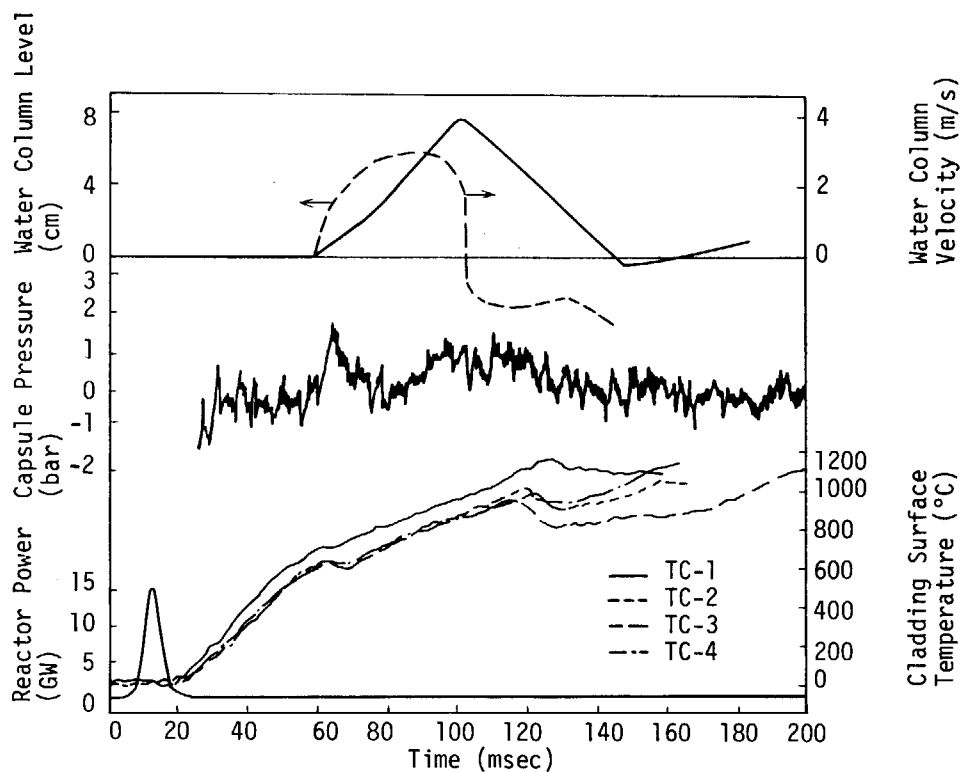
B-16 Transient records of Test No. 501-8 (GE-reference rod, 393 cal/g.UO₂)

The transient records of capsule pressure and water level sensor (Appendices B-16, B-17 and B-18) indicate that the fuel failure occurred just after the power burst.

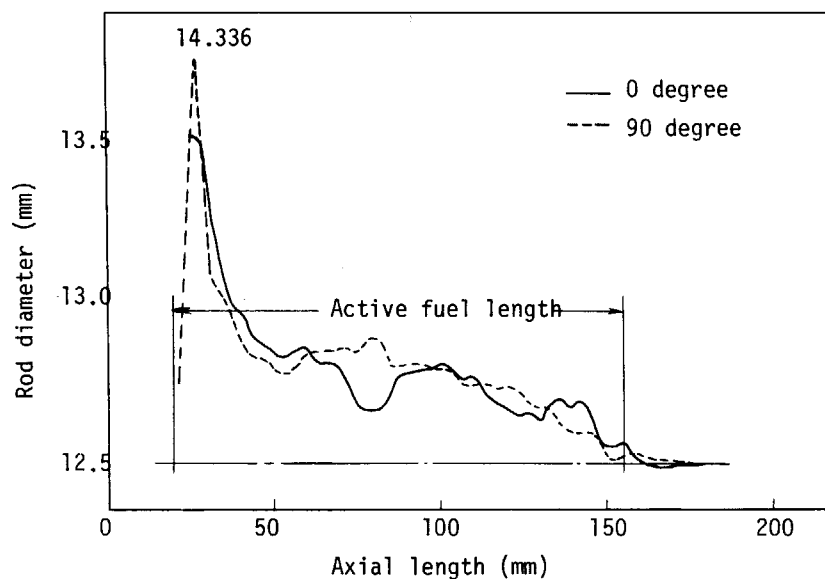
C-3 Diametral profile of a Reference rod in
Test No. 501-4 (284 cal/g.UO₂)

However, as seen in the figures of Appendices C-3 & C-5, the large ballooning of cladding is observed in Test Nos. 501-4 & 502-4 of which energy deposition is 280 to 300 cal/g·UO₂. As discussed in the preceeding section 4.2, the energy deposition at the edge of fuel stack might exceed 450 cal/g·UO₂. Therefore, the ballooning seems to be the result of increasing of the fuel rod internal pressure due to evaporation/or melting of fuel pellets at the edge of fuel stack.
