Study on Pb-Bi Corrosion of Structural and Fuel Cladding Materials for Nuclear Applications

**Part III. Corrosion investigation of steels between 500 and 650°C during
10,000 h of exposure to stagnant liquid Pb-Bi containing 10^{-6} wt% of oxygen**

January, 2004

**Japan Nuclear Cycle Development Institute
Forschungszentrum Karlsruhe GmbH**

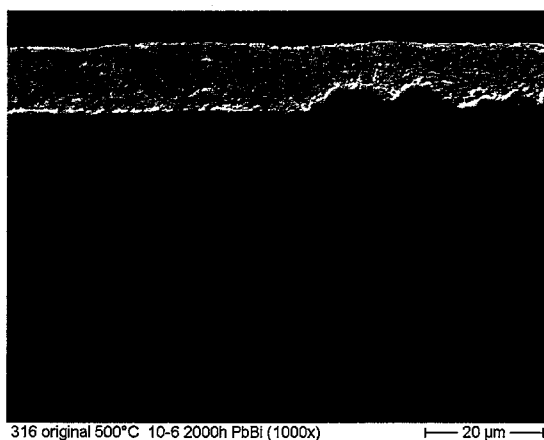
Fig. 1: Thin spinel layer partly with oxide nodes on the surface of 316 FR after 2000 h of exposure at 500 °C

This appearance does not change up to 5000 h of exposure. Fig. 1 presents the cross section perpendicular through the surface region after 2000 h. The thin spinel layer in the left surface region is not visible but was detected by EDX technique with signals from the surface employing different electron energies.

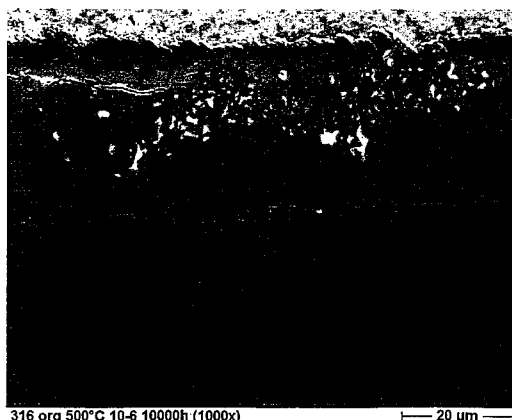
Fig. 2: Dissolution attack by grain boundary penetration in 316 FR after 10000 h of exposure at 500°C.

After 10000 h of exposure a partly dissolution attack (up to 40 µm) was observed, Fig. 2. LBE obviously penetrates the spinel scale and migrates along grain boundaries to the interior of the specimen. This process is accompanied by depletion of Ni around the grain boundaries. Grain boundary attack occurs because the oxide layer has no complete coverage.

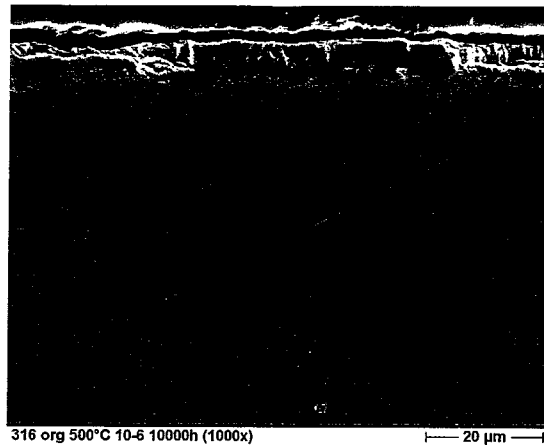
Fig. 3: Surface part of 316 FR steel without dissolution attack after 10000 h exposure at 500 °C. Note the oxide scale observed at some places increased to 10 µm and more.

However, there are great parts of the surface area in which a thin and also thick oxide layer still protects the 316 FR steel from dissolution attack, Fig. 3.

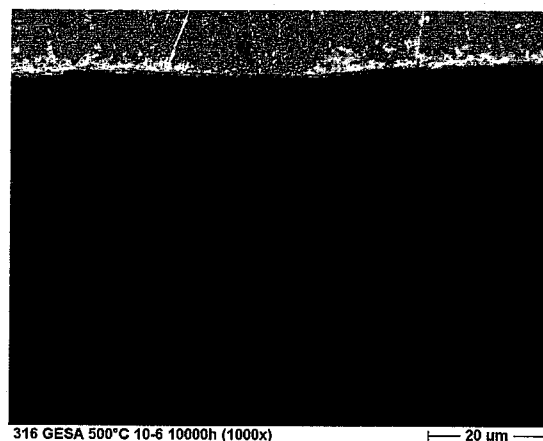
Fig. 4: Surface of the 316 FR steel specimen surface alloyed with Al by the GESA process after 10000 h of exposure at 500°C.

There are no signs of surface attack at the 316 FR specimens surface alloyed with Al by the GESA process. After all of the exposure times nothing changed at the surface which is still protected by a thin alumina layer. Fig. 4 shows the surface cross section of the specimen after 10000 h.

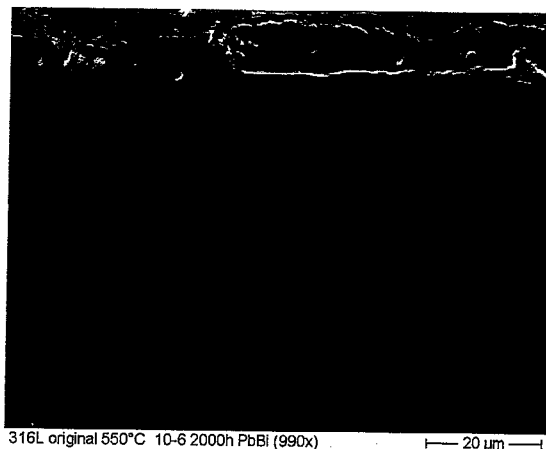
Fig. 5: Continuous magnetite and spinel layer on 316 FR steel after 2000 h of exposure at 550 °C.

The surface behaviour of 316 FR up to 2000 h of exposure seems to be untypical because of the formation of a continuous magnetite and spinel layer of 10 – 20 µm instead of thin spinel layers with oxide nodes like observed at 500 °C. Fig. 5 shows the surface structure of the specimen after 2000 h of exposure.

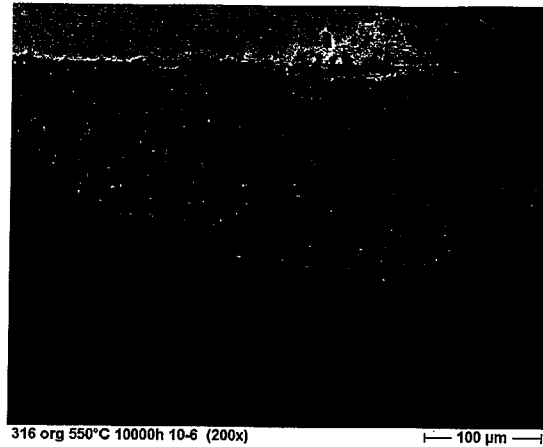
Fig. 7: Dissolution attack on 316 FR steel after 10000 h of exposure at 550 °C. Note the lower magnification!

After 10000 h of exposure strong dissolution attack occurs on a large part of the surface area. The maximal depth observed on the cross section was 200 μm. Fig. 7 shows this part of the surface area. The still existing oxide scale is penetrated by LBE which proceeds into the interior by migration along the grain boundaries.

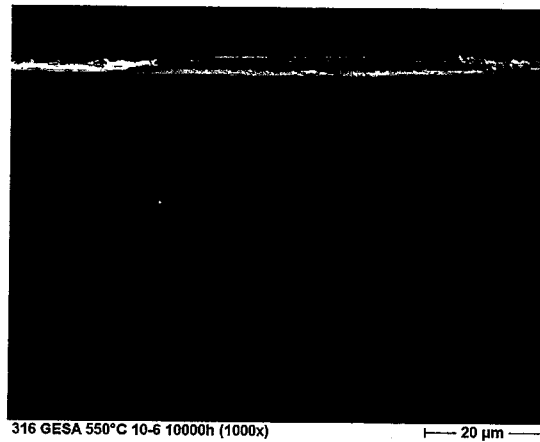
Fig. 8: 316 FR steel surface alloyed by GESA after 10000 h of exposure at 550 °C.

All of the specimens Al – alloyed by GESA show no dissolution and oxidation attack like demonstrated in Fig 8 obtained from the 10000 h specimen.

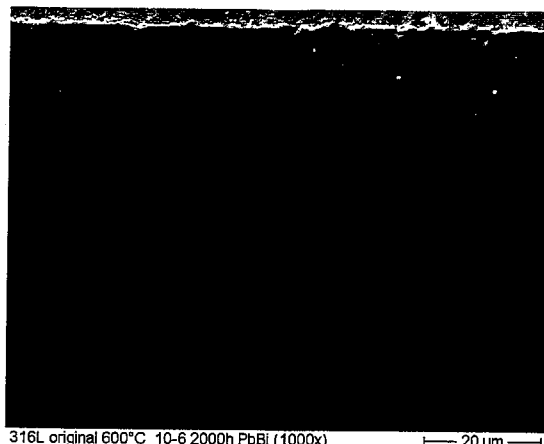
316L original 600°C 10-6 2000h PbBi (1000x) 20 μm

There is no magnetite layer observed on 316 FR steel at 600 °C. The surface is covered by a thin spinel layer like it is known to grow on ferritic steels at 600 °C. However, the spinel is penetrated by LBE after 800 h already to a depth of 5-10 μm. The dissolution attack increases in the cross sections observed to a depth of about 20 μm in the specimens exposed for 2000 and 5000 h. The effect on the 2000 h specimen is shown in Fig. 9.

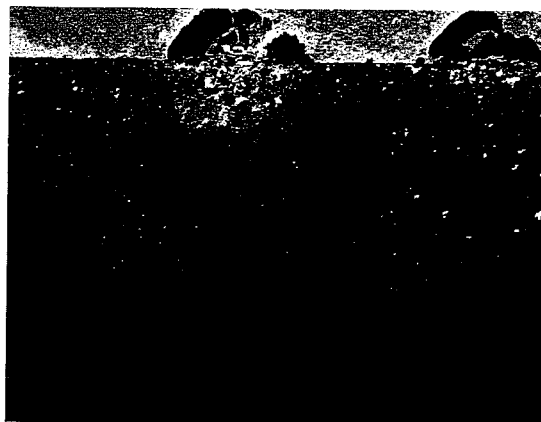
316 600°C 10-6 10000h (200x) 100 μm

After 10000 h the dissolution attack along the grain boundaries spreads out to a depth of about 180 μm in the observed parts of the specimen, Fig. 10.

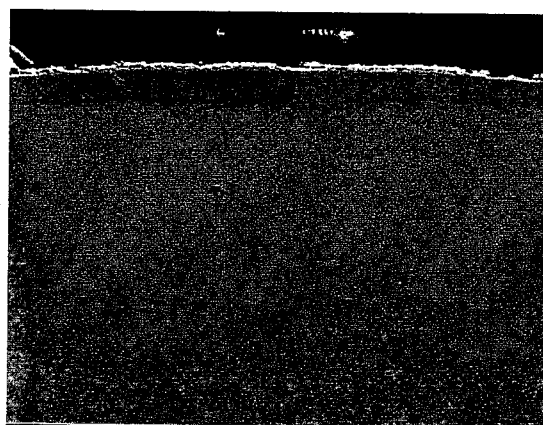
316 GESA 600°C 10-6 10000h (1000x) 20 μm

No dissolution and oxidation attack occurs on the specimens surface alloyed with Al by GESA after all the exposure times. Fig. 11 shows the non affected surface of the 10000 h specimen.

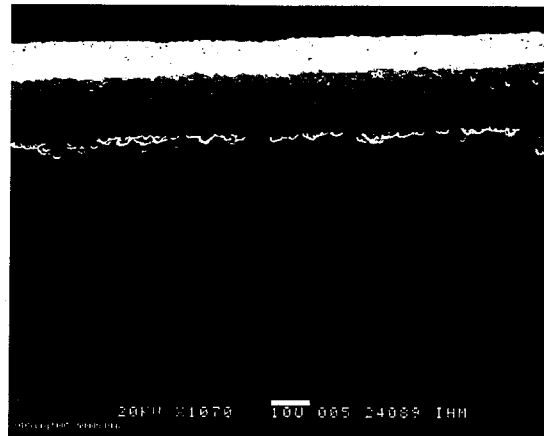
Fig. 12: Thick protective magnetite and spinel scale on ODS steel after 5000 h of exposure at 500 °C. A pore belt develops by iron migration into the magnetite layer.

A thick magnetite and spinel layer of 6 - 7 μm appears on the surface already after 800 h like it is typical for martensitic steels. After 5000 h this scale increases to about 20 μm as shown in Fig. 12. A pore belt appears below the spinel layer which is caused by migration of iron into the magnetite layer. It starts to develop after 2000 h. No dissolution attack is observed because this scale protects the surface.

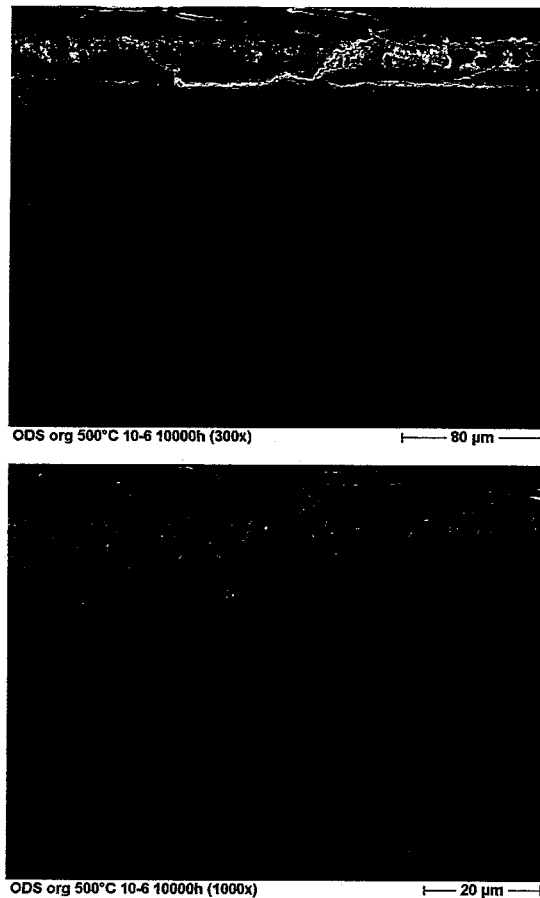
Fig. 13: Oxide layer grown to 30-40 μm on ODS steel after 10000 h of exposure at 500 °C. It starts to spall off at some places. Low magnification above, high below.

After 10000 h the oxide layer grows to 40-50 μm thickness (Fig. 13) and starts to spall off at some places. No dissolution attack is observed.

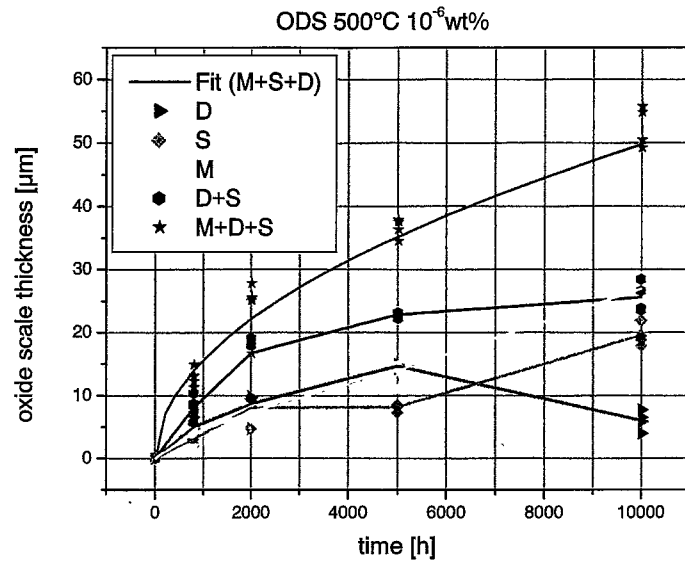
Fig. 14: Oxide scale thickness as function of exposure time for ODS at 500 °C

$$d = 0.447 \cdot \sqrt{t} \quad [\mu\text{m}] \quad (1)$$

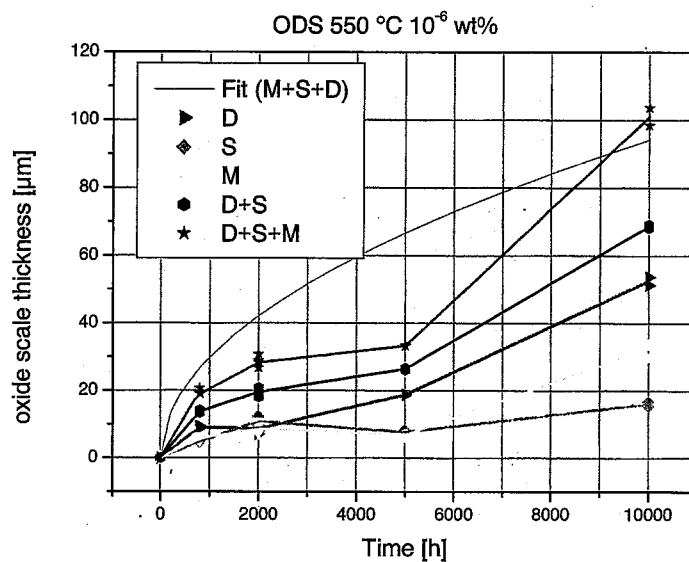
Fig. 18: Oxide scale thickness as function of exposure time for ODS at 550 °C

$$d = 0.938 \cdot \sqrt{t} \quad [\mu\text{m}] \quad (2)$$

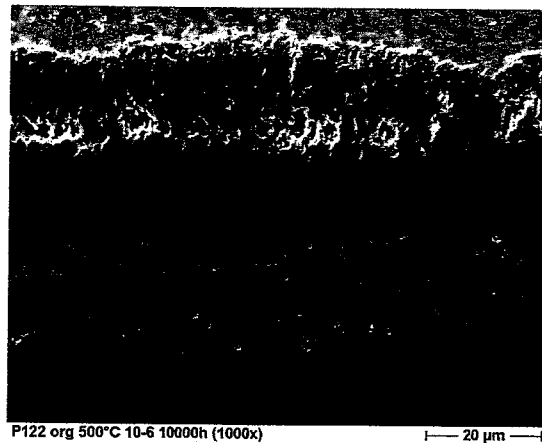
Fig. 26: Massive oxide scale formation on P122 steel after 10000 h of exposure at 500 °C. High porosity zone between magnetite and spinel layer.

There is no dissolution attack on P122 steel during 10000 h of exposure to LBE. A thick magnetite and spinel layer scale protects the steel. The oxide scale is steadily growing from 8 μm after 800 h to 60 – 70 μm after 10000 h. After 800 h of exposure a small zone, enriched in Cr with 2 wt% Cu appears, represented by a small dark band in Fig. 25. While the oxide layers have a good density up to 5000 h, a zone with high porosity exists between magnetite and spinel layer on the 10000 h specimen, Fig. 26.

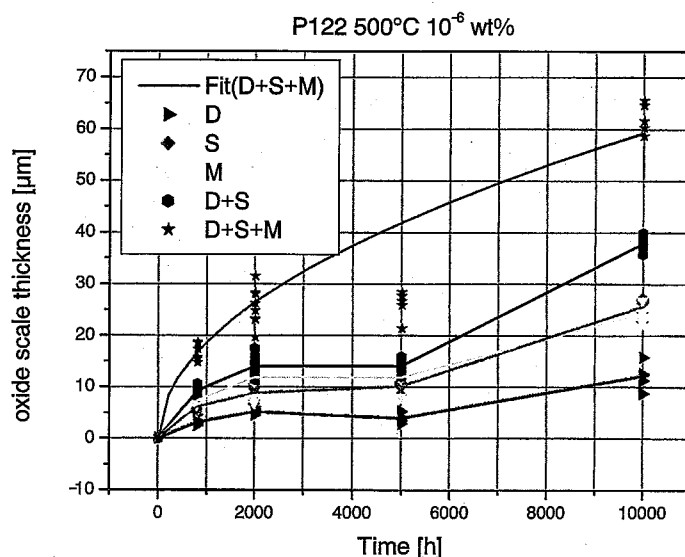
Fig. 27: Oxide scale thickness as function of exposure time for P122 at 500 °C

This oxidation rate is lightly higher compared to that of the ODS steel at the same temperature. The scale thickness obtained after 5000 h is lowered by spallation of the magnetite layer.

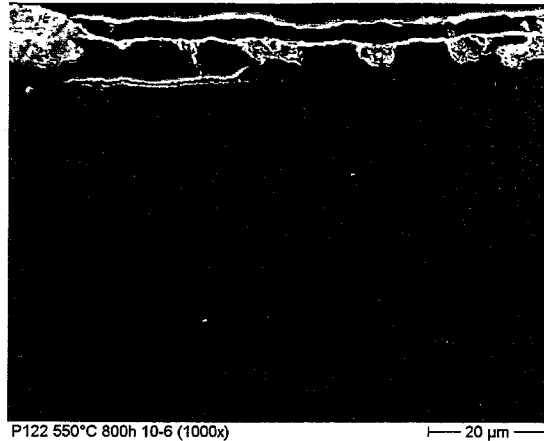
Fig. 29: Partly broken magnetite layer and scale detachment on the P122 steel surface after 800 h of exposure at 550 °C.

The P122 steel specimen after 800 h of exposure to LBE has a magnetite and spinel layer of about the same thickness as the one exposed to 500° C. However, the magnetite layer is partly broken out, Fig. 29. It also looks like the whole oxide layers starts to spall off.

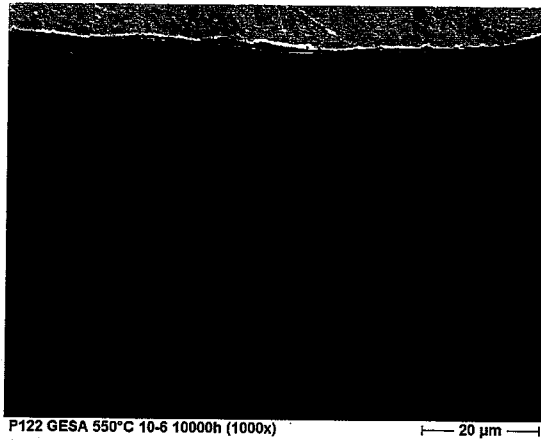
Fig. 32: P122 steel surface alloyed by GESA after 10000 h of exposure at 550 °C.

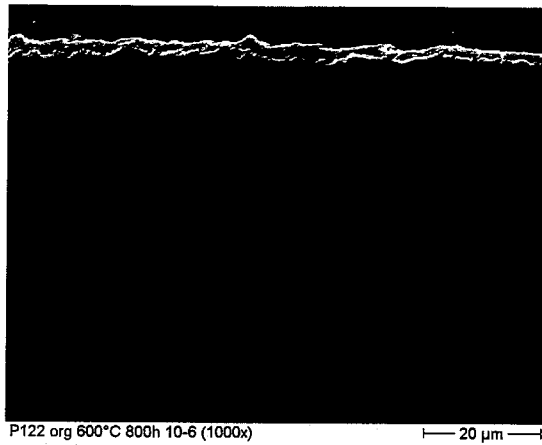
Fig. 33: Spinel scale without magnetite on the surface of P122 steel after 800 h of exposure at 600 °C.

As opposed to lower temperatures no magnetite layer could be observed after 800 h at 600° C on the P122 steel specimen, Fig. 33. Furthermore, the spinel layer is much richer in Cr with a Cr/Fe ratio of 1. After 2000 h the dissolution attack starts at few spots, Fig. 34. Below these spots S and C containing precipitations appear. 20 µm deep penetration of Pb/Bi is observed. Most parts of the sample are still protected by the spinel layer.

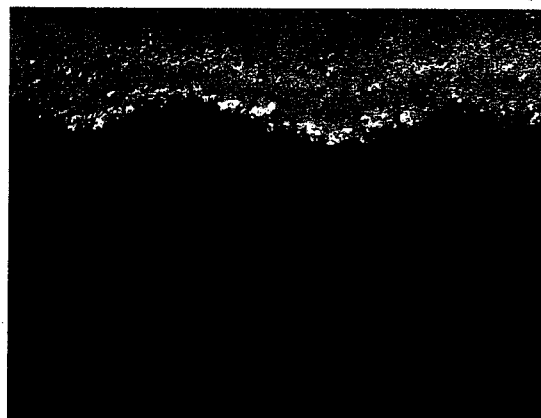
Fig. 36: Deterioration of P122 steel by dissolution attack after 10000 h of exposure at 600 °C. Low magnification above, high below.

Complete massive surface attack occurs up to 10000 h of exposure. The original surface can not be identified anymore. The depth of attack is estimated to be up to 200 μm. Fig. 36 gives an impression of the deterioration of the specimen.

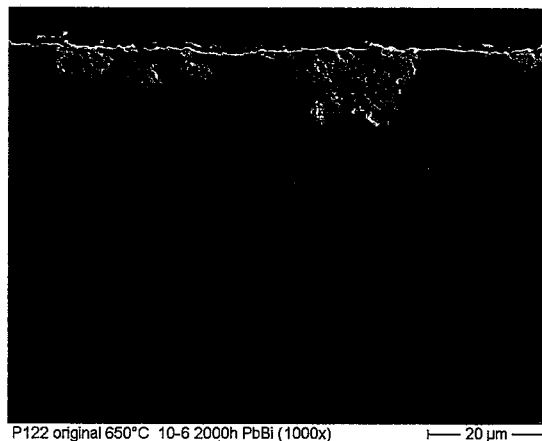
Fig. 38: Local dissolution attack after 2000 h of exposure at places which contain spinel nests after 800 h of exposure at 650 °C.

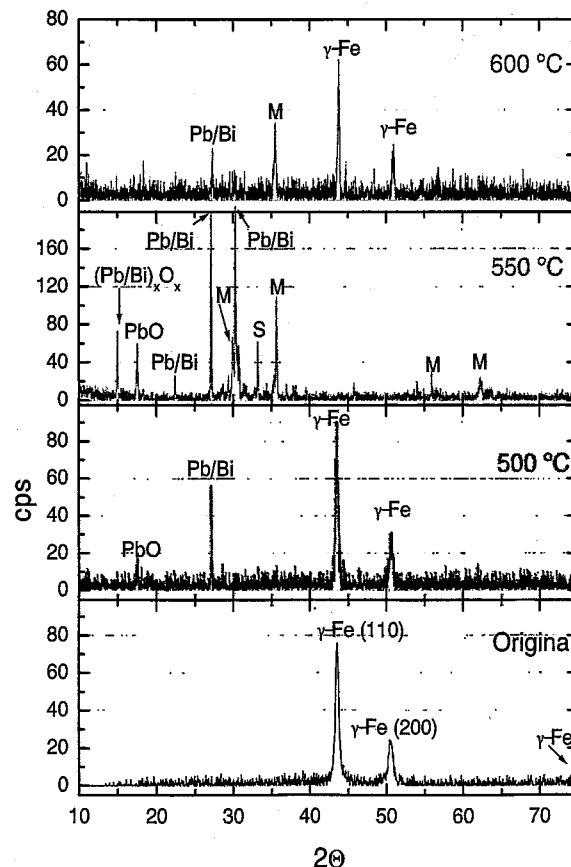
Fig. 41: XRD patterns of 316 FR steel after 800 h

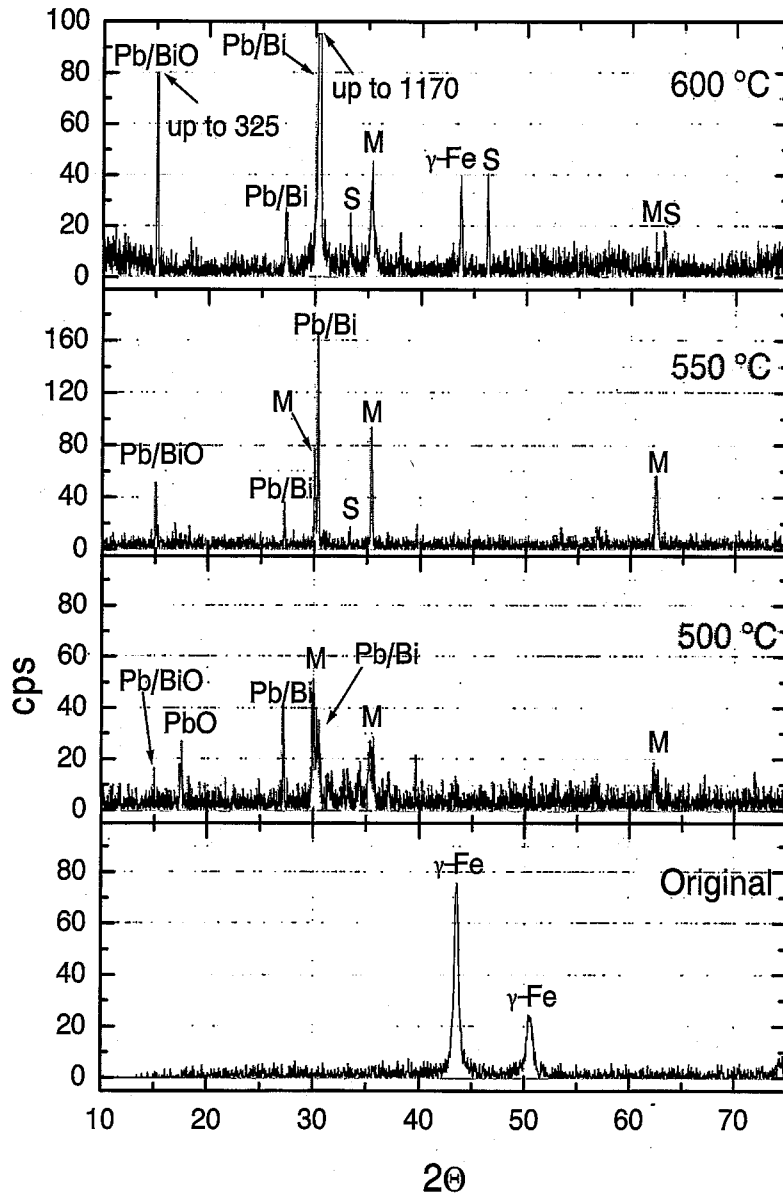
Fig. 42: XRD patterns of 316 FR steel after 2000 h

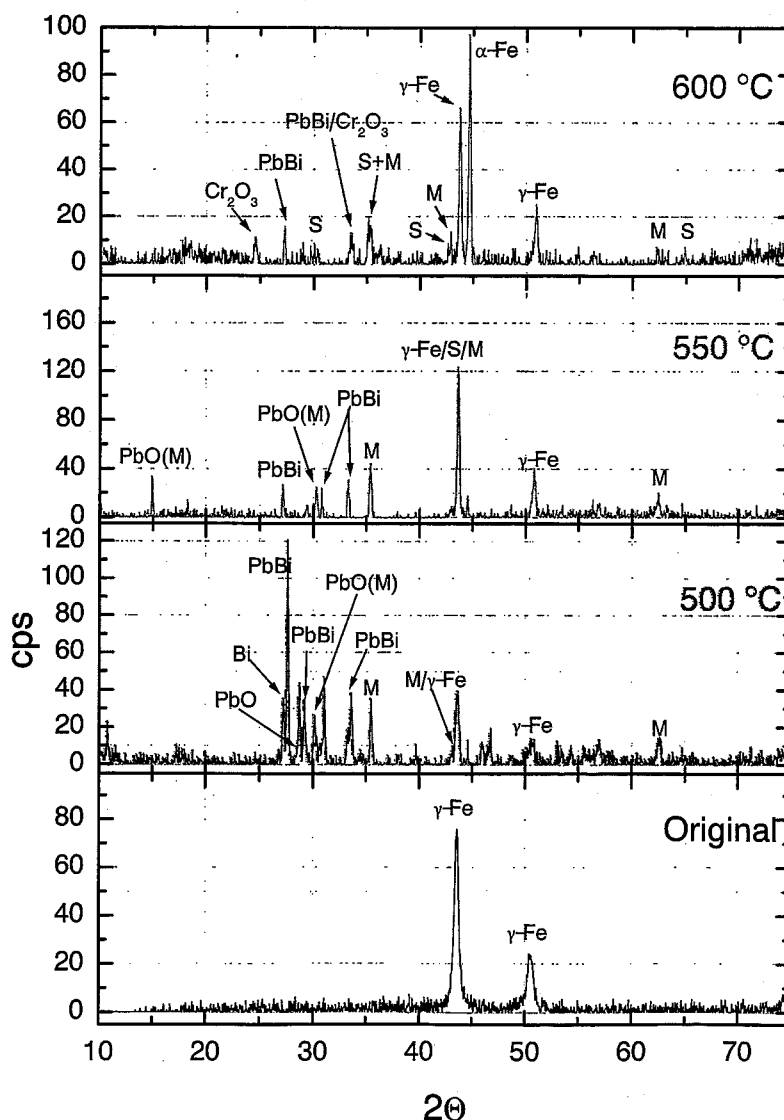
Fig. 43: XRD patterns of 316 FR steel after 5000 h

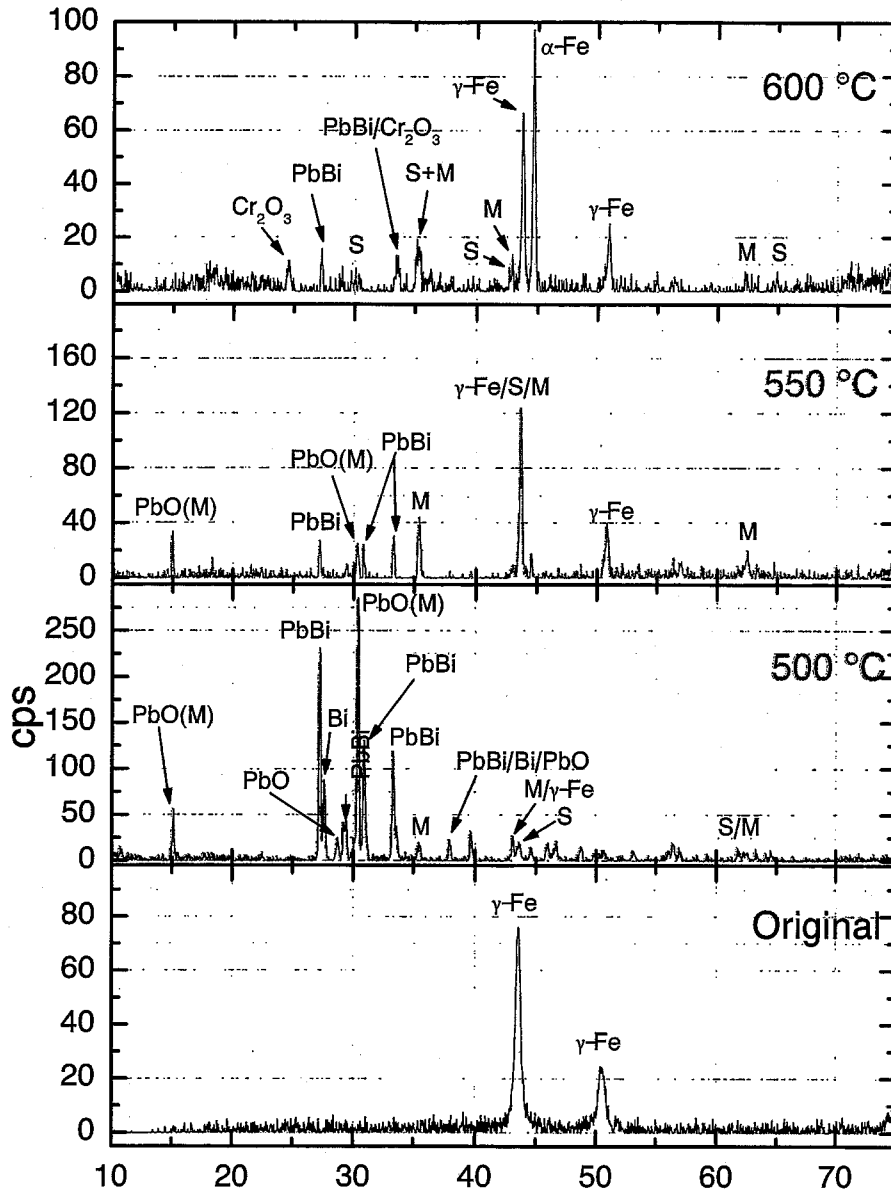
There are no changes to be observed in comparison of the 5000 and 10000 h specimens. Only the different height of the main magnetite peak indicates a larger coverage of magnetite after 10000 h. At 600 °C the XRD patterns after 5000 and 10000 h are practically identical.

Fig. 44: XRD patterns of 316 FR steel after 10000 h

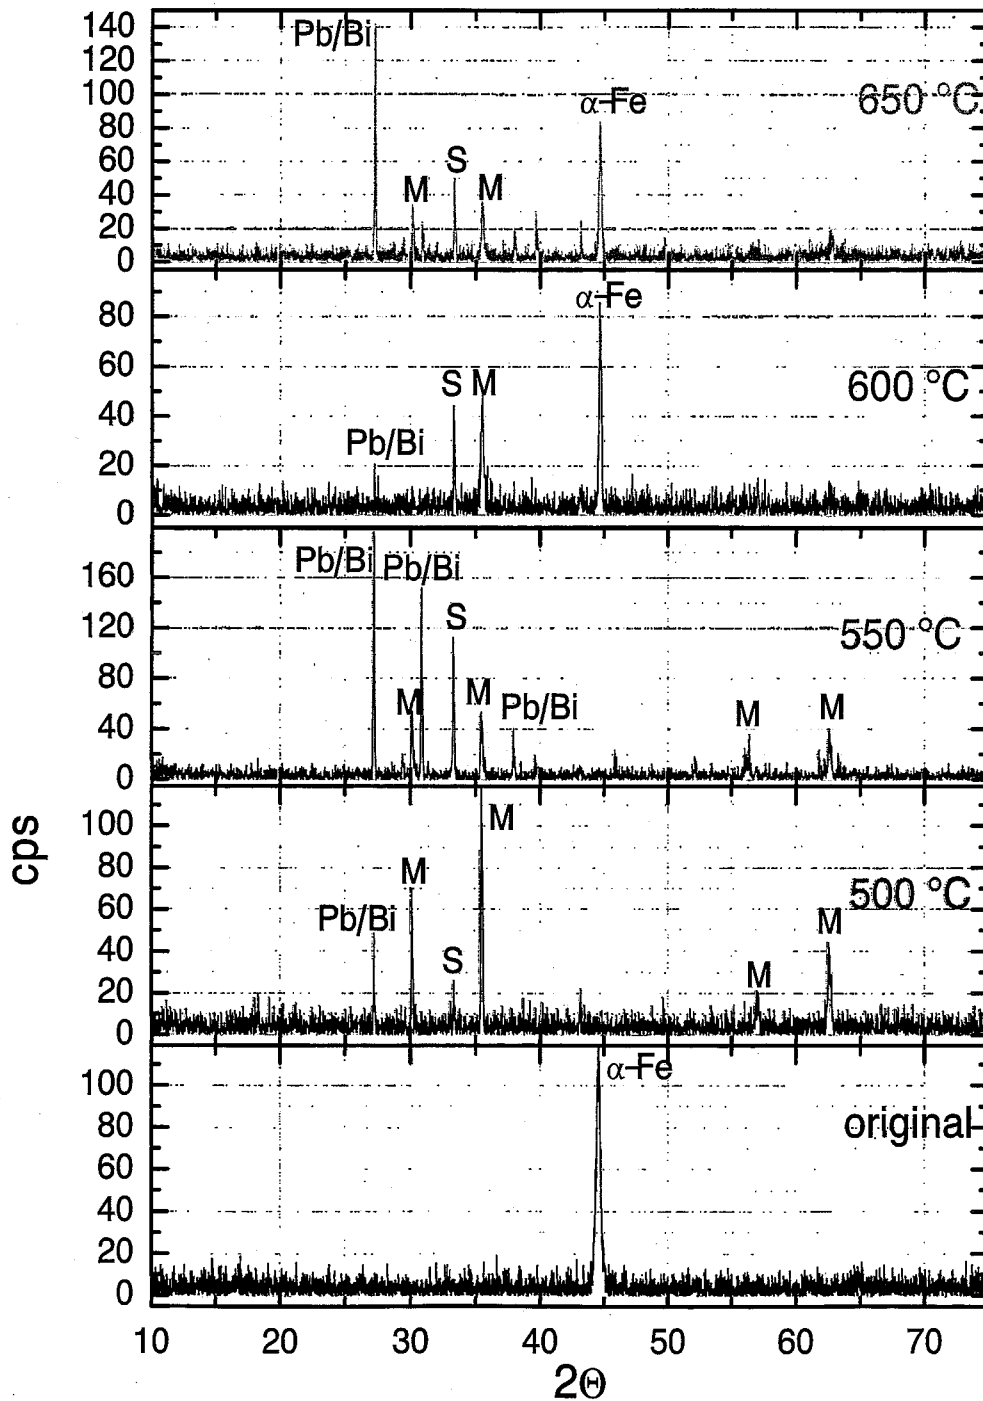
Fig. 45: XRD pattern of ODS after 800 h

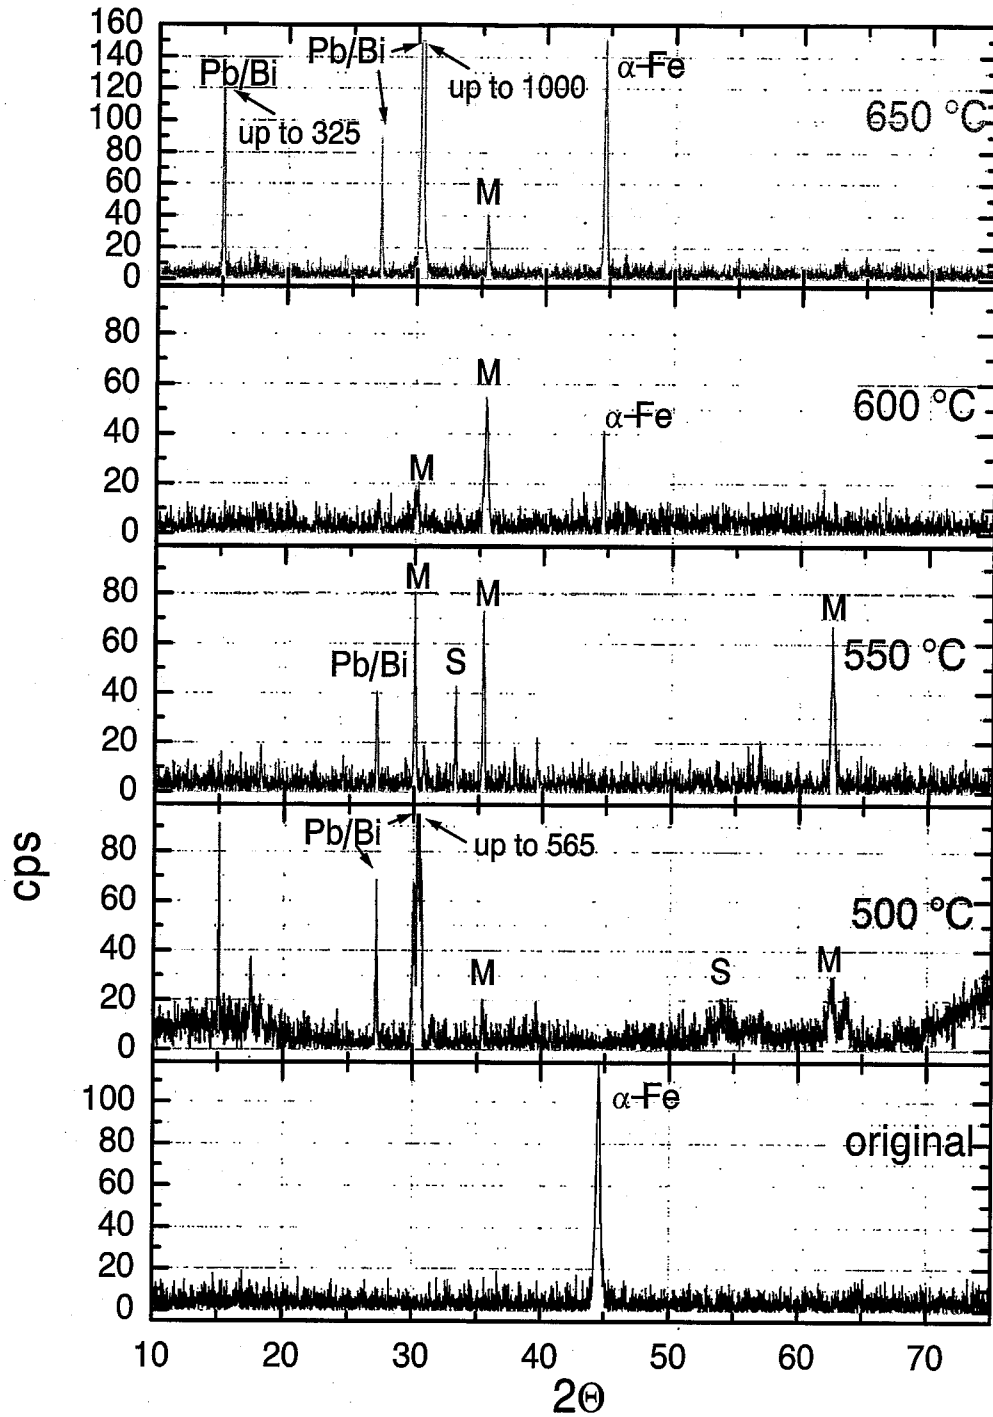
Fig. 46: XRD pattern of ODS after 2000 h

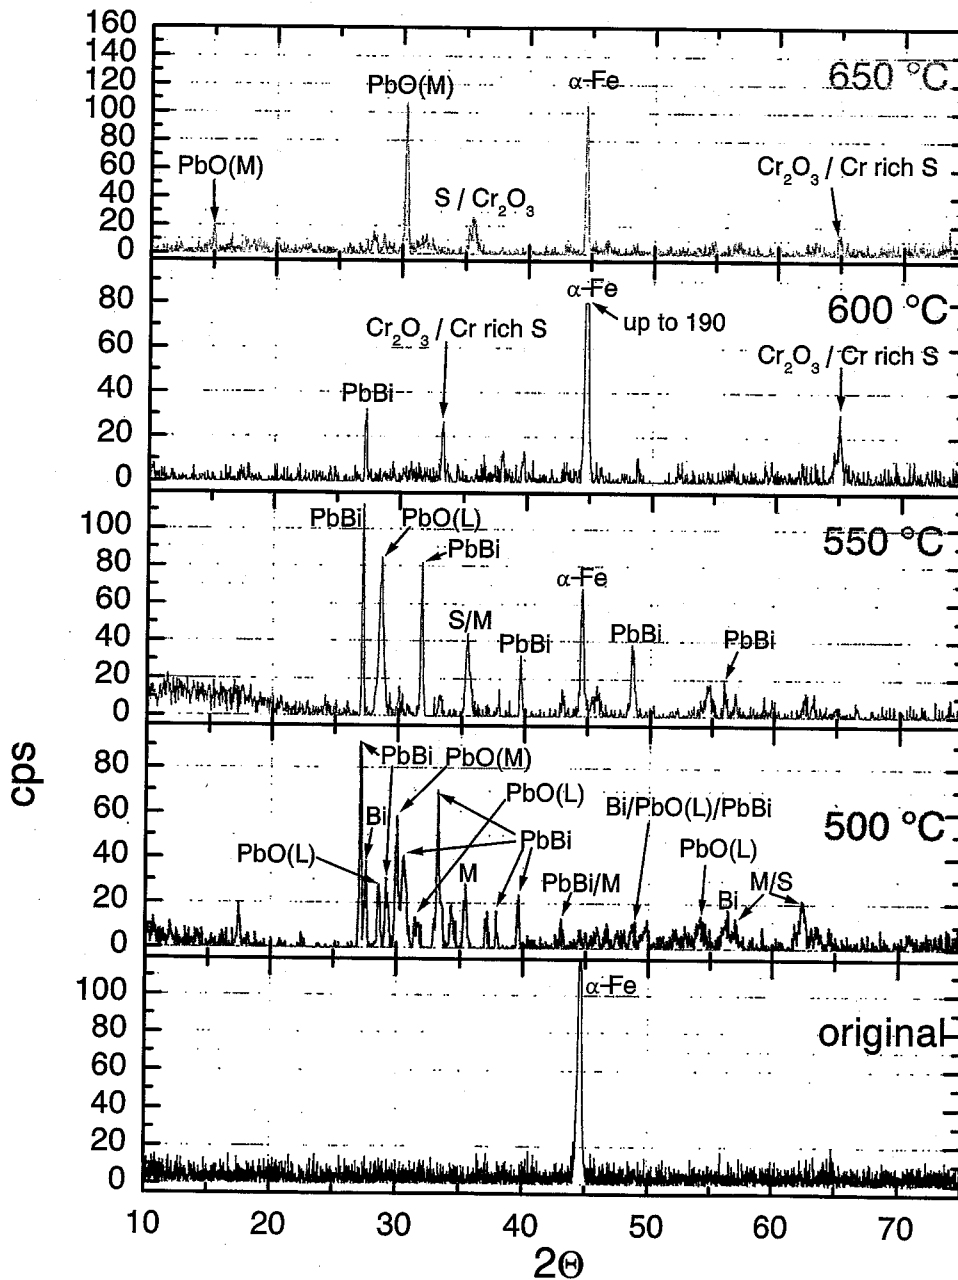
Fig. 47: XRD patterns of ODS after 5000 h

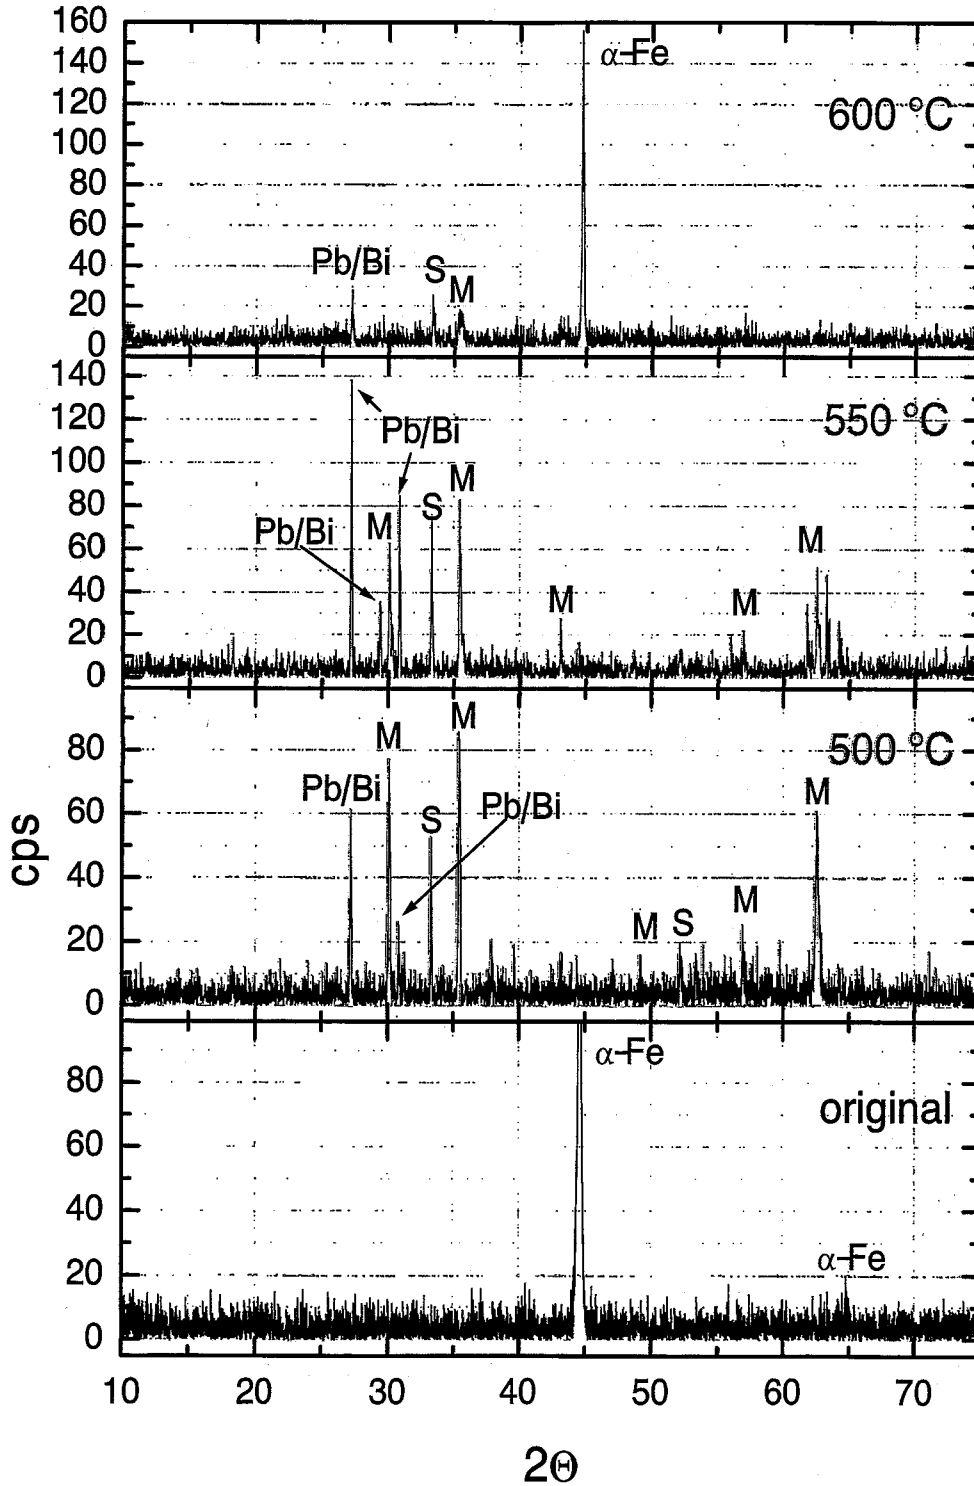
Fig. 49: XRD pattern of P122 after 800 h

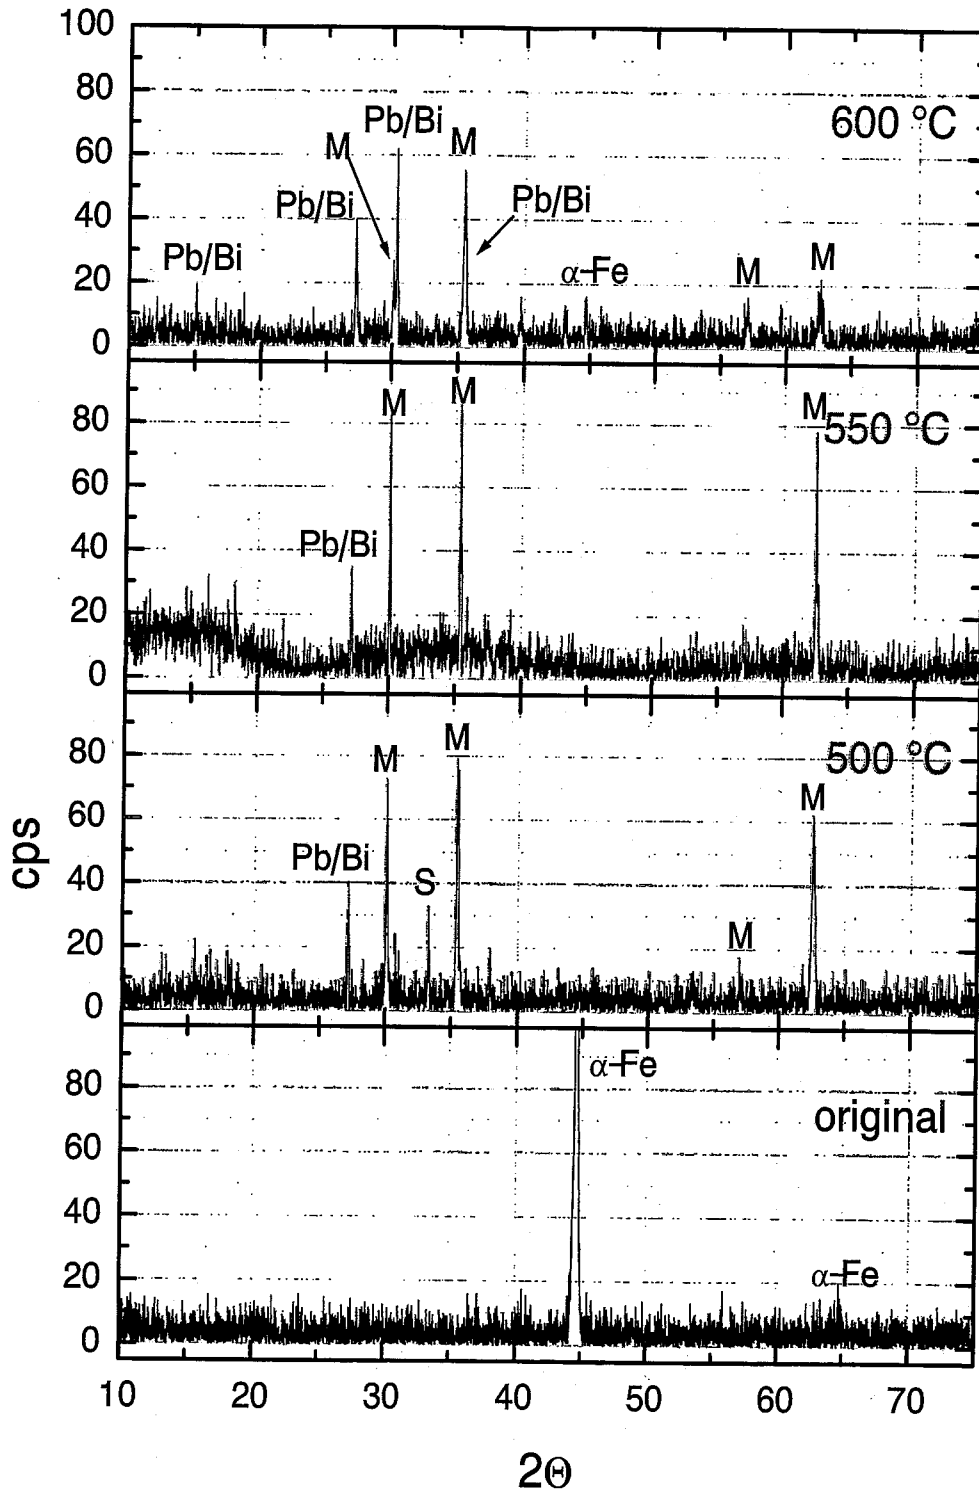
Fig. 50: XRD pattern of P122 after 2000 h

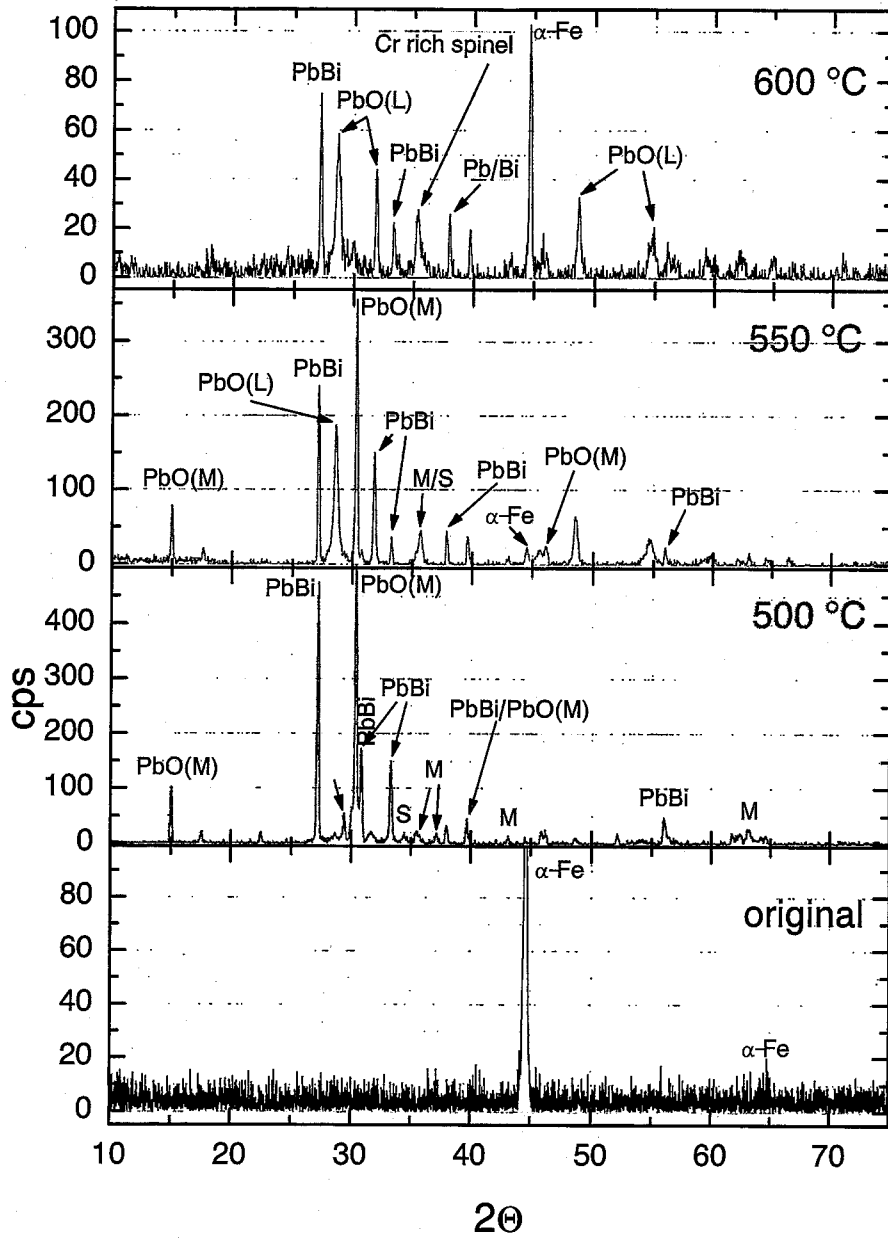
Fig. 52: XRD patterns of P122 after 10000 h

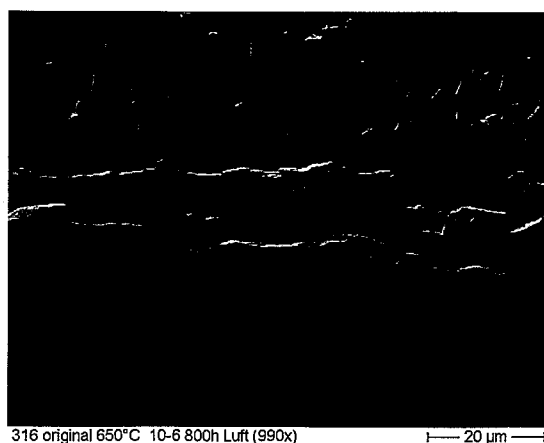
Fig. 54: 316 FR after 800 h oxidation in furnace atmosphere at 650 °C

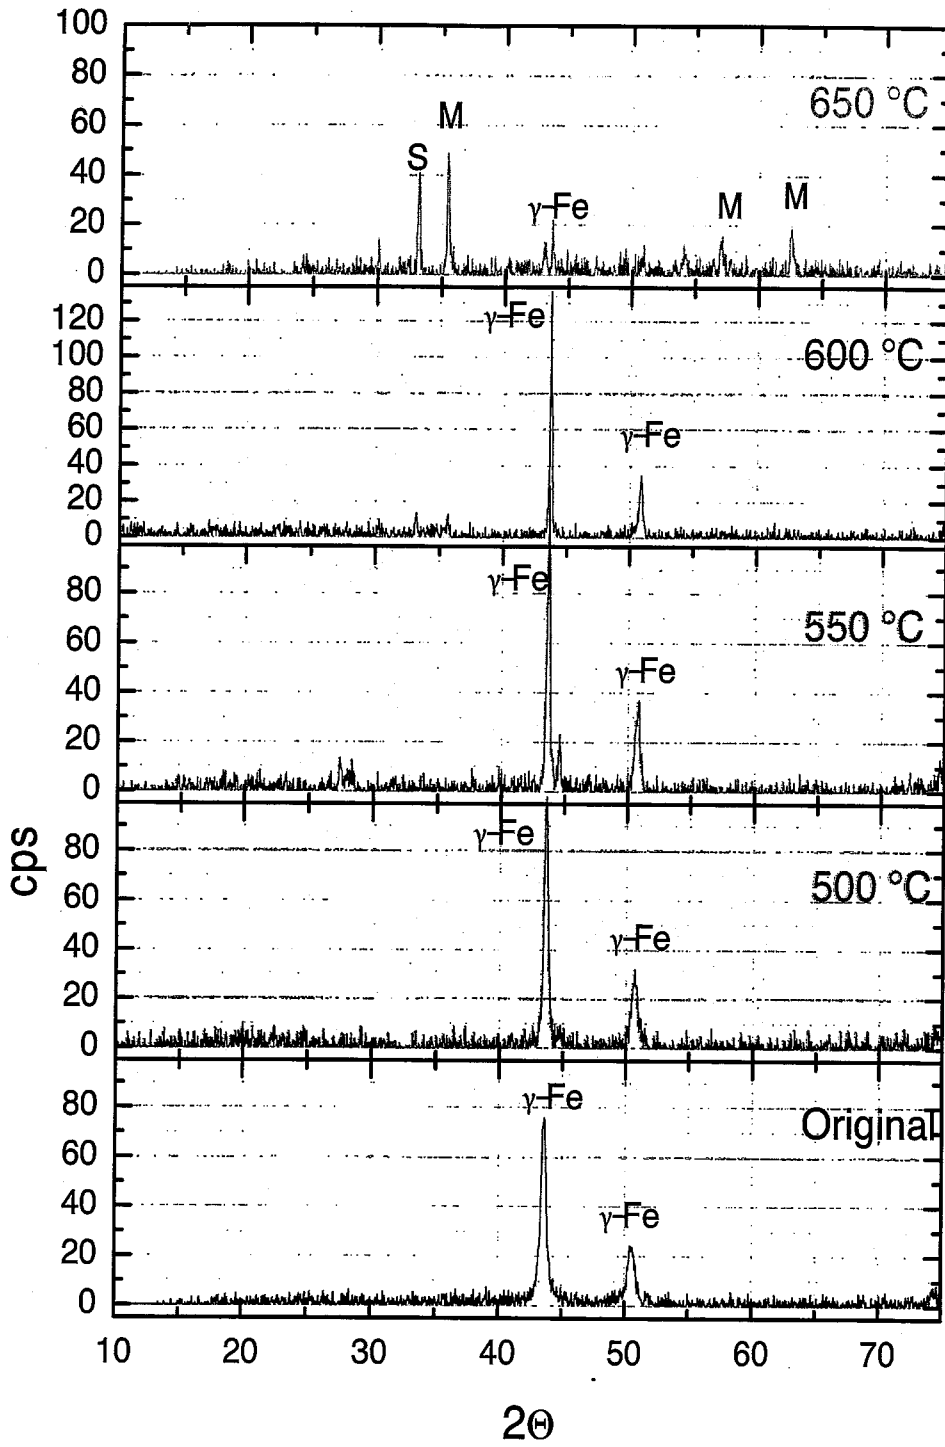
Fig. 55: XRD pattern of 316 FR exposed 800 h to furnace atmosphere

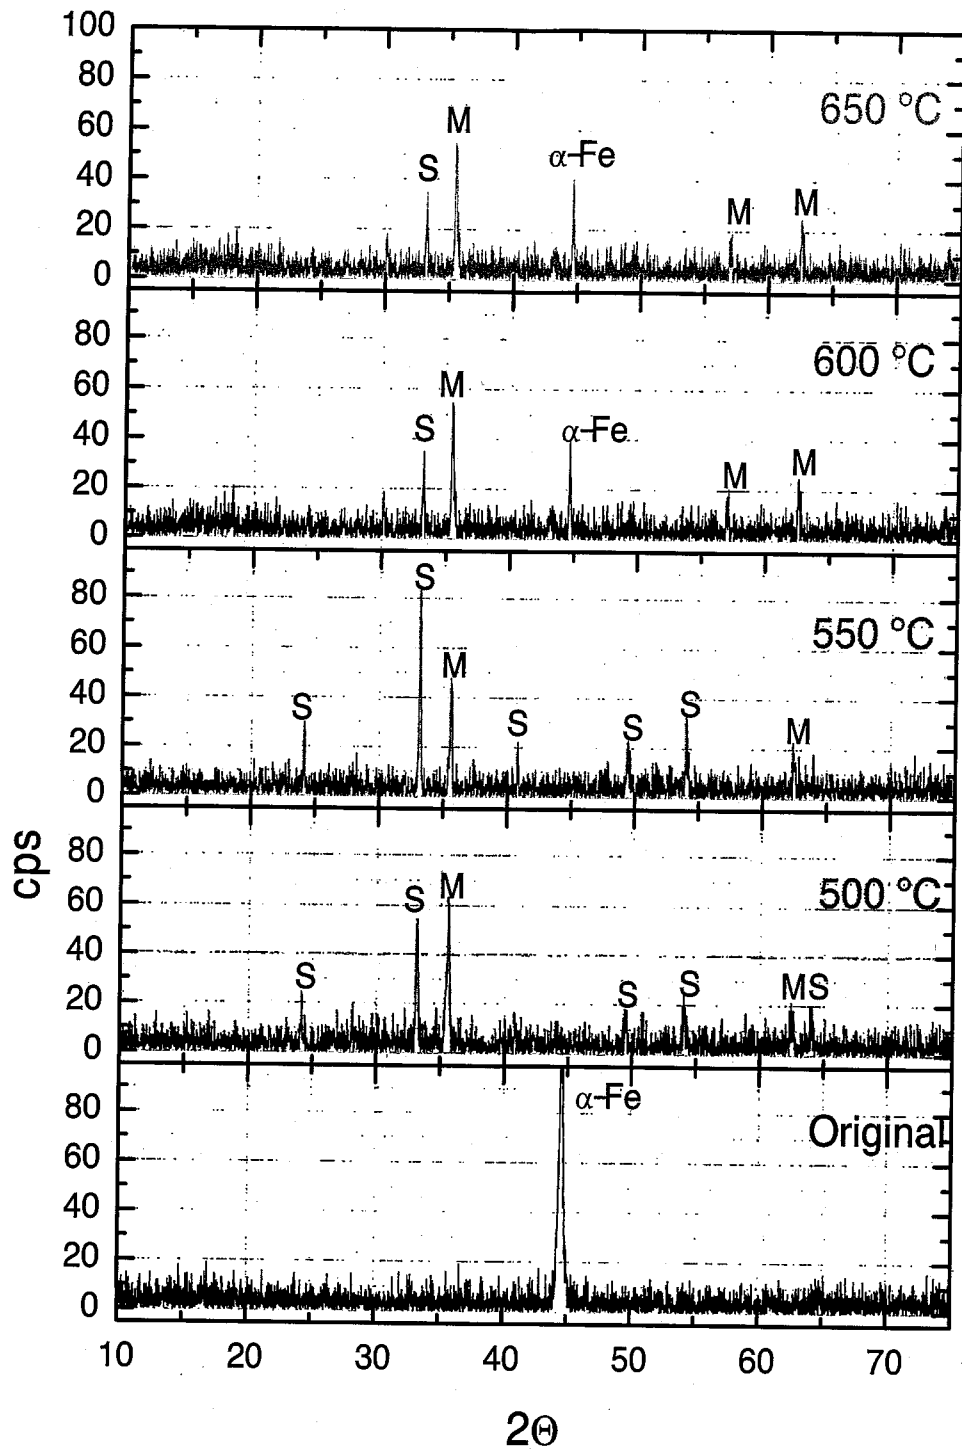
At 500 and 550 °C no metal peaks are visible any more on the x-ray patterns but only magnetite and spinel peaks. The fact that large spinel peaks appear besides magnetite indicates that large parts of the magnetite top layer is spalled off. The presence of α -Fe peaks at 600 and 650 °C shows that also a large part of spinel is spalled off at these temperatures.

Fig. 57: XRD pattern of ODS steel exposed 800 h to furnace atmosphere
