Study on Pb-Bi Corrosion of Structural and Fuel Cladding Materials for Nuclear Applications

**Part III. Corrosion investigation of steels between 500 and 650°C during
10,000 h of exposure to stagnant liquid Pb-Bi containing 10^{-6} wt% of oxygen**

January, 2004

**Japan Nuclear Cycle Development Institute
Forschungszentrum Karlsruhe GmbH**

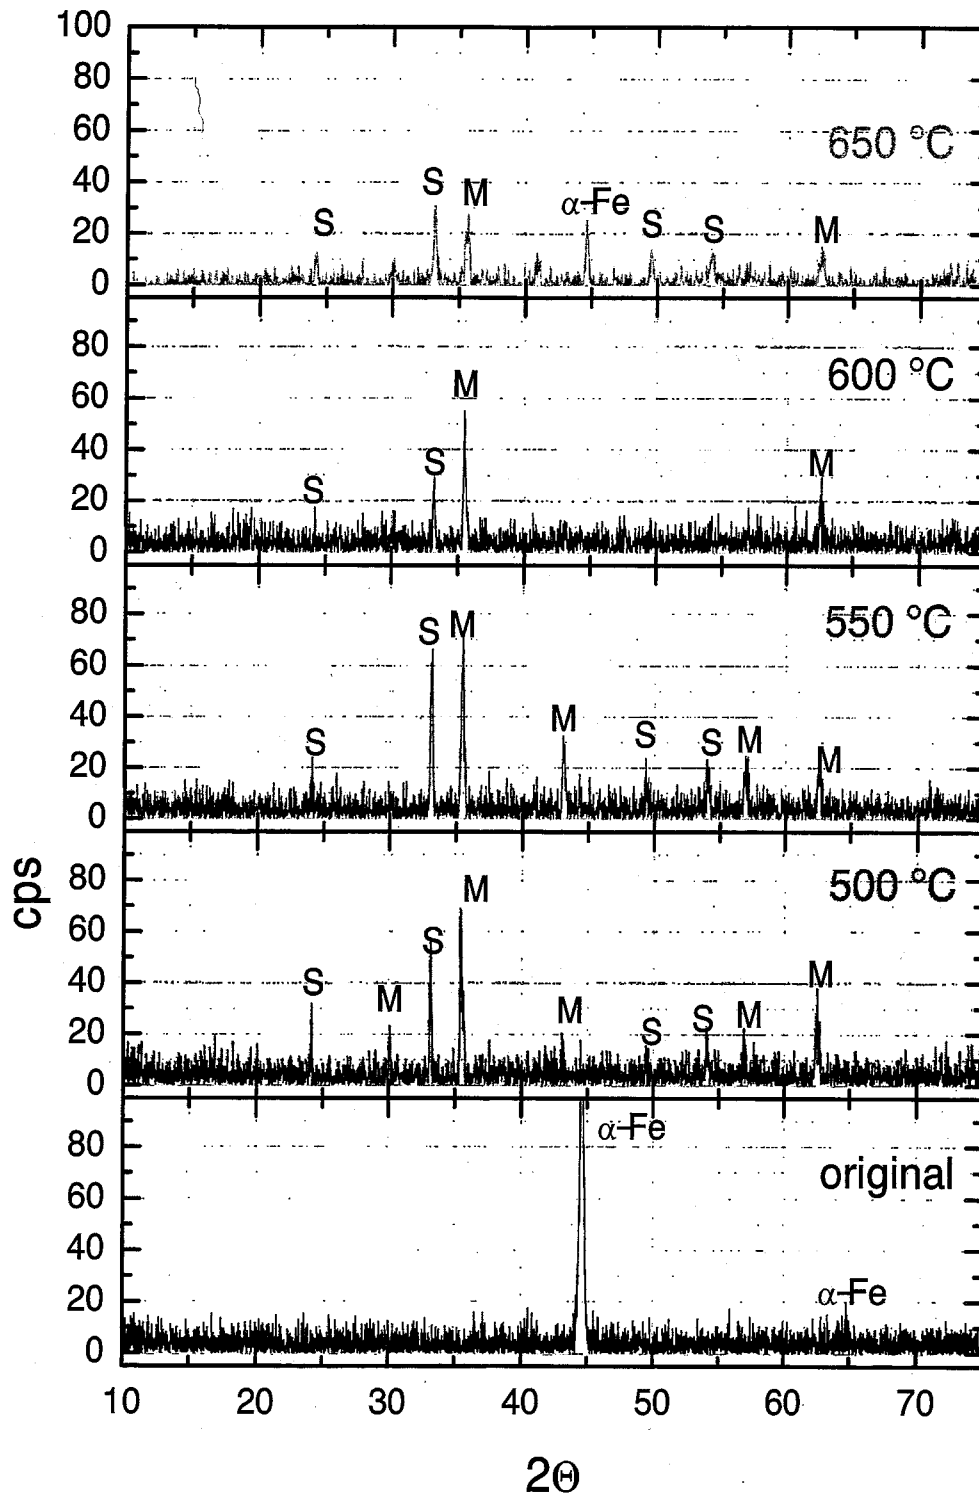
Only oxide patterns are observed on P122 X-ray pattern after exposure to LBE at 500 – 600 °C. The spinel peaks indicate partial spallation of the magnetite scale.

Fig. 59: XRD pattern of P122 steel exposed 800 h to furnace atmosphere

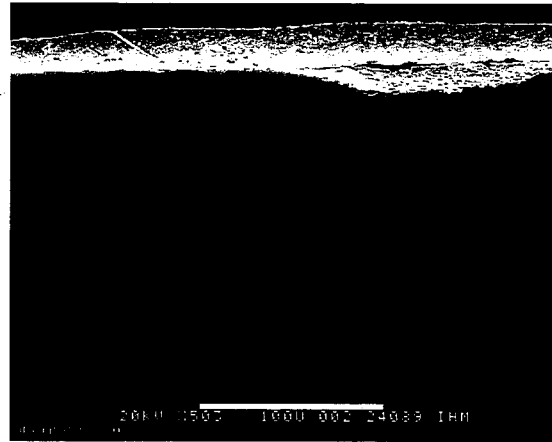
Dissolution attack on ODS steel after 5000 h of exposure – near bottom of crucible

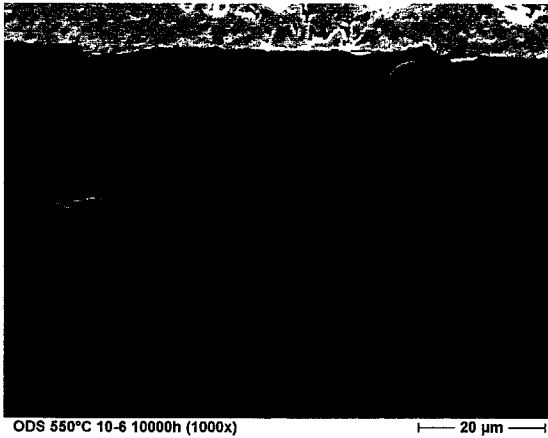
Oxide scale on ODS steel after 10000 h of exposure – near LBE surface – top of crucible

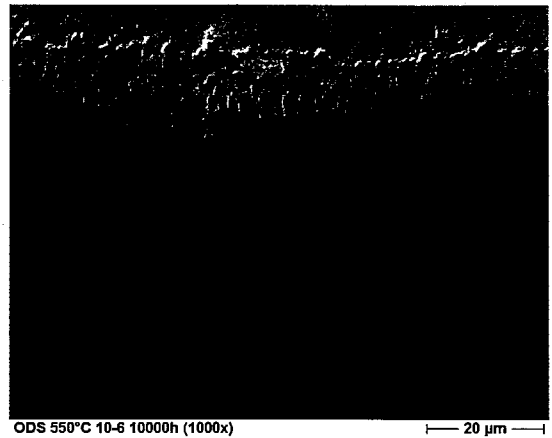
Dissolution attack on ODS steel after 10000 h of exposure – near bottom of crucible

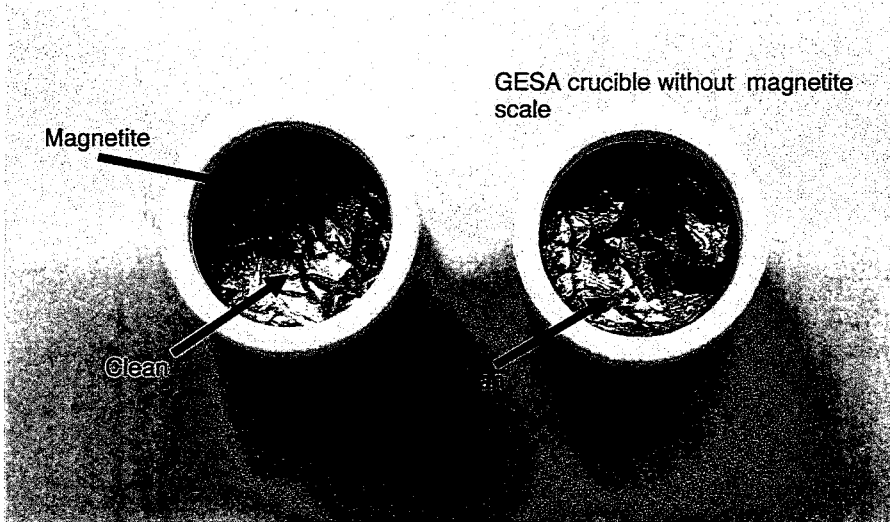
Fig. 2: Alumina crucible with and without oxide scale covering the LBE surface
