表面硬化材のナトリウム中試験(I)

2000時間腐食試験

1977年6月

動力炉・核燃料開発事業団

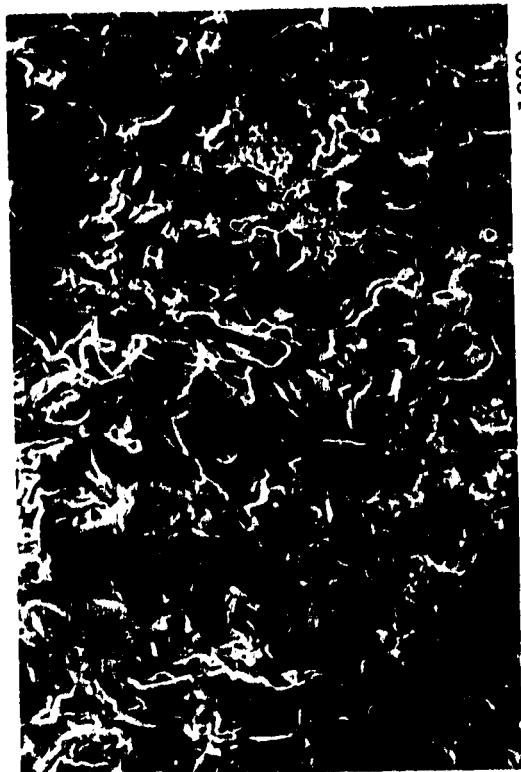
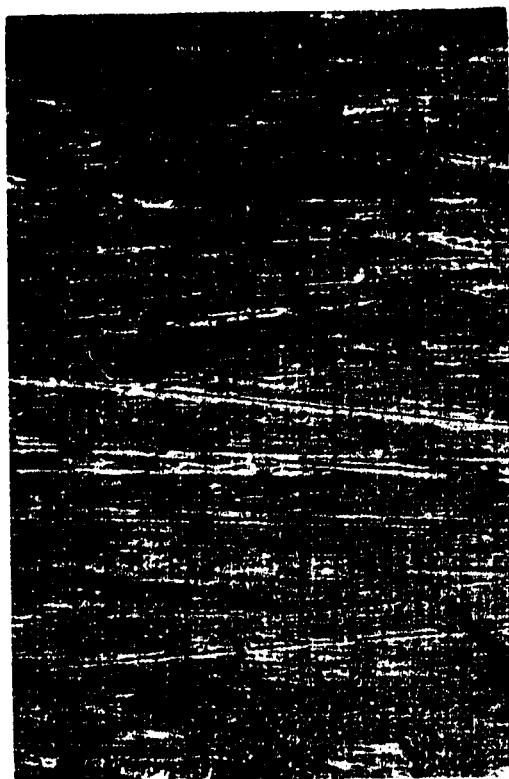
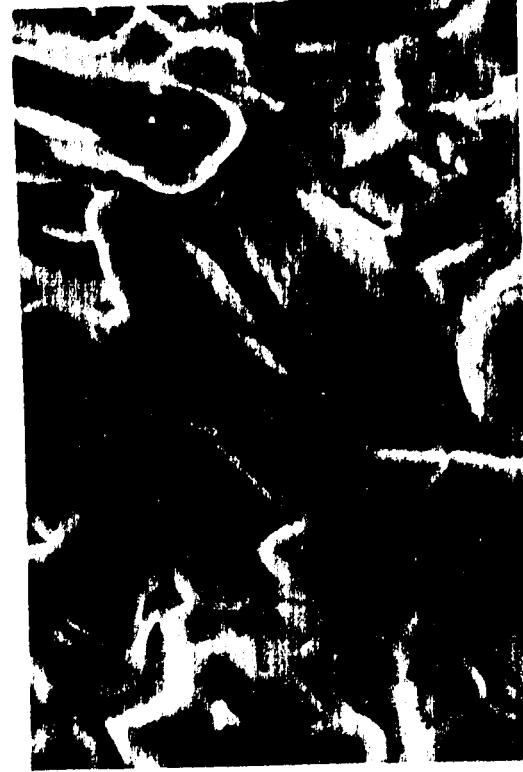
Photo. 4 Scanning Electron Probe Micrographs of Colmonoy No.20

Photo. 1~22にナトリウム浸せき試験前後の試験片表面の走査型電顕写真を示す。いずれの試験片も浸せき前後で表面形態が変わっているが、これは後述の重量変化データによるとステライトNa6およびカーバイトを除き浸せき後重量減少を示しているので、成分元素がナトリウム中に溶出したためと考えられる。コルモノイ合金、 $2\frac{1}{4}\text{Cr}-1\text{Mo}$ 鋼および純鉄では結晶粒界がはっきりとあらわれている。ハスティロイC表面にみられる白色粒状物は素材中にもともと存在する初析カーバイト(Mo rich)と考えられる。

試験材中最も大きな腐食を呈し、コルモノイ合金は 10 ~ 40 μm 厚さの変質層を生ずる。かたさはいずれも低下し、表面あらさはコルモノイ合金の増加が著しく、これは腐食量の増加に対応している。ナトリウム腐食によりコルモノイ合金表面には結晶粒界がはっきりあらわれる。

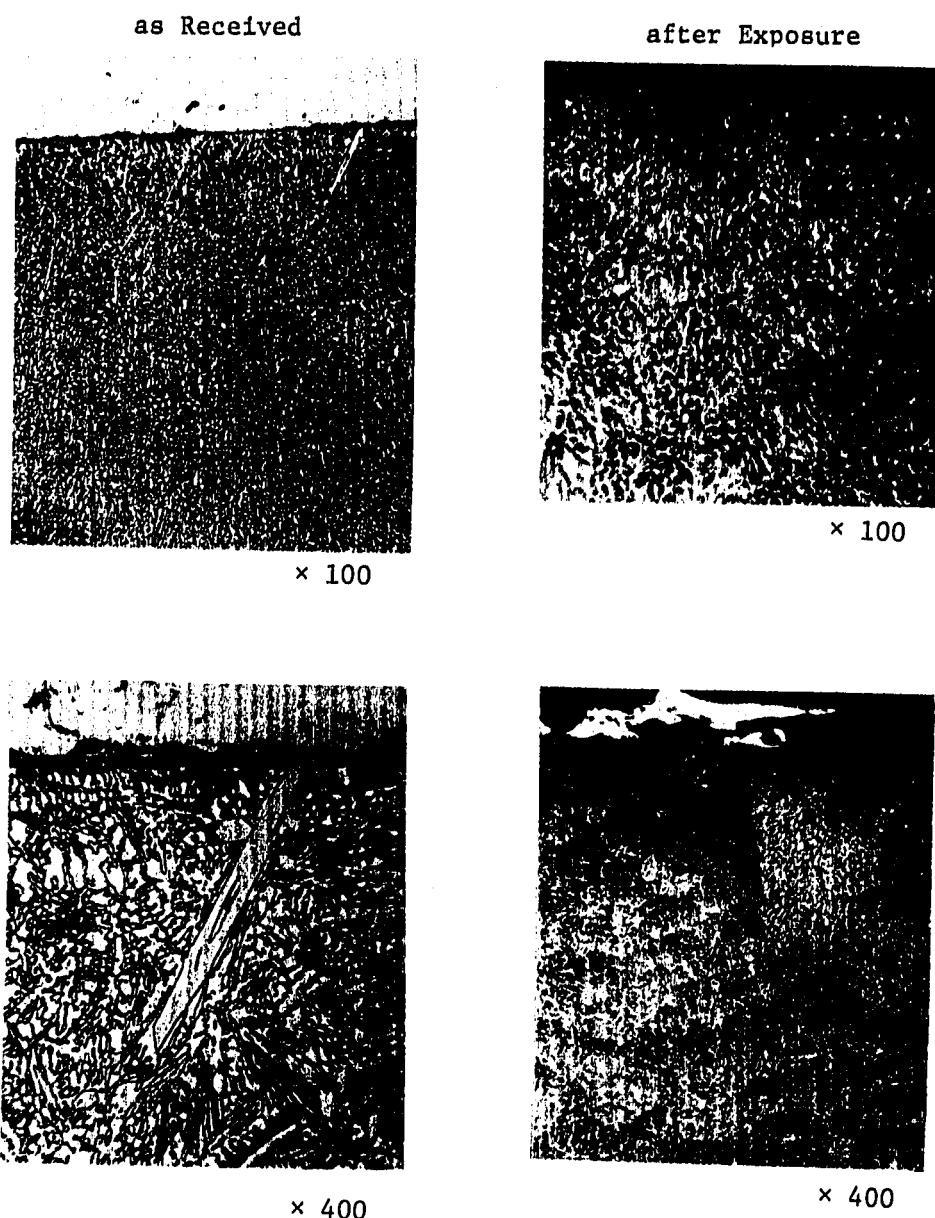
Photo. 23 Cross-Sectional Micrographs of Stellite No.1

Photo. 23～44にナトリウム浸せき前後の試験片断面組織を示す。ステライト合金はナトリウム接液近傍に変質層はみとめられないが、ステライト No. 1 は組織全体が変化している。コルモノイ合金はいずれもナトリウム接液面近傍に 10～40 μm 厚さの変質層が生じている。メテコ 16 C およびデロロステライト SF - 60 M にはナトリウム浸せきによる組織変化はみとめられないが、受入れ材に巣がある。インコネル合金にはいずれも 1～4 μm 厚さの変質層が生じている。インコネル 718 およびインコネル X 750 組織には金属間化合物 Ni₃(Ti, Al, Nb) が、またインコネル 600 組織には微細な炭化物がみられる。ハスティロイ C, AISI 661 およびカーペンター 20Nb のナトリウム接液面近傍は著しい変化は示していない。ハスティロイ C 組織には初析カーバイト (W, Mo)₆C が、AISI 661 組織には Laves 相 (Fe₂Mo, Fe₂Nb, Ni₃Mo) がみられる。AISI 661 の粒界はナトリウム浸せき後明白となり接液面に近いほど炭化物が多くなっている。カーペンター 20Nb はナトリウム浸せき後双晶が消失し、粒界の炭化物が多くなっている。インコロイ 800 はナトリウム浸せき後粒界および粒内に析出物が多くなっている。

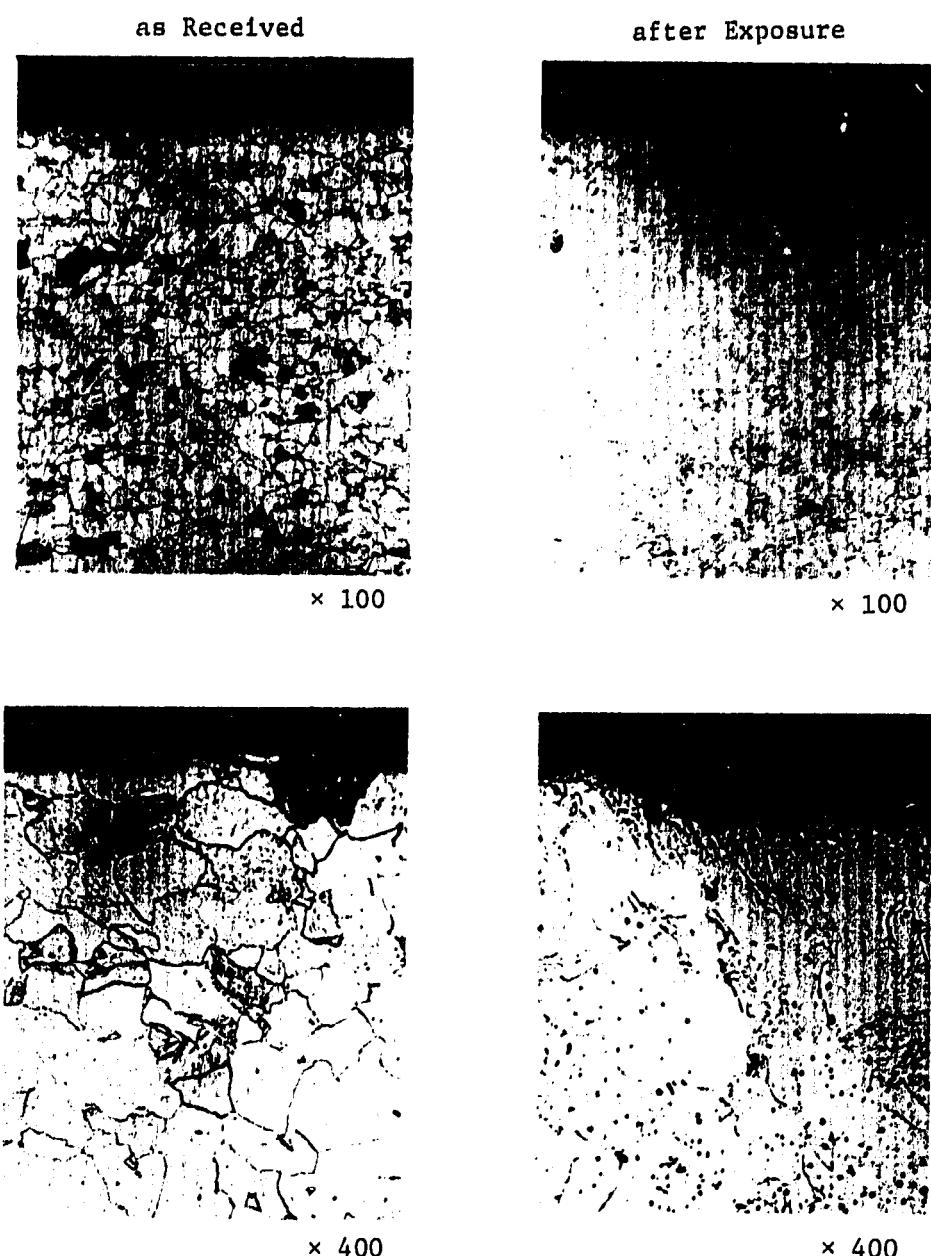
Photo. 41 Cross-Sectional Micrographs of 2 1/4Cr-1Mo Steel

SUS 304 およびSUS 316 はナトリウム接液面近傍に変質層はみられないが、SUS 316 粒界に δ 相がみられる。この δ 相はナトリウム接液面に近いほど多くなっている。2 1/4Cr - 1Mo 鋼は完全焼きなましの 3 mm 厚板を片面のみの研削により 2 mm 厚とした。熱処理時に脱炭が生ずると考えられるため両面の組織を比較したが、本試験では明白な差はみられなかった。純鉄はナトリウム浸せきによる組織変化がみられない。LW-1N 40 も同様である。LC-1C は合金との境界面組織に変化がみられる。LC-1C は一部が合金からはく離したがこの組織変化が原因と考えられる。

29に示した表面の変質層のためと考えられる。LW-1N40のかたさはナトリウム没せき後増加しているが、LC-1Cは著しく低下している。2 1/4Cr-1Moは試験片両表面のかたさが異なっている。これは完全焼きなましした3mm厚板材を片面のみ研削し2mmほにしたため、研削しない側の表面は熱処理過程で生ずる表面近傍の脱炭の効果があらわれて研削した面よりかたさが低いと考えられる。

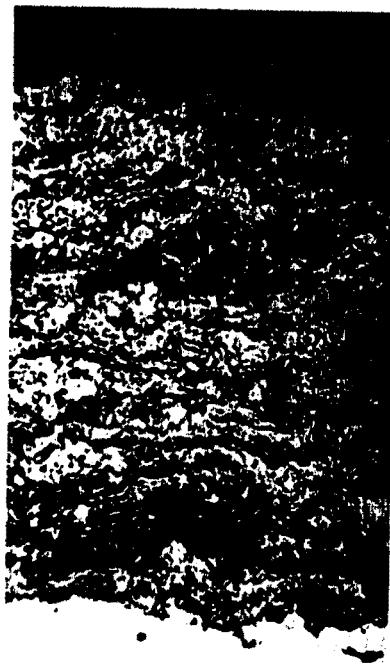
× 400

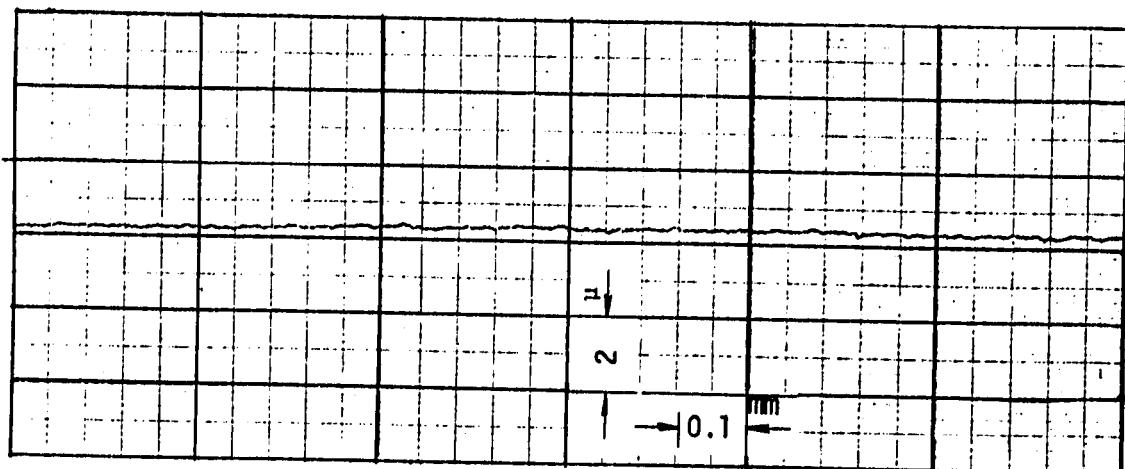
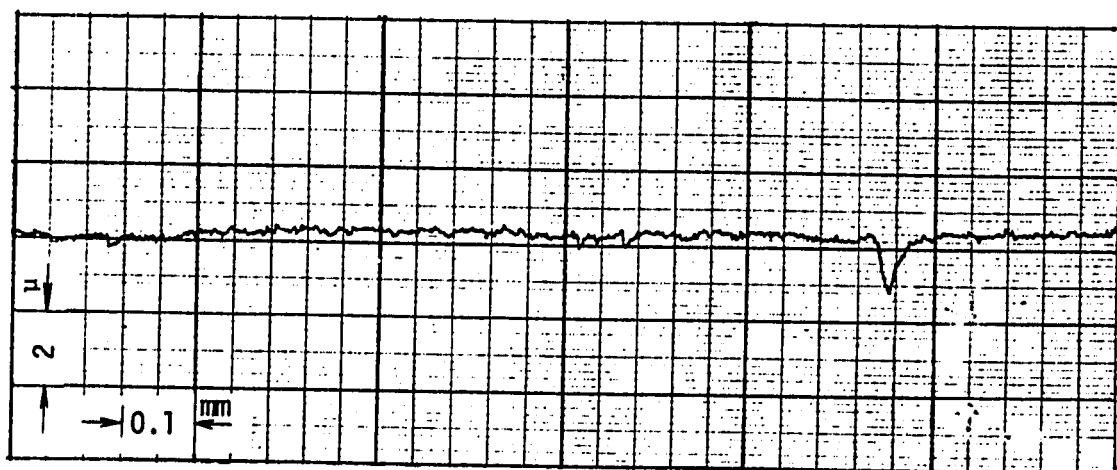
Fig. 1 Surface Roughness of Stellite No.1

Table. 7にナトリウム浸没前後の試験片表面のあらさ値を示す。Fig. 8は浸せき前後の表面あらさ平均値を試験片ごとにプロットしたものである。ほとんどの試験片は浸せき後表面あらさが増加する傾向がみられるが、コルモノイ合金およびカーバイトを除くとその変化は小さい。コルモノイ合金はFig. 6に示した腐食量の増加と対応して表面あらさが増加している。カーバイトはカーバイト粒子の表面からの脱落のため表面あらさが増加したと考えられる。Fig. 6において最も大きな腐食量を示したメテコ 16 C およびデロロステライト SF - 60 M のあらさはほとんど変化していない。Appendix I に表面あらさ曲線の例を示した。

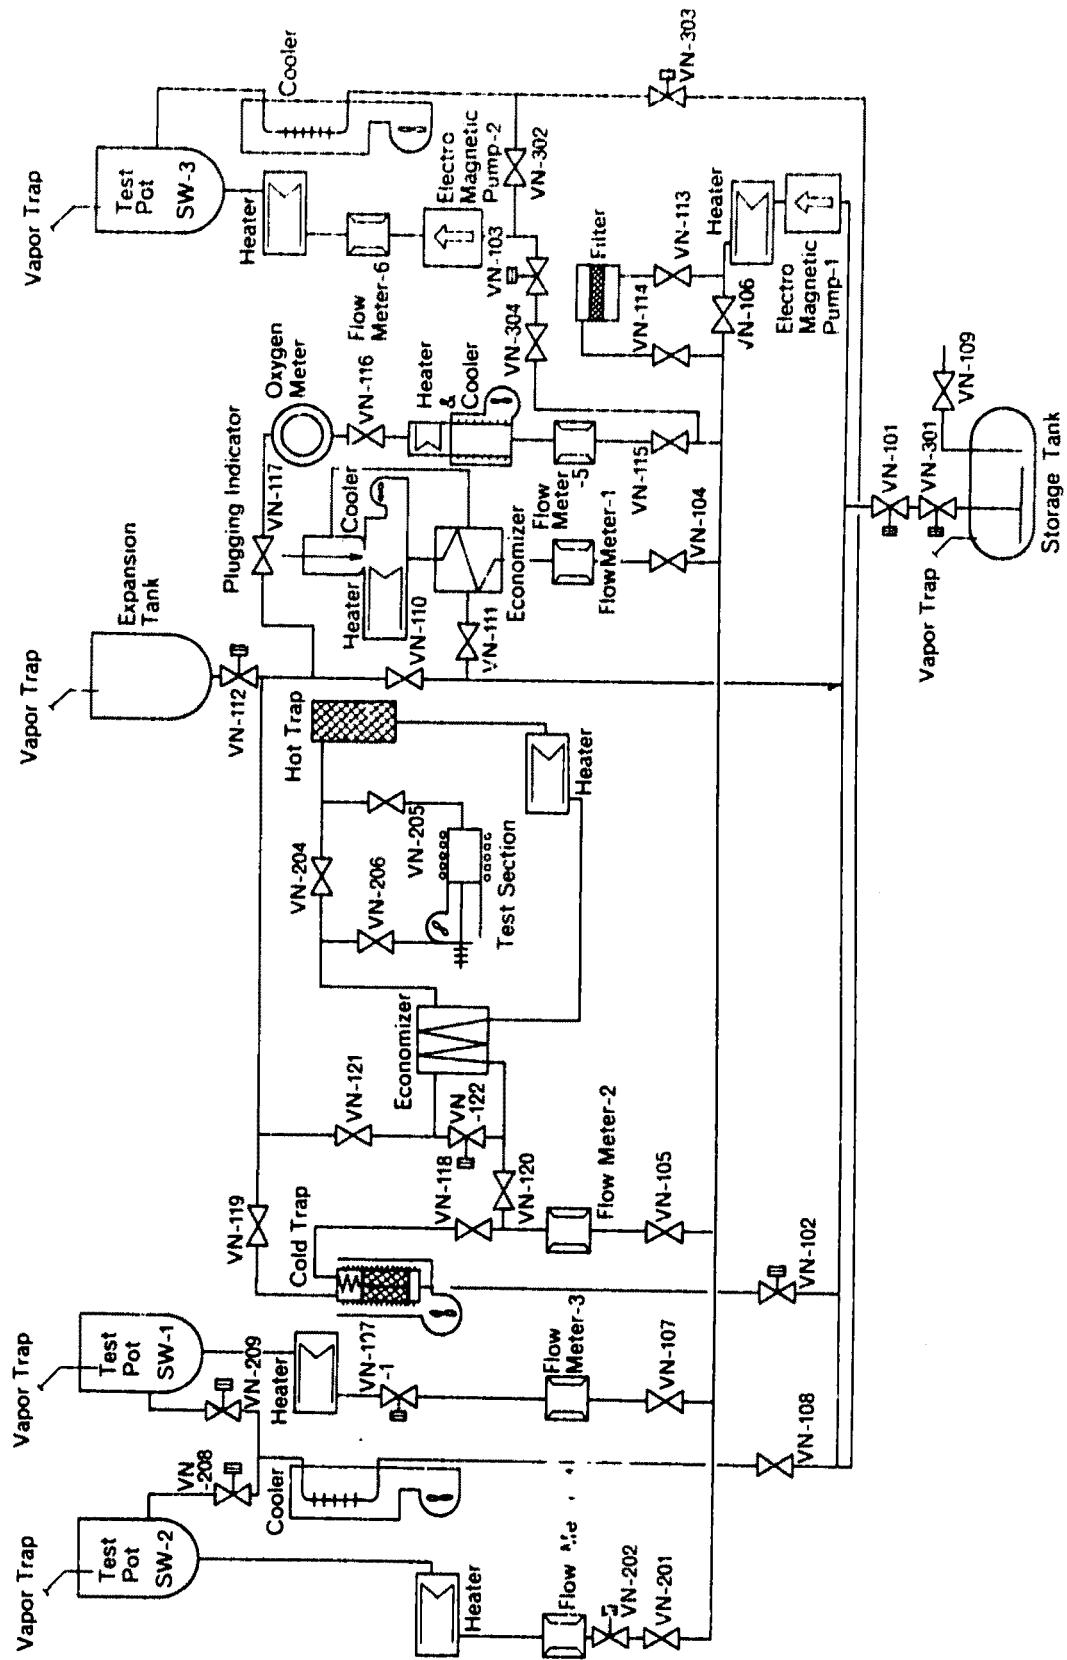
Fig. 2 Flow Sheet of Self-Welding and Wearing Test Loop

Fig. 2にSUS316製自己融着・摩擦試験ループのフローシートを示す。本試験に使用した試験装置は流動ナトリウム中における表面硬化材の摩擦係数の時間依存性をしらべる目的で設置されたSW-3ポットである。Fig. 3にポットの断面を示す。試験片はFig. 4に示すSUS316製ホルダー2個に取付けられ、ポットの入口ノズルわきのナトリウム中に浸せきされた。なお、材質間の相互作用を極力小さくするため化学成分の異なる試験片は互いに離してナトリウム中に浸せきした。

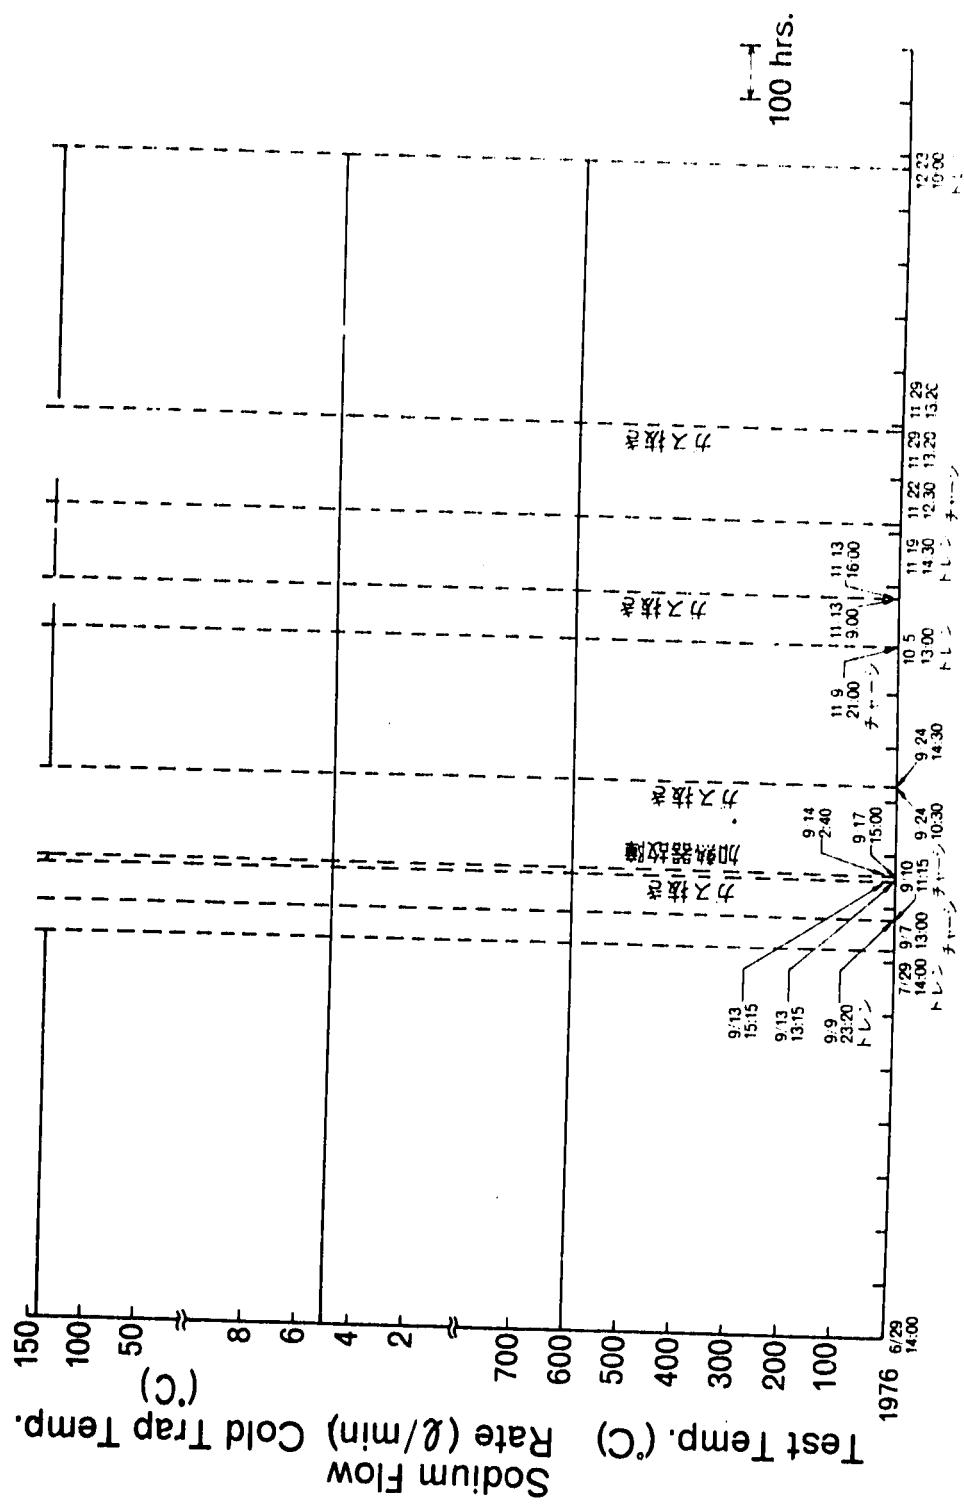
Fig. 5 Progress of Test Loop

Table. 4にナトリウム中浸せき条件を、Fig. 5に試験装置の運転経過を示す。試験時間は試験部の温度が600°C、ナトリウム流速が5ℓ/minであった期間の合計値とし、2,174時間である。試験片表面におけるナトリウム流速はほぼ0に等しいと考えられる。ナトリウム弁VN301, 302, および303の切り替えにより、コールドトラップで純度管理したナトリウムを時々試験部に供給した。コールドトラップで純化したナトリウムを試験部に供給した合計時間は約1700時間である。

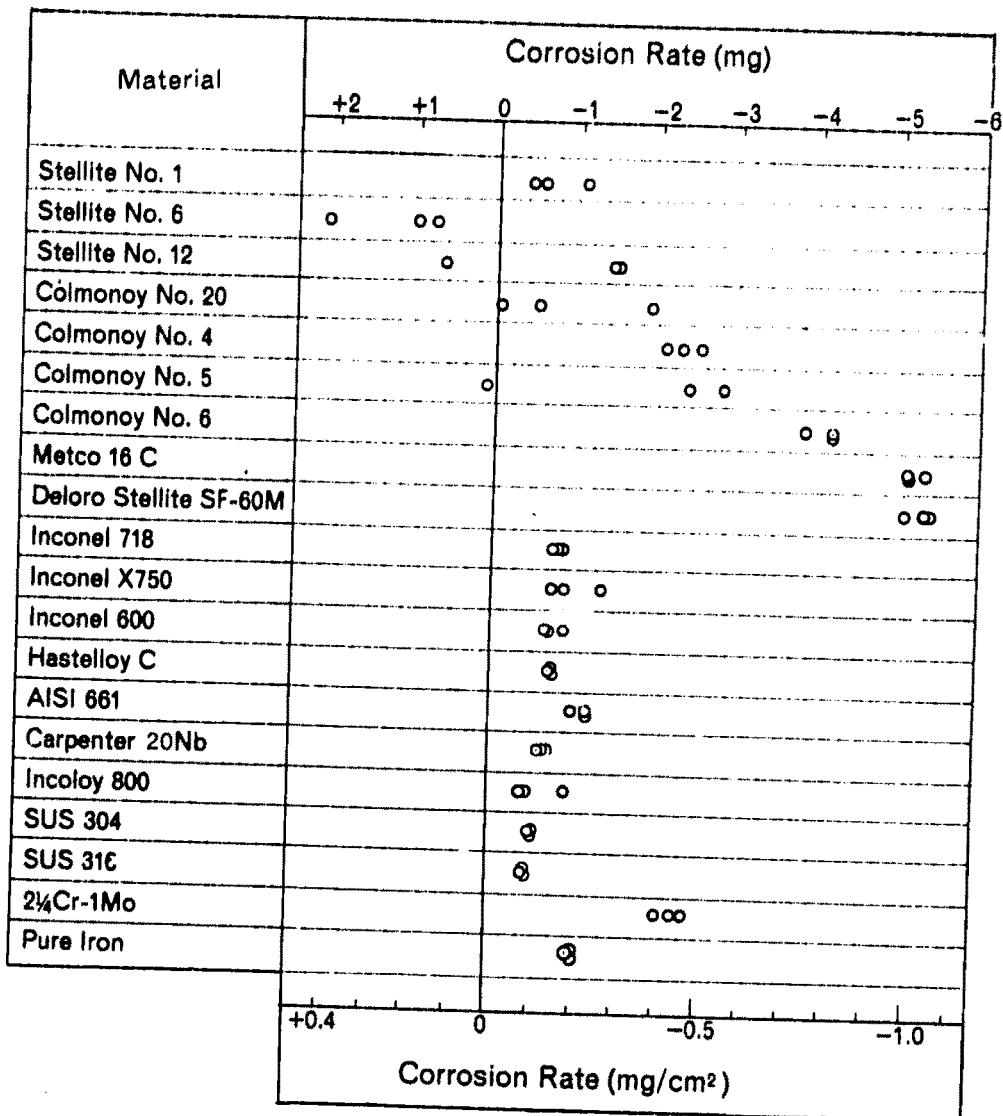
Fig. 6 Weight Change

Fig. 6にナトリウム浸せき前後の重量変化を試験片ごとにプロットした。縦軸の「-」は浸せき後重量が減少したことをあらわす。Table. 5には各試験片の重量測定値を示す。SUS304およびSUS316の腐食量が最も少なく、インコネル合金、カーペンター20Nb、インコロイ800、純鉄などはSUSの1~2倍となっている。 $2\frac{1}{4}\text{Cr}-1\text{Mo}$ 鋼はSUSの4.5倍と高い。酸素アセチレンガス溶融した材料のうちコルモノイ合金はNo.20, 4, 5, 6の順に腐食量がふえている。ステライト合金の腐食量はコルモノイ合金より少ないが変動が大きい。特にステライトNa6は重量が増加している。メテコ16CおよびデロロステライトSF-60Mは本試験のうち最も大きい腐食量を示しておりSUSの10倍となっている。

Table. 5に示すようにLW-1N40の腐食量は著しい変動を示したので、Fig. 6にはプロットしなかった。またLC-1Cはナトリウム浸せきにより合金から一部がはく離したので重量測定を行なわなかった。

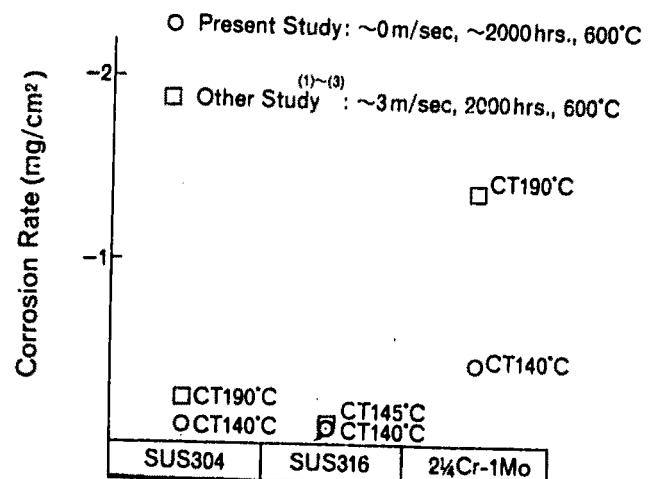
Fig. 7 Corrosion Rate

Table. 6はSUS304, SUS316 および $2\frac{1}{4}\text{Cr}-1\text{Mo}$ 鋼の腐食量に関する本試験結果と材料試験ループ1および2による試験結果^{(1)~(3)}を比較したものである。材料間の腐食量の大小は双方とも同じ傾向である。本試験のほうが腐食量が小さくなっているが、Table. 4に示したように本試験ではナトリウム流速がほぼ0であることとコールドトラップ温度が低いことが原因していると考えられる。Fig. 7に示すようにコールドトラップ温度が高いほど、各材料とも腐食量が大きくなっている。

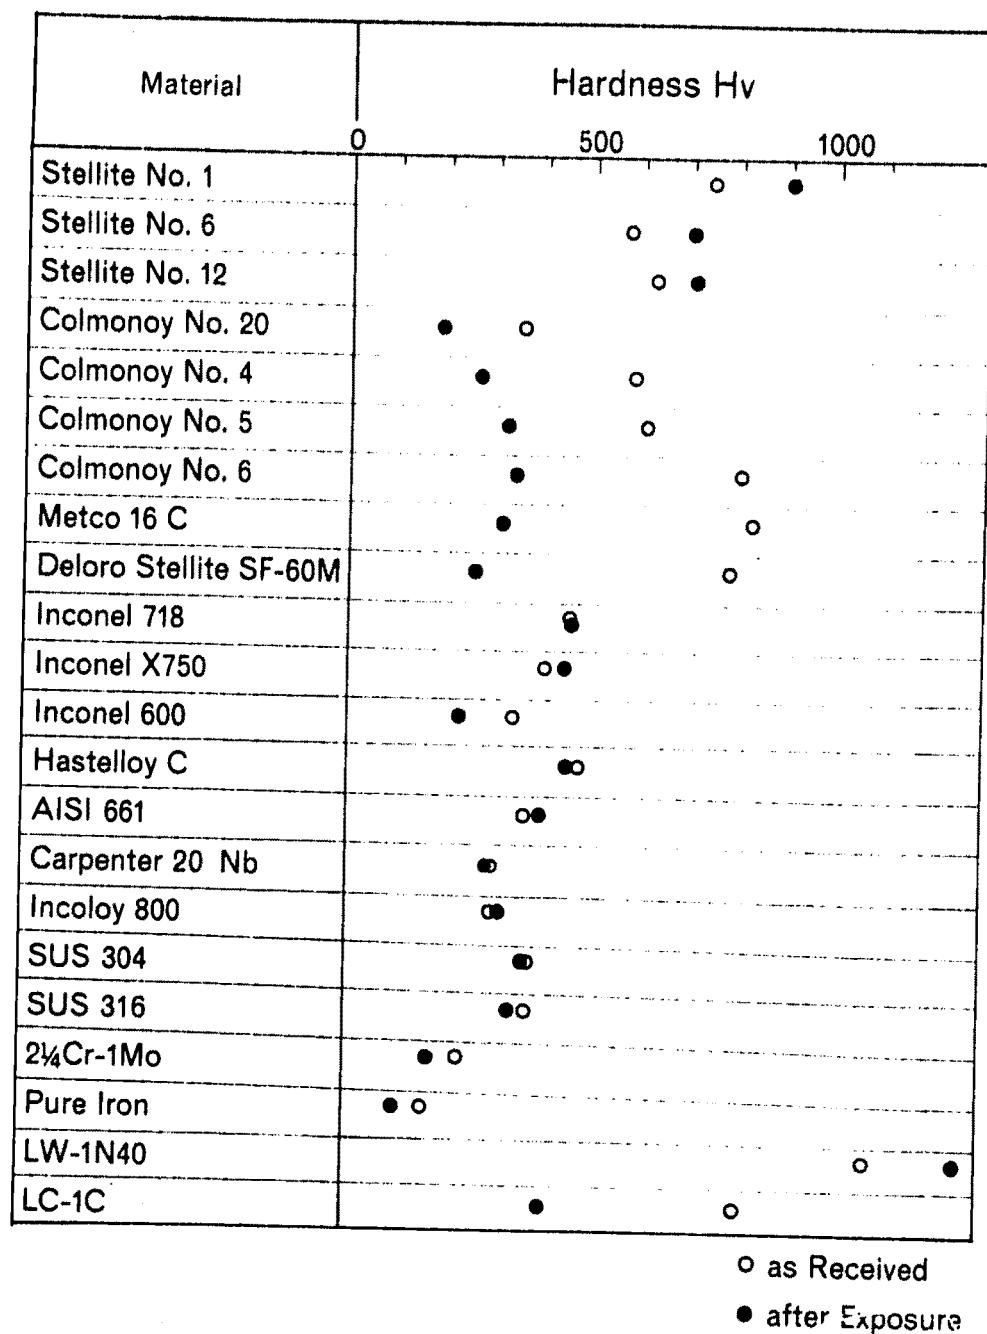
Fig. 9 Change of Hardness

Table. 8 にナトリウム浸せき前後の試験片表面のかたさ測定値を示す。また Fig. 9 に平均のかたさ値をプロットした。ステライト合金はナトリウム浸せきによりいずれもかたさが増加しているが、Ni 基の肉盛合金は著しく低下している。コルモノイ合金の低下は Photo. 26～Photo.
