Postirradiation Examination of

GETR-IRT(B)

August, 1974

Postirradiation Examination of GETR-1RT (B)

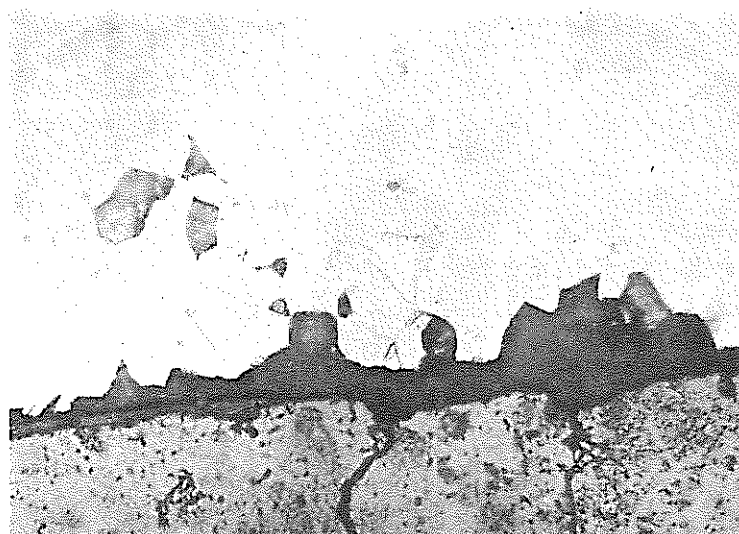
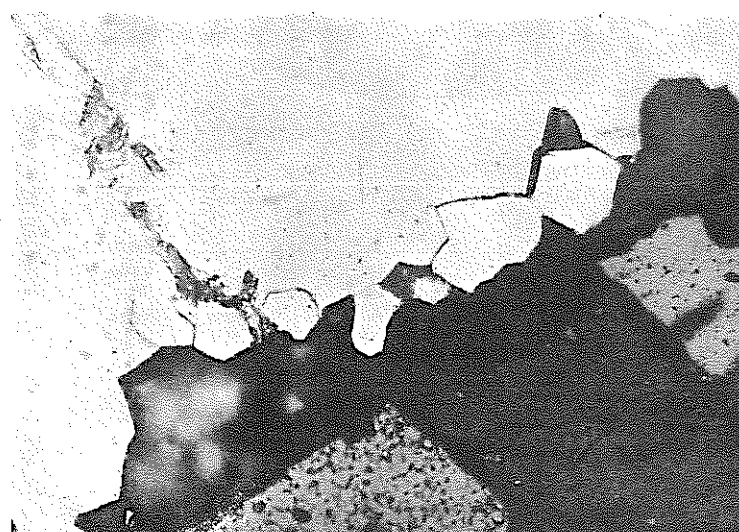
Photograph 23. Damage to inner surface of cladding tube
Pin-E-20502

Damage on the inner surface of the cladding tube are remarkable in Pins E (Specimen No.20502) and G (Specimen No.20702). As shown in Photograph 23, damage on the inner surface of the cladding tube reaches a depth of about 50 μ m and shows the structure losing some grain along the grain boundary in Pin E which contains pellet fuel having a plutonium content of 40%. Damage on the inner surface of the cladding tube corresponds to concaves, probably voids, on the surface of the fuel and shows the evidence of a mechanical interaction between them (Photograph 24).

← Attacked layer
