Corrosion Behavior of the Cladding Tube
(AISI Type-316SS)

for FBR in High Temperature Sodium

- (1) Experimental Studies on Effects of Oxygen
Concentration in Sodium on Corrosion

POWER REACTOR AND NUCLEAR FUEL DEVELOPMENT CORPORATION

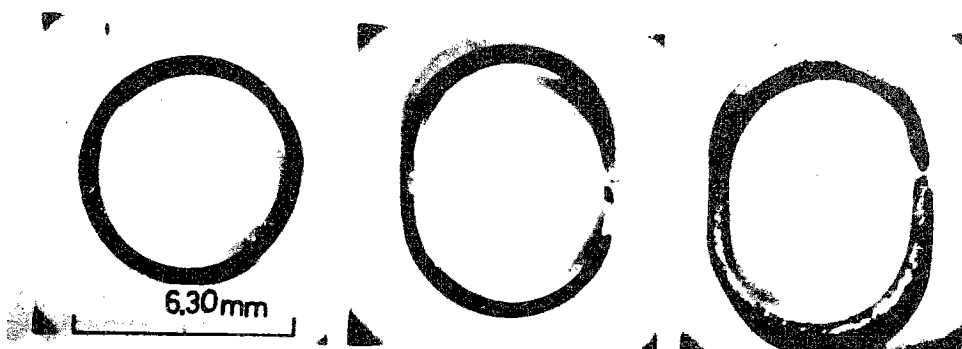
Stress-strain curve due to ring tensile test

Fig. 17 Appearance of specimens after ring tensile test and stress-strain curve.

In order to investigate the influence of corrosion on the mechanical properties of the cladding tube, the tensile test was made at room temperature, using 1 mm wide ring-shaped test pieces. Figure 17 shows the results with the appearance of the test pieces. The strain in this figure is the ratio of the value of elongation and the gauge length. The gauge length was taken with the length of the external circumference of the test piece before testing. The stress is the nominal one. The photograph and stress-strain curve of the specimen after rupture evidently show remarkable decrease of yield stress and increase of elongation in the specimen exposed in sodium. The mechanical properties obtained from the stress-strain curve in

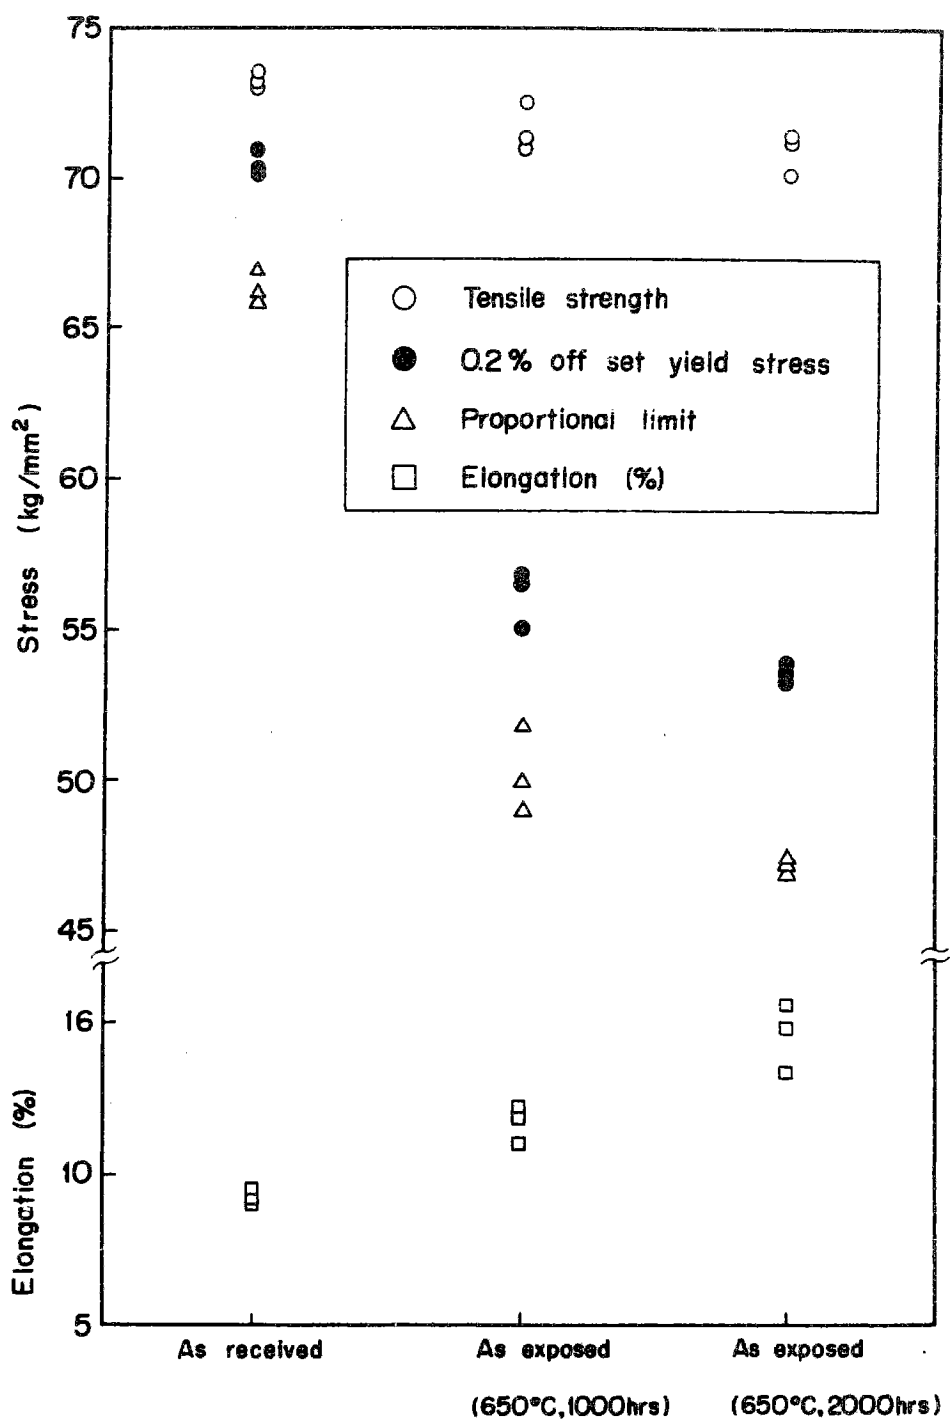
Fig.18. Change of mechanical properties due to ring tensile test of the stainless steel cladding tube specimen after exposure in 650°C sodium.

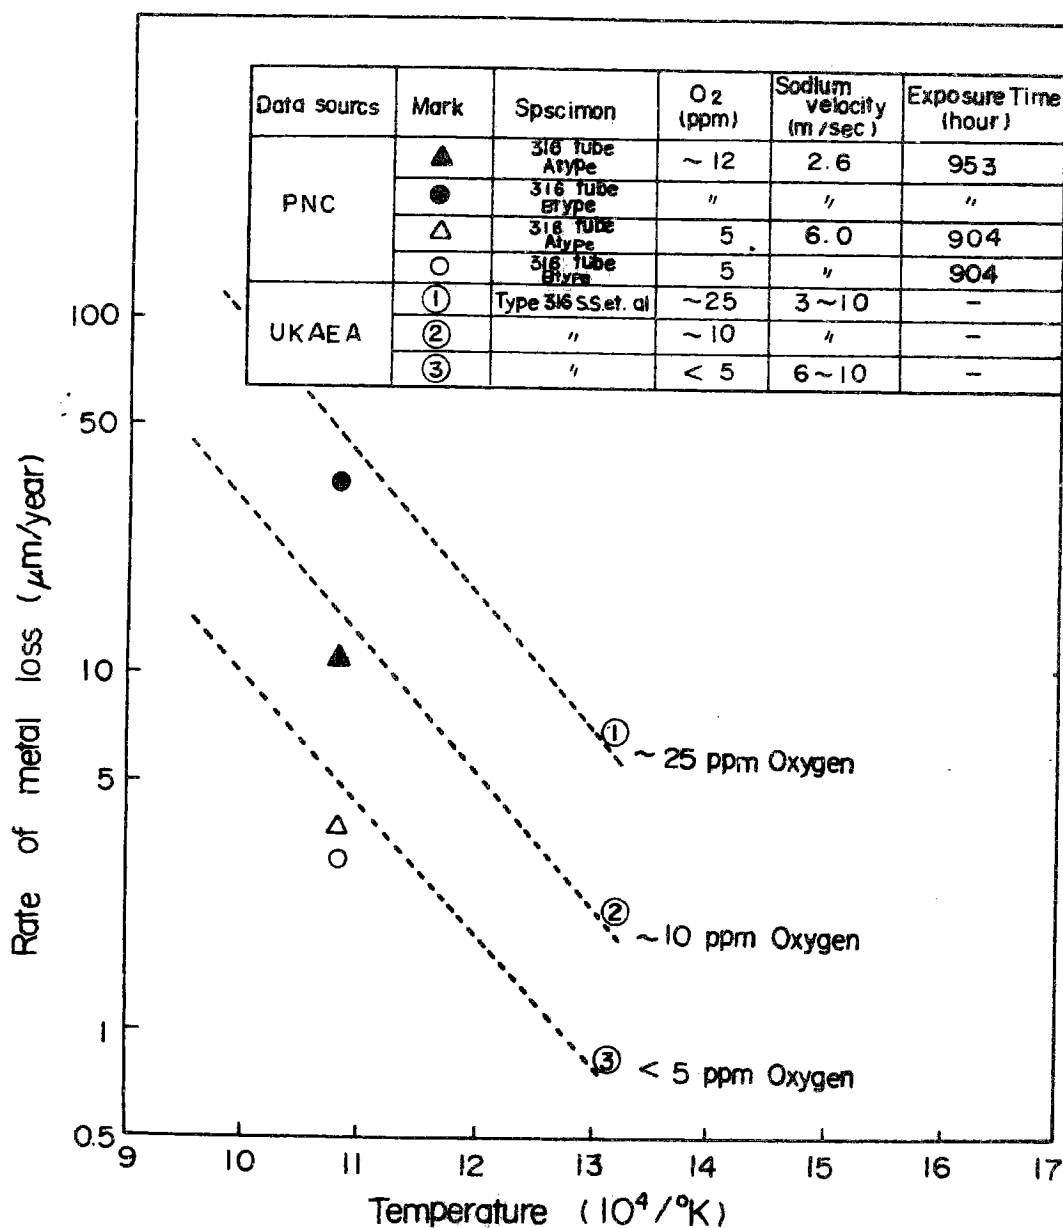
Fig.19. Metal-loss rate of Type-316 cladding tube specimen in 650°C sodium.

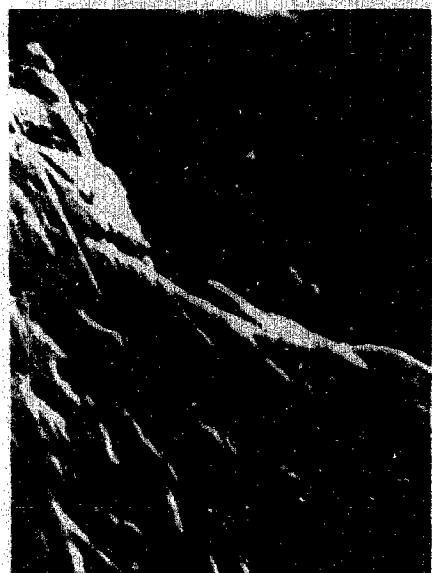
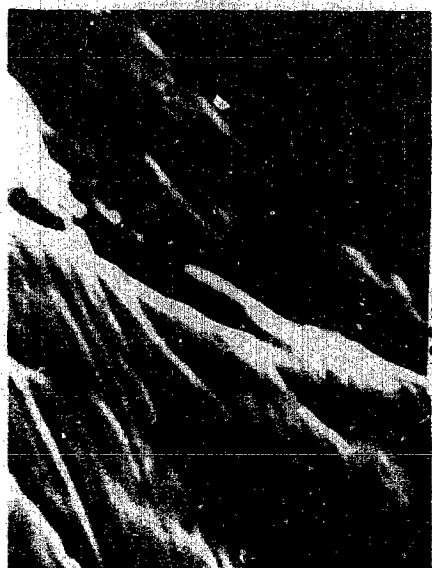
Photo-2. Scanning electron micrographs of Type 316 stainless steel cladding tube specimen before sodium exposure.

Photo 2 shows the scanning electron micrographs of the surface of cladding tube specimen before exposure to sodium. As seen from Photo 2(a), the surface of the cladding tube shows only the minute abrasions presumably made during its final machining and the surface condition is good. Photos 2(b) and (c) show further magnified views of the surface. The maximum height of the surface roughness (JIS) was $0.9\text{ }\mu\text{m}$. Photo 3 shows the surface corrosion after sodium exposure. Photos 2(A), 2(D) and 2(E) show the surface corrosion after sodium exposure. Photos 3(A), 3(D) and 3(E) show the surface of the tube, while Photos 3(B) and 3(C) show the heat-affected zone of the welded end plug. Photos 3(C) and 3(E) are the micrographs of higher magnifications of the same places with (B) and (D). The surface corrosion showed the general characteristics as follows:

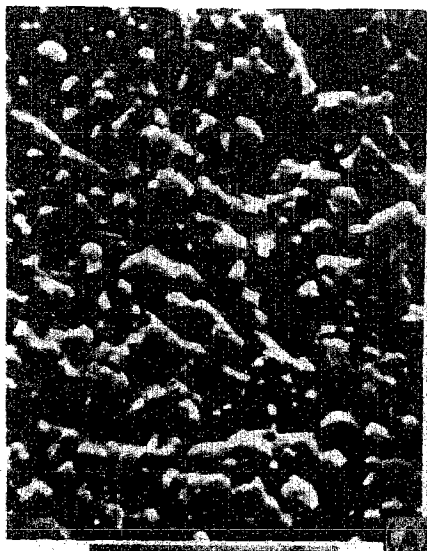
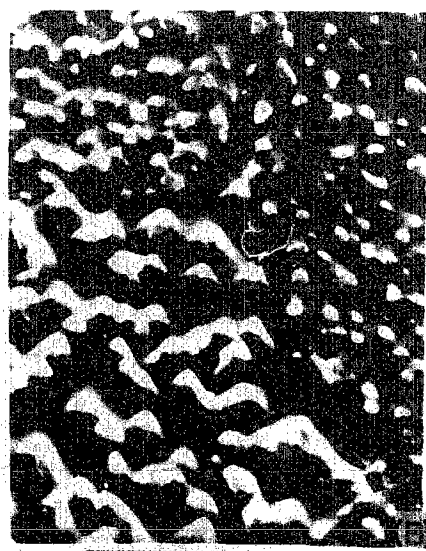
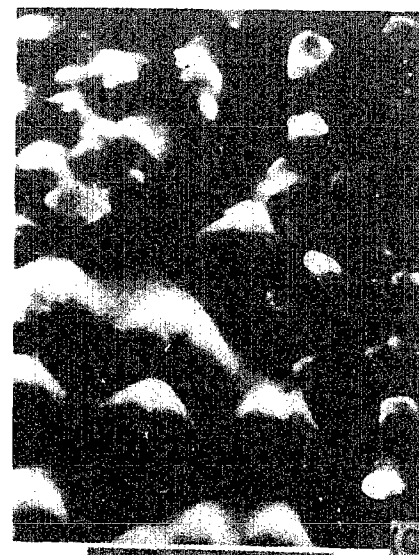
Surface after exposure for 1000 hours
(12ppmO₂)

Surface of welding heat-affected zone after exposure for 1000
hours (12ppm O₂)

Surface after exposure for 2000 hours. (5ppm)

Photo-3. Scanning electron micrographs of Type 316 stainless steel cladding tube specimen surface after exposure in flowing sodium at 650°C.

- (i) The grain boundary appears distinctly and is slightly depressed compared with the matrix. Noticeable intergranular corrosion is not observed and the main corrosion morphology is considered to be the general corrosion.
- (ii) Corrosion products of about $0.2\text{ }\mu\text{m}$ to $1\text{ }\mu\text{m}$ in size are observed on the surface of the matrix.
- (iii) The degree of corrosion varies slightly along the direction of the individual crystal grains in the surface, which may be related to the wavelike surface roughness.
- (iv) Both welded and heat-affected zones have no noticeable difference as compared with the tube surface except the welded part (refer to Photos 3(A), 3(B) and 3(C).
- (v) On the oxygen concentration dependence of corrosion, the corroded surface is more crystalline.
