JAEA-Review
2009-055

Investigation on Integrity of JMTR Concrete Structures, Cooling System and Utility Facilities

Hiroyuki EBISAWA, Kenji TOBITA, Akitomi FUKASAKU and Masanori KAMINAGA

Department of JMTR Operation
Neutron Irradiation and Testing Reactor Center
Oarai Research and Development Center

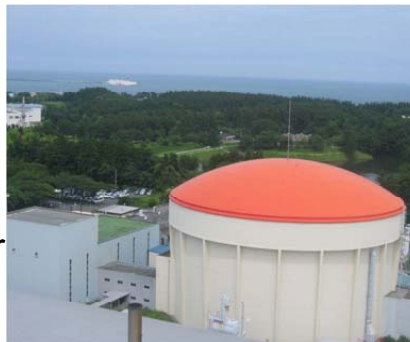
No damage was observed for the **outer wall**. On the other hand, small cracks (maximum gap size is **0.4 mm**), float of paint and falling of masonry were observed for a part of the **inner wall**.

The point rust was caused on the surface of 7 samples of 16 samples. (Corrosion grade I) → **No problem**

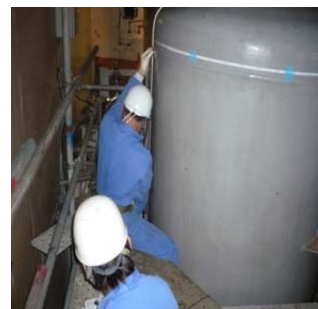
1. **Eddy current testing** for heat exchanger tubes
 10 tubes in Unit No.1, 6 tubes in Unit No.2 and 7 tubes in Unit No.3 were evaluated to have the thinning rate 20% or more.
 Thinning was observed at the inner surface of the tube wall.
2. Thickness measurement of the main body
 All measured thickness were greater than required minimum thickness of **6 mm**.
3. Visual observation using an endoscope
 Surface condition and color change of the tubes which had been evaluated as the thinning of the thinning rate 20% or more, were checked.
 No evidence of abnormal condition was observed. ➔ **No problem**

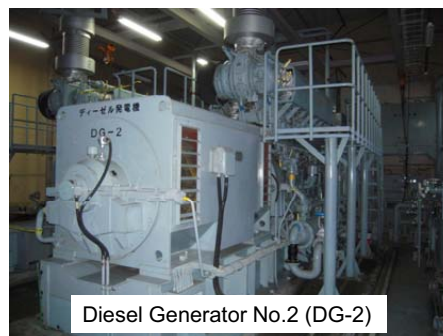
There was no surface leakage of current was measured(see figures). There is no deterioration of insulation resistance caused by moisture uptake.

There was no evidence of the moisture uptake of the stator coil, the stain, changing in quality, flaking off. No void was generated.

There was no void caused by flaking off and the breakdown voltage was measured to be 6.6KV or more.

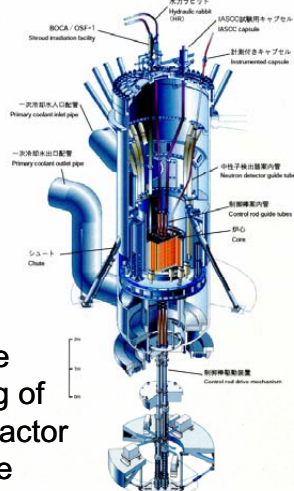
Pressure vessel

- ❑ As a result of the visual observation, the harmful wound was not confirmed. Moreover, there was no loosening of the bolts and the screws. Negligible rust was observed near the upper part of the reactor pressure vessel.

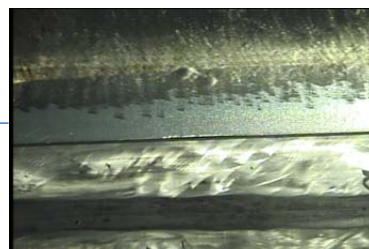
- ❑ It is thought that the rust observed near the upper part of the reactor pressure vessel comes from the adhering iron etc. Because the upper part of the reactor pressure vessel will be exposed to the air during the reactor shut-down period in order to carry out necessary work for irradiation samples.

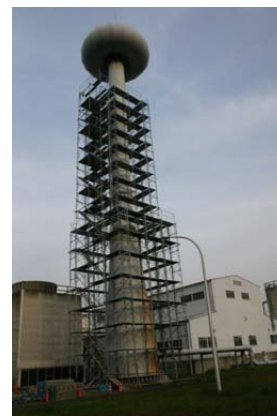
There is no evidence of crack and false indication in the welding region.

After repairing and paints

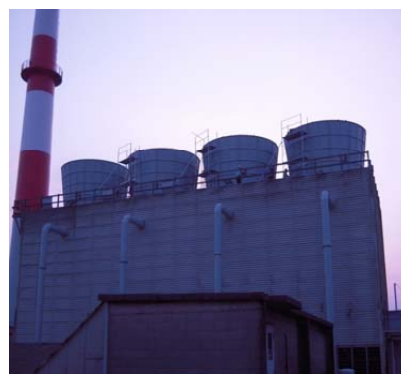
JMTR secondary cooling system cooling tower (4 cells)

- As a result of the visual observation, partial internal decay and cracks caused by dryness were confirmed at the top deck, fan stacks, and deck joists, etc. It was confirmed that there were no remarkable corrosion or rust of bolts.

- Therefore, cracks of concrete and a part of the secondary cooling tower, etc., were repaired. The linings of the secondary cooling system pipes were replaced. Thus the long-term integrity of the concrete structures and the JMTR related facilities was established.

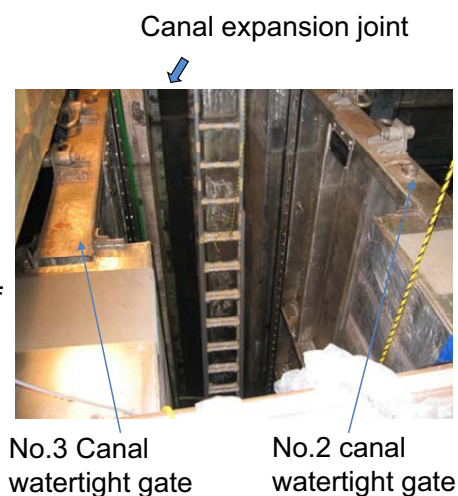
Near the part of the waterline and underwater part, small swelling and cracks were observed in both east and west sides of the canal expansion joint. On the other hand, no abnormal condition was observed above the water surface part.
