## JCO Criticality Accident Termination Operation

Masashi KANAMORI

Nuclear Emergency Assistance and Training Center

July 2010

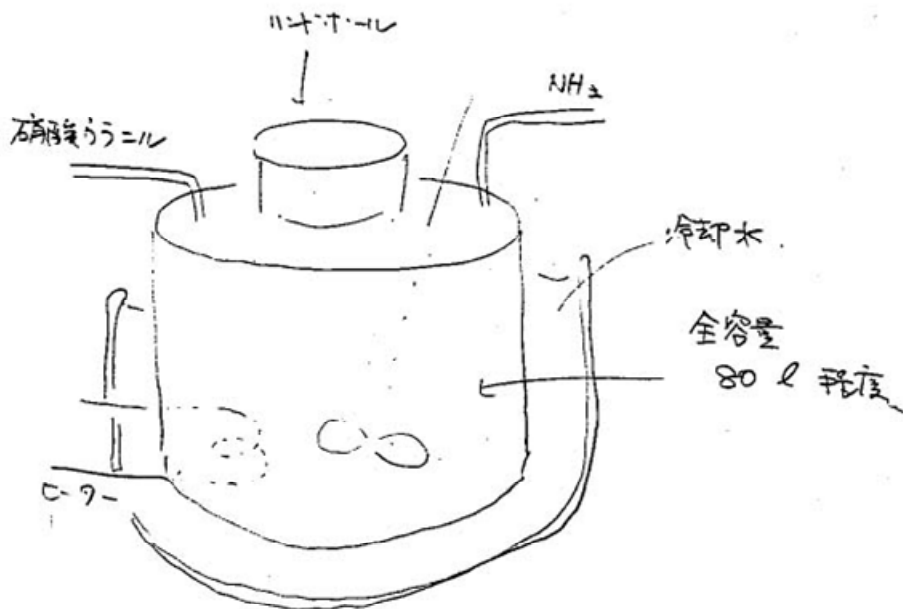
Fig.1 Initially created sketch drawing of the precipitation tank

1. タンク内で臨界が起るといふと考へらる。
2. 本乗 2kg 投入するところ。16kg 投入した。
3. 流量は不明。
4. タンク周囲の冷却水が、中性子反射剤となるといふ可能性がある。

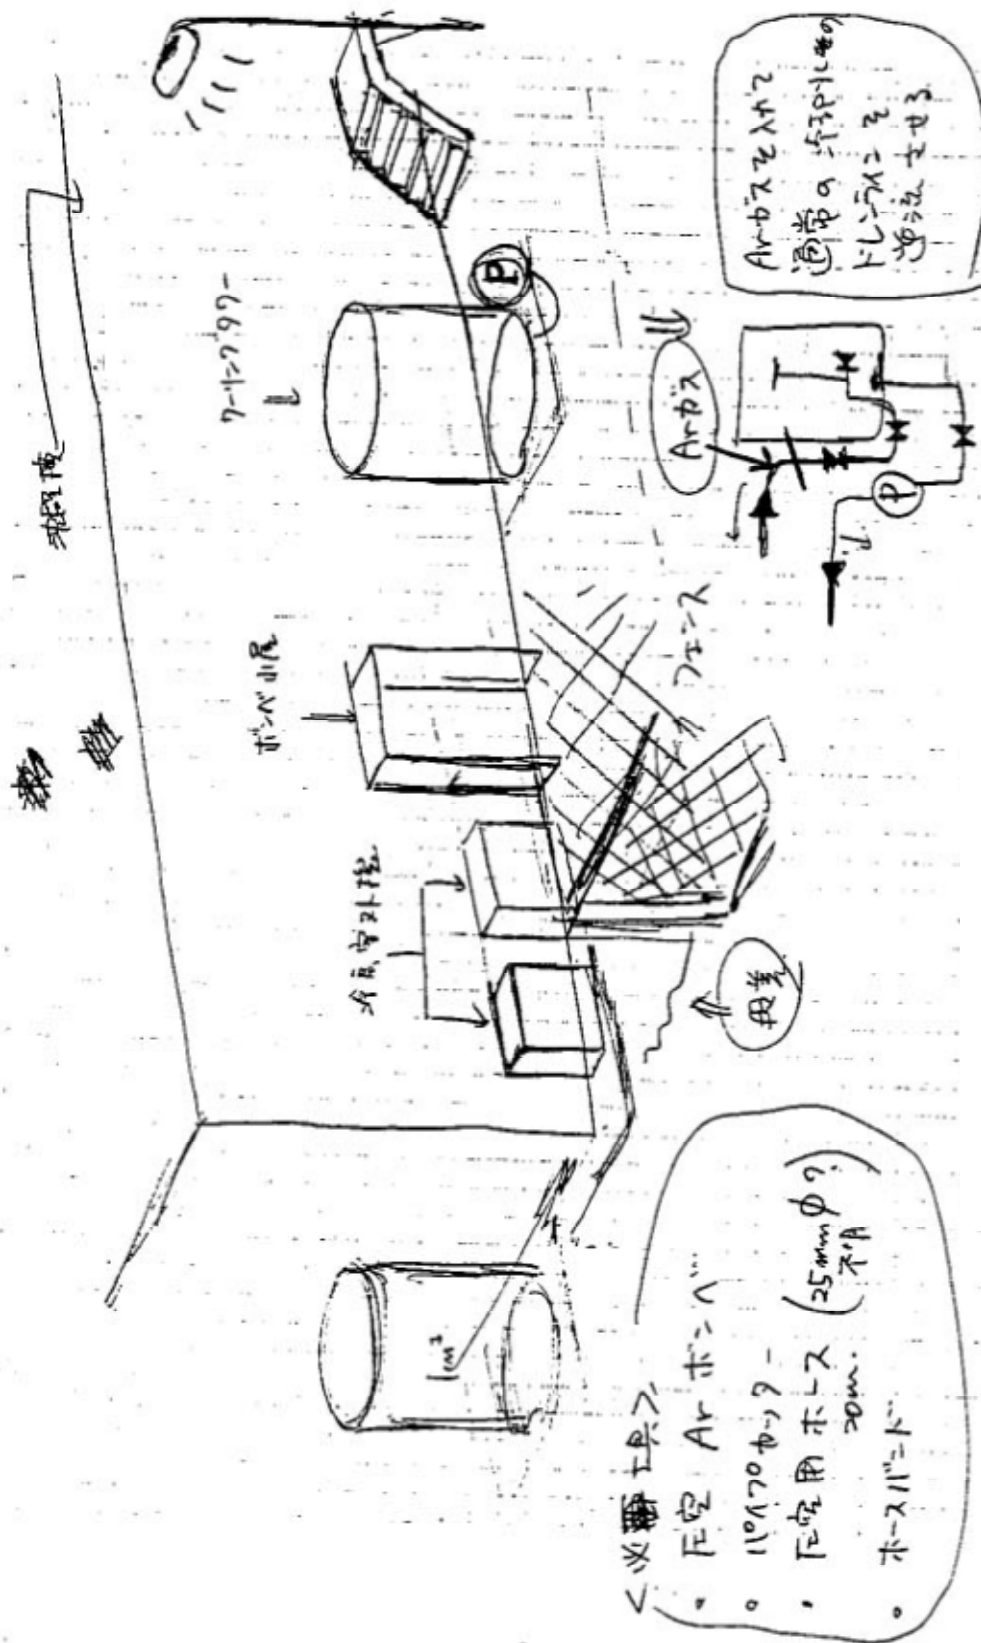
Fig.7 Backside view of Conversion Facilities

In order to confirm the piping at the site, there was no other way than to take Polaroid photographs, and bring them back for review. There was also a need to estimate in a short time the exposure dose received when working around the accident site. Therefore, it was decided to conduct Polaroid photography by approaching from the outside of the Conversion Test Building near the sedimentation tank, and at the same time ascertain the dose during actual work by setting alarms to a dose low enough to ensure a margin of safety. We created a schematic chart of the work procedure to be carried out. (Fig. 7)

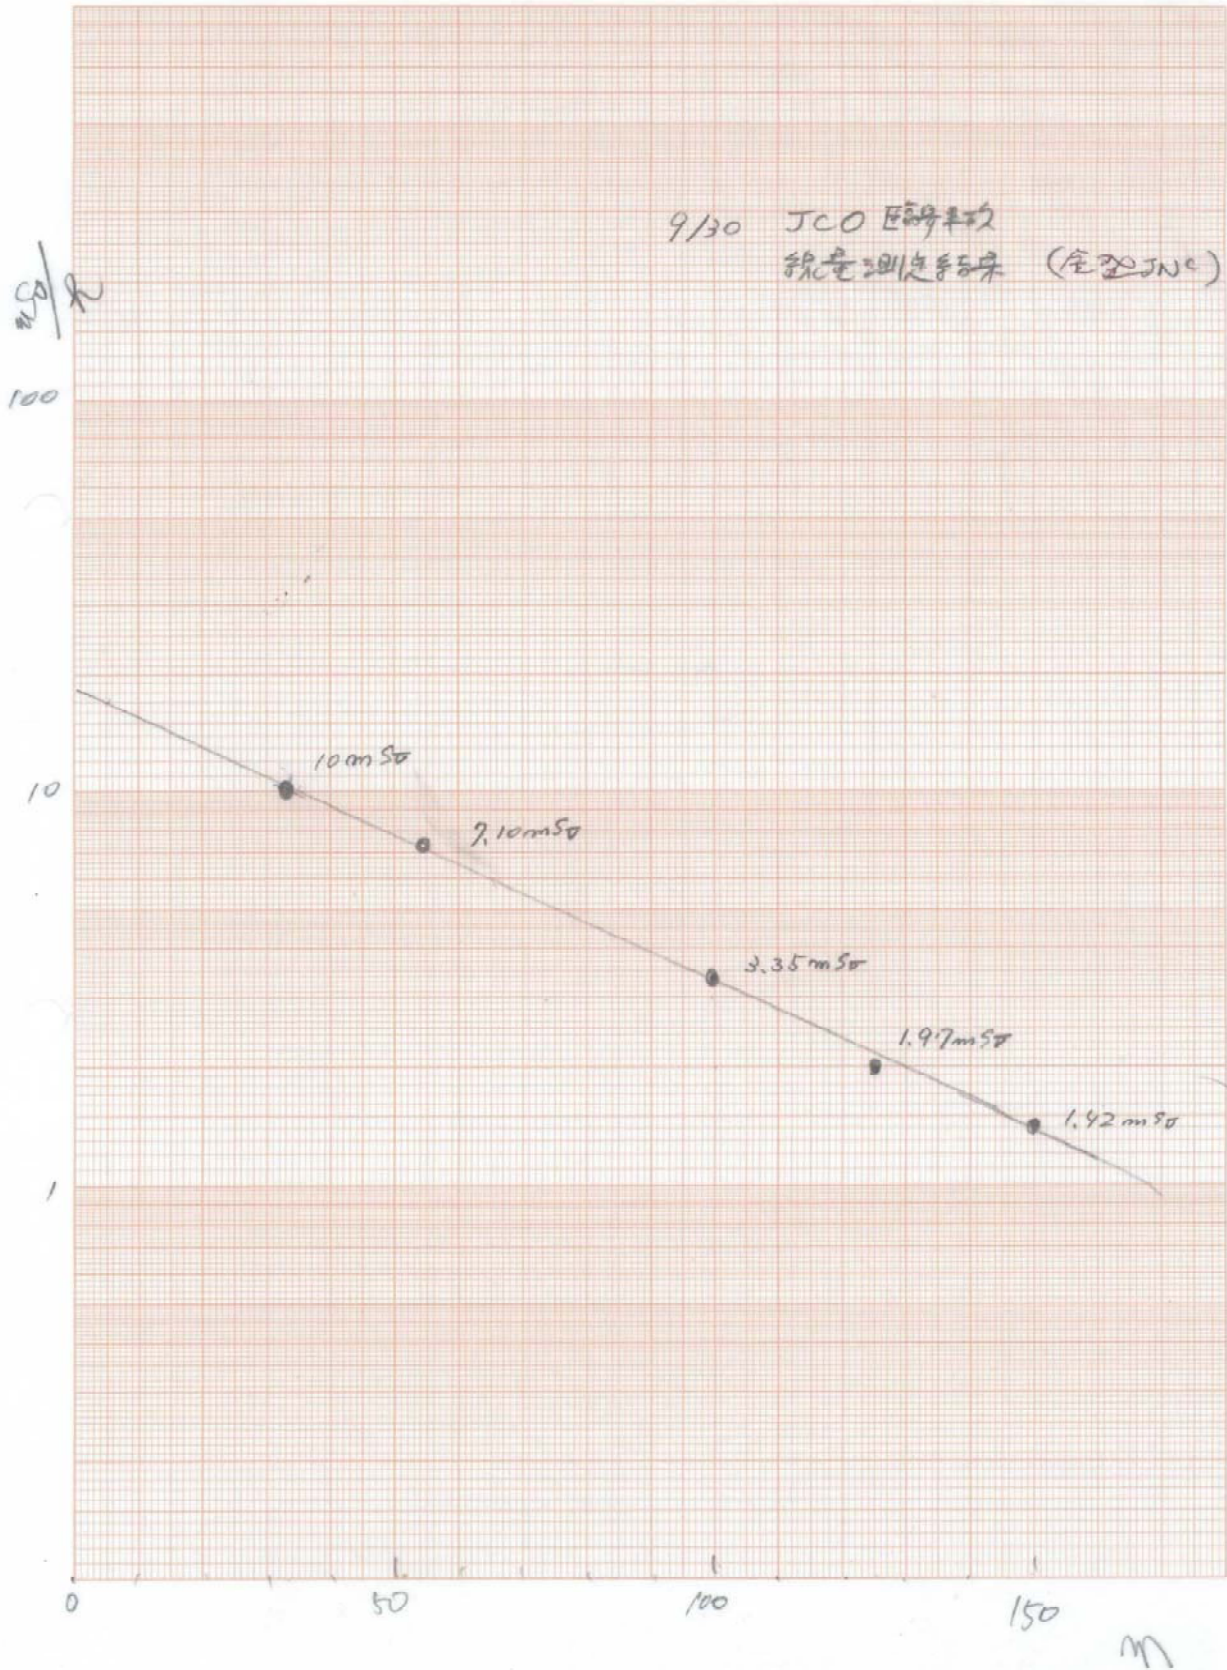
Fig.8 Neutron plot chart

On the 1F of the Administrative Building, we plotted the neutron doses from the sedimentation tank to about 250 m on semi-logarithmic graph paper based on the comments of Mr. K of JAERI, and the points were confirmed to lie almost on a straight line. (Fig.8) According to this line, neutron radiation near the sedimentation tank was about 18 mSv/hr.
