JAERI-M

MODIFICATION OF JRR-2

January 1978

Yasuhiko MIYASAKA et al

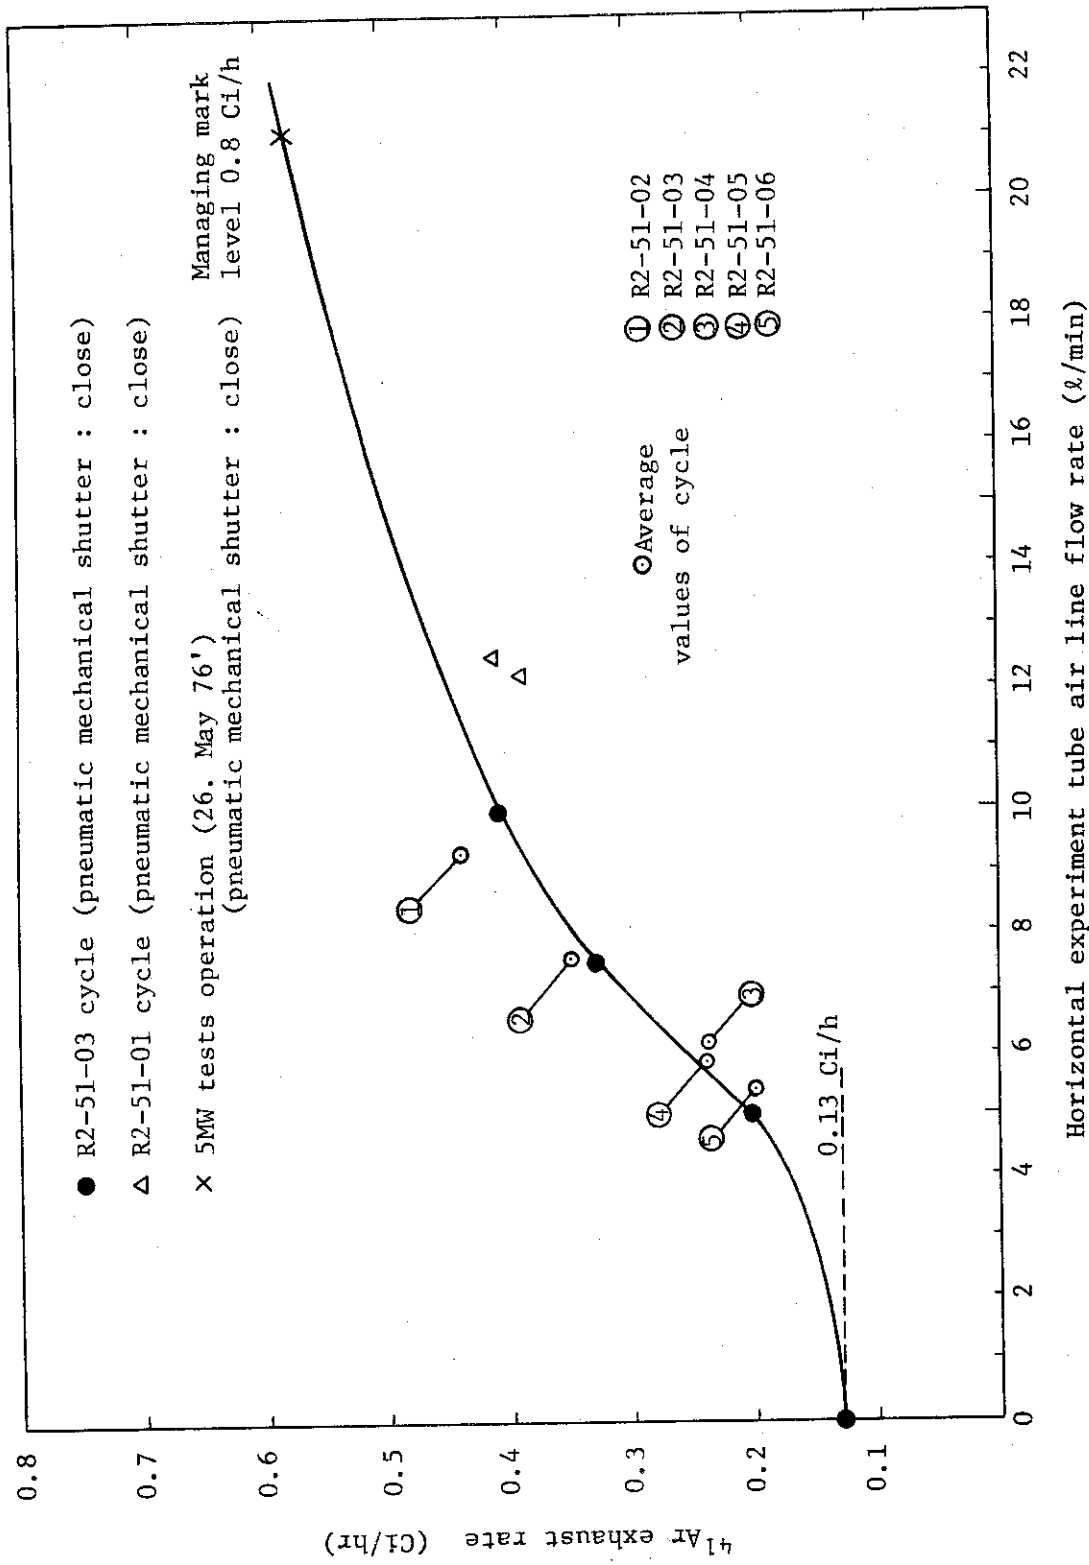
Fig. 11 Radioactive argon (⁴¹Ar) gas from the JRR-2 stack

After the improvements, operation showed good results as follow: ^{41}Ar gas release rate from the JRR-2 stack reduced to 0.22 Ci/h from 3.2 Ci/h per day on the average as shown in Table 3. Also, ^{41}Ar gas release rate is kept below 0.3 Ci/h by adjusting below 7 l/min the flow rate through the horizontal beam tube air line such as in Fig. 11. These values are less than $1/2$ the managing mark level of 0.8 Ci/h .
