FATIGUE TEST RESULTS OF STRAIGHT
PIPE WITH FLAWS IN INNER SURFACE

January 1981

Katsuyuki SHIBATA, Toshihiro OBA, Takaichi KAWAMURA
Norio YOKOYAMA* and Shohachiro MIYAZONO

日 本 原 子 力 研 究 所
Japan Atomic Energy Research Institute

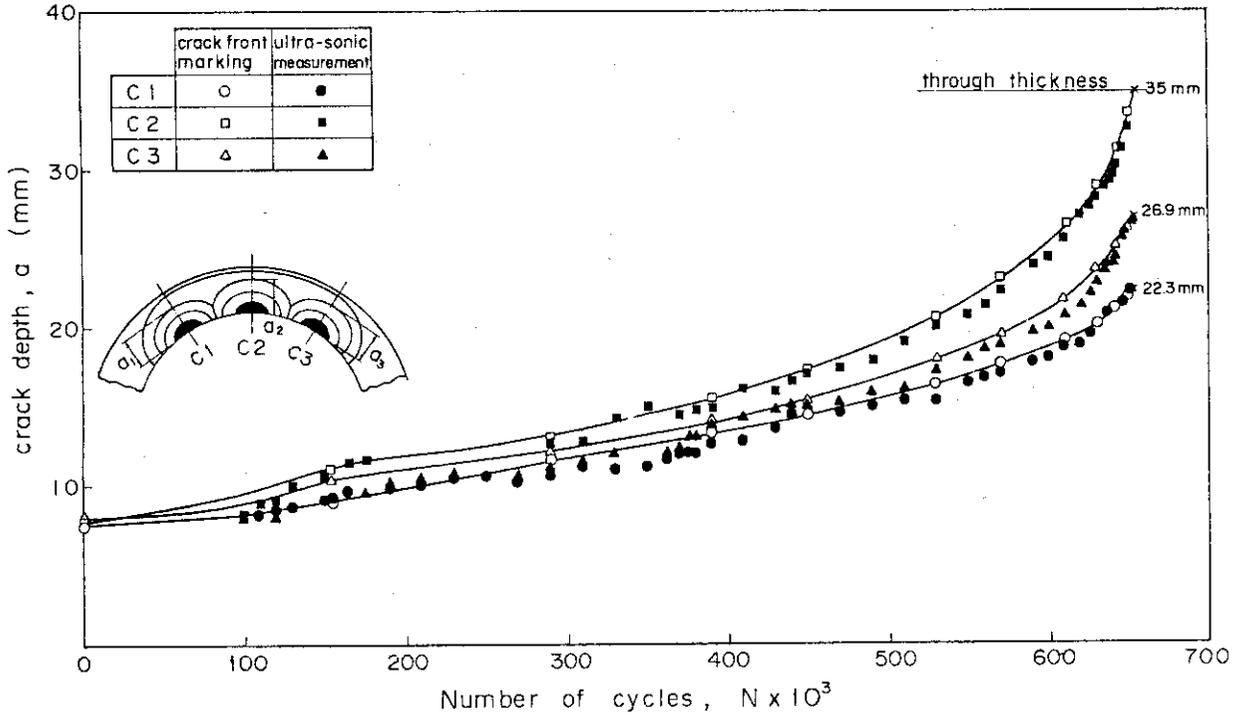
Fig. 5.3 Crack depth vs. N curves of ST-1 test results

Figs.5.3 and 5.4 show the crack depth obtained by the ultrasonic technique and by the fracture surface observation. The test results obtained by the ultrasonic technique give slightly smaller than those of the fracture surface observation, as shown in these figures. However it seems that the deviation of both the results is very small and the ultrasonic technique gives high accuracy.

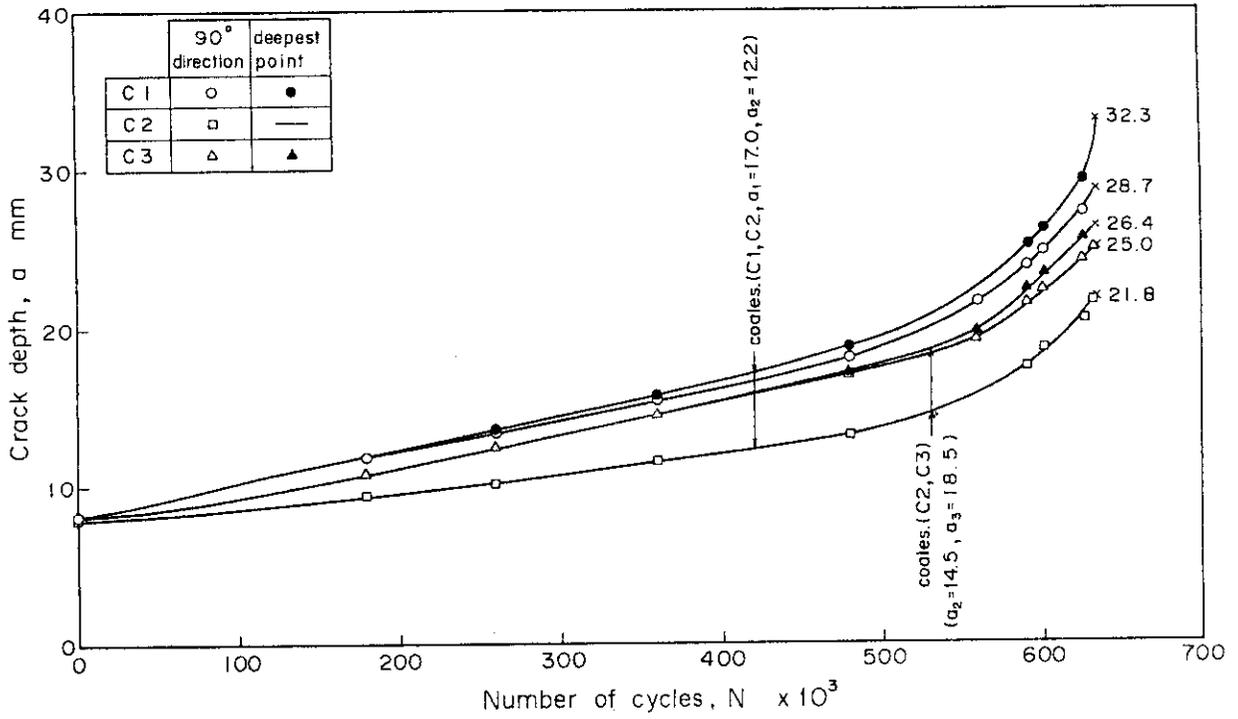
Fig. 5.5 Summary of crack depth vs. N curve obtained by fracture surface observation

In case of ST-2 test pipe, a particular crack growth behavior that C1 and C3 cracks grew faster than C2 is observed as shown in Fig.5.2 and Photo.5.2. The deepest points of C1 and C3 cracks tend to move from the center line of the artificial crack to C2 crack. The crack growth curves of ST-2 test pipe along the deepest point and the centerline (90° direction) are shown in Fig.5.5.

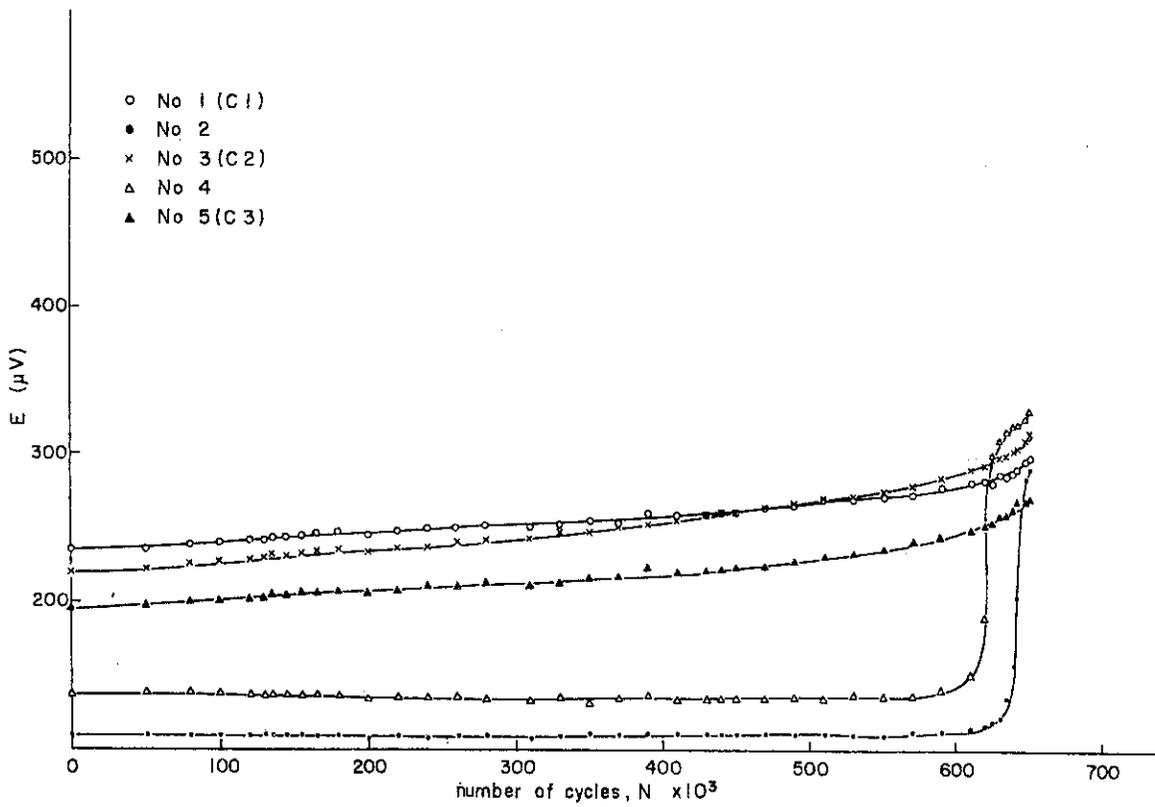
Fig. 5.6 Results of electric potential measurement (ST-1)

Figs.5.6 and 5.7 show the results of electric potential measurement. In these figures, No.2 and No.5 probes attached at the center between two cracks (No.2 probe at the center between C1 and C2 and No.4 probe at the center between C2 and C3), show steep electric potential

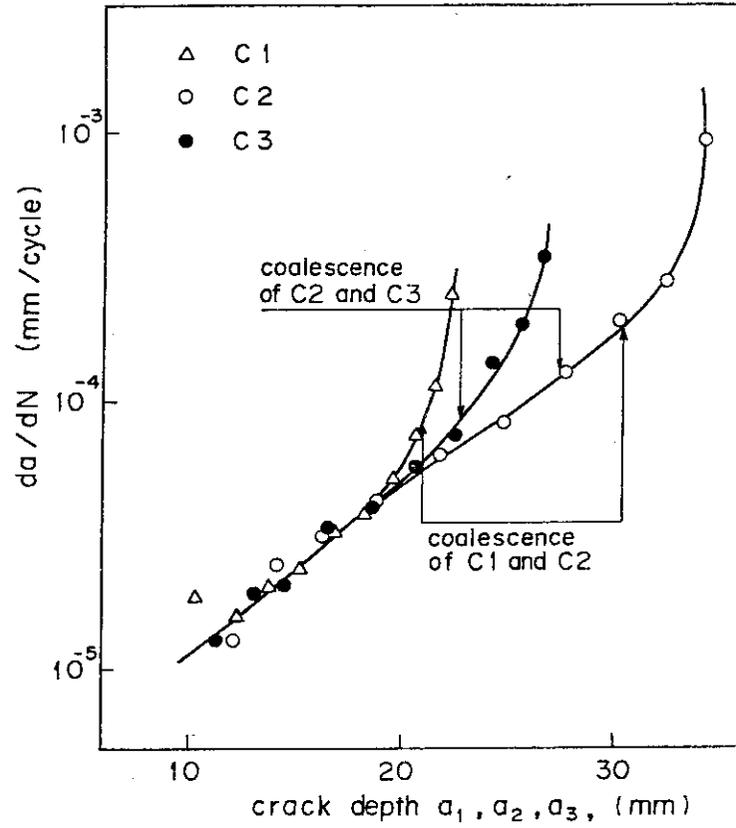
Fig. 5.8 da/dN vs. a curve (ST-1)

The crack growth rate of each crack of ST-1 test pipe along the radial direction was obtained from the beach mark spacing. Fig.5.8 shows the relationship between da/dN and crack depth, a , of each crack. As shown in this figure, each curve shows good agreement till the cracks grow to the depth of 18 mm, and the difference is caused among three curves when they are closer with growth of each crack front in the inner surface.

The influence of the crack coalescence on da/dN vs. a curves seems to be the largest for C1 crack, because the crack growth rate of C1 crack is larger than that of C2 and C3 cracks and they have almost the same crack growth rate as shown in Fig.5.8.

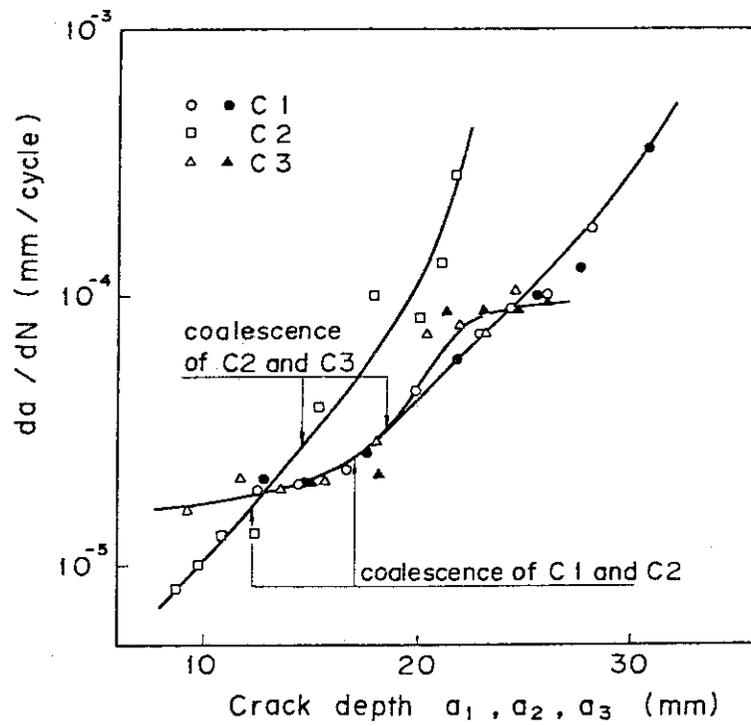
Fig. 5.9 da/dN vs. a curve (ST-2)

As shown in Fig.5.9, the relationship between da/dN and the crack depth, a , of ST-2 test pipe is somewhat different from that of ST-1. As shown in Fig.5.2, the crack growth of C1 and C3 cracks is larger than that of C2 crack. Consequently the crack growth behavior of ST-2 test pipe is different from that of ST-1 after three cracks coalesce.

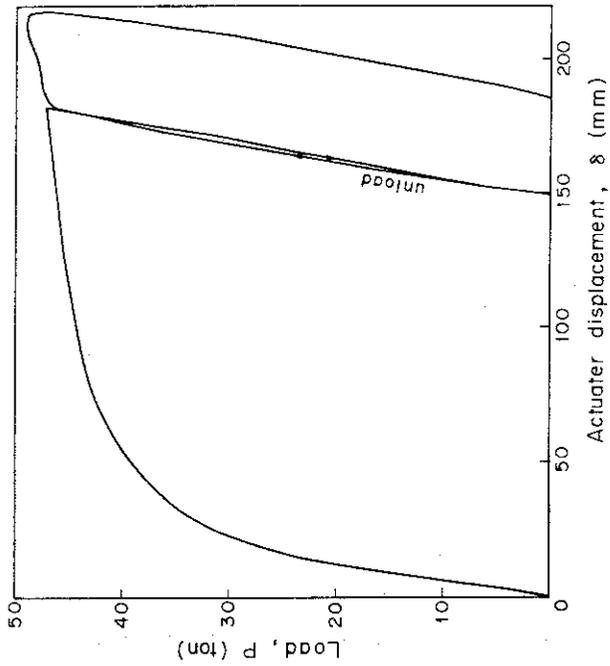
Fig. 6.7 Load vs. displacement curve (ST-1)

Figs.6.7 and 6.8 show the relationship between load and displacement of the gage (D4) and the hydraulic actuator of ST-1 test pipe. It is evident from these figures that both the curves are almost identical and the deformation of the loading apparatus is negligible.

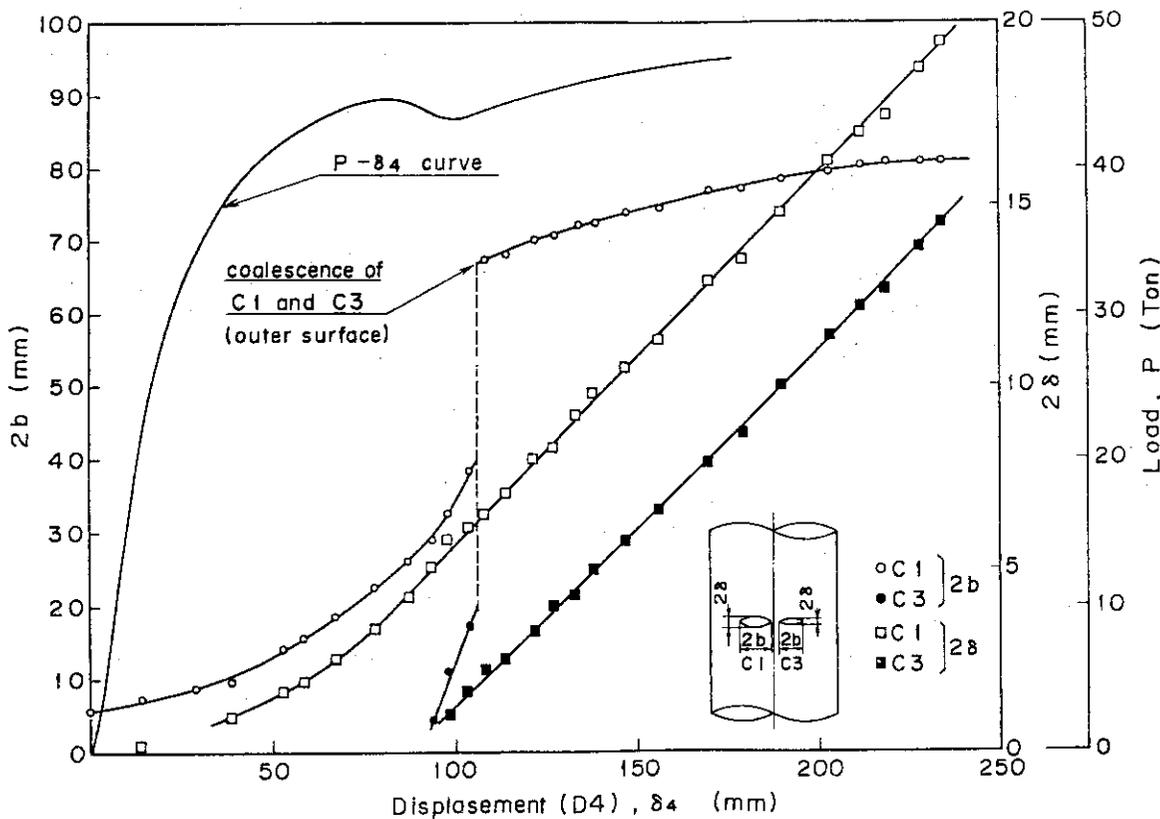
Fig. 6.12 Result of crack size and COD measurement of the outer surface in the fracture test

It is known from Fig.6.12 that the cracks coalesce in the outer surface and the crack becomes a large penetrated one over the displacement, $\delta = 100$ mm. In this displacement the crack extension is low, whereas the increase of crack opening displacement is almost linear with the displacement, and the progress of deformation is very large. This behavior is almost the same with ST-1 test pipe. The load vs.

displacement curves of the ST-1 and ST-2 test pipes show a tendency that the load is still increasing when the displacement is more than 200 mm. Allowable load of the faulted condition defined in the Section III, Appendix F of ASME Code is 46.8 ton ($3 S_m$) for the test pipes, and the test results of ST-1 and ST-2 test pipes indicate that they have enough strength and toughness for this allowable load, even though a large crack exists in the inner surface of the pipe.

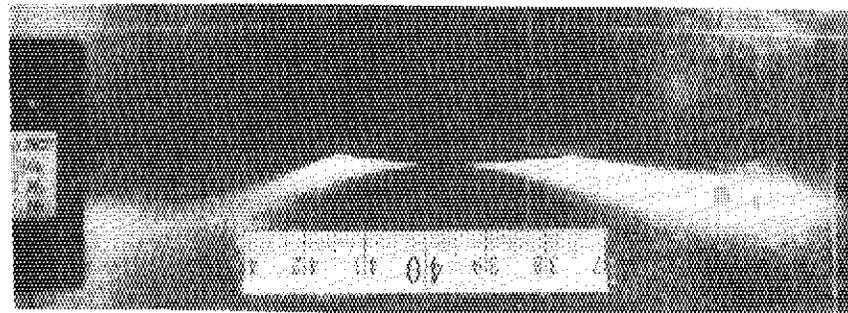
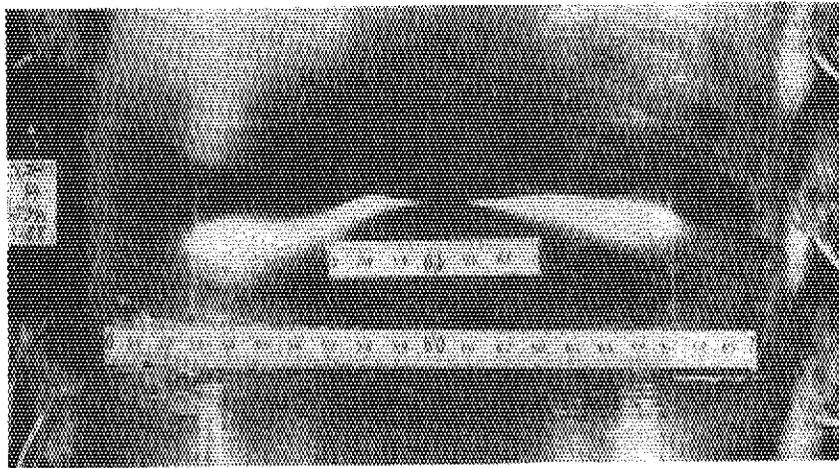
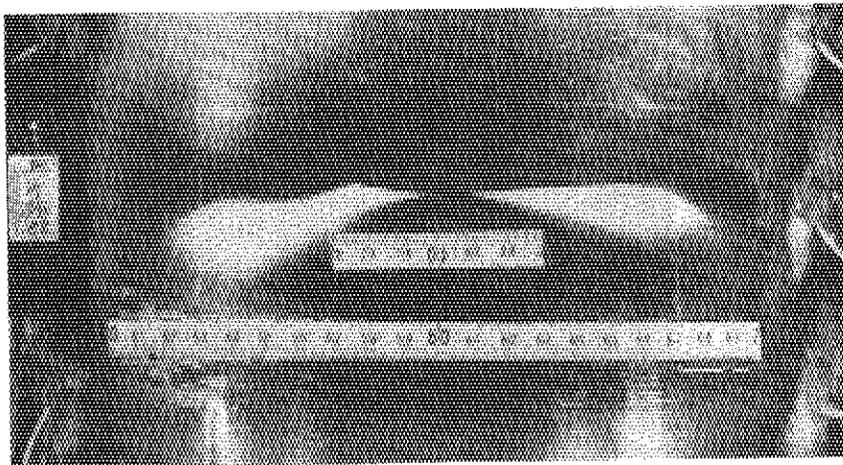
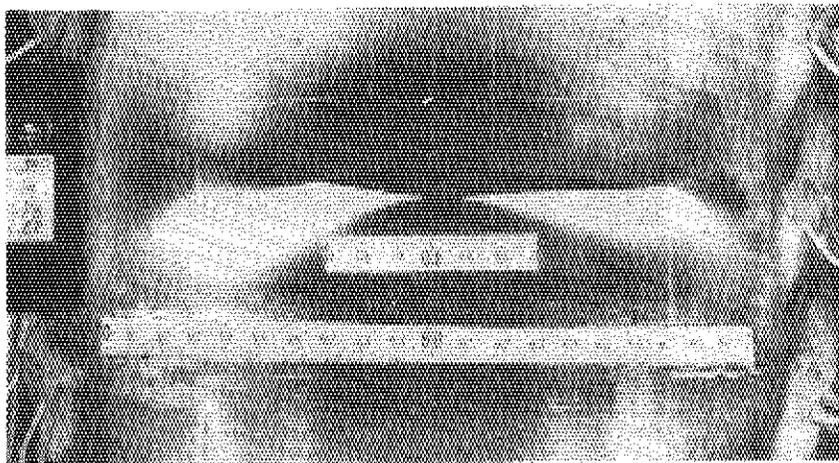
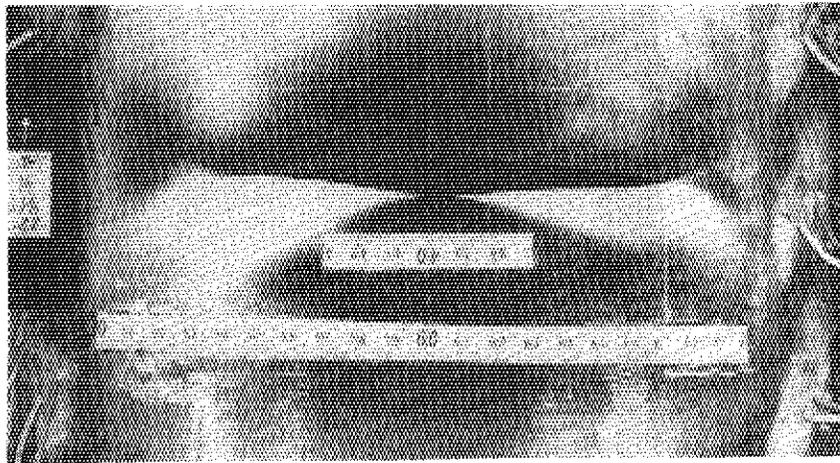
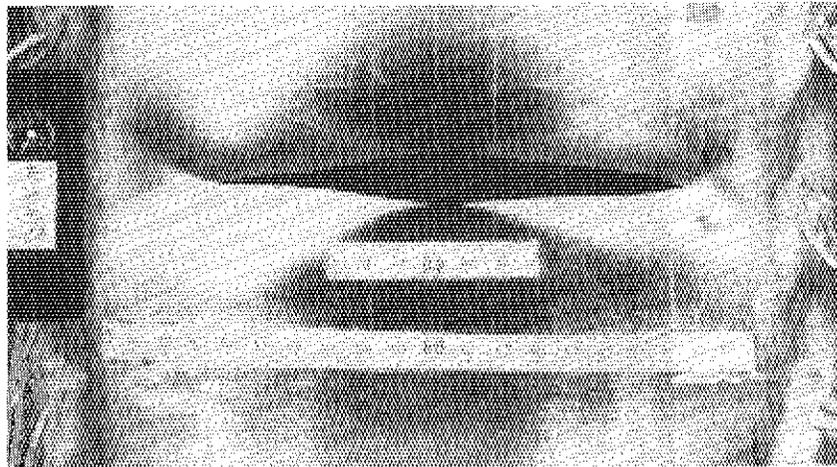
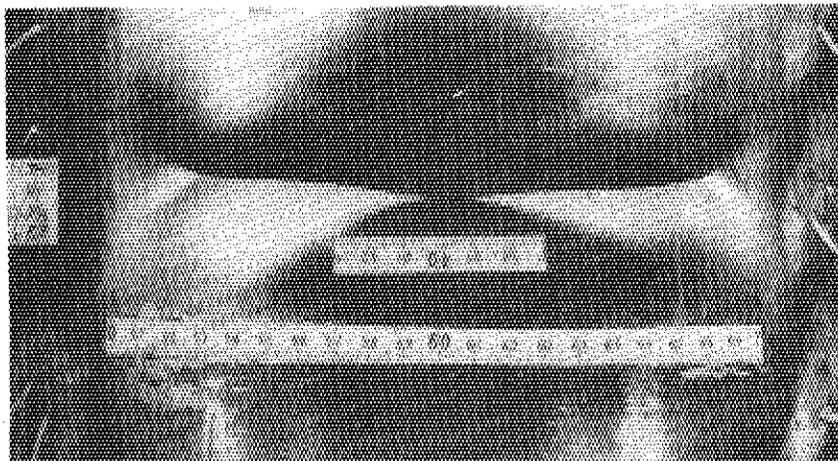
Photo. 6.1 State of the crack extension during fracture test (ST-1) (1/4)

In the fracture test the crack penetrated locally at the end of the fatigue test extends gradually to the circumferential direction at the outer surface of the test pipe. This crack extension was observed by photographs as shown in Photos.6.1 and 6.2.

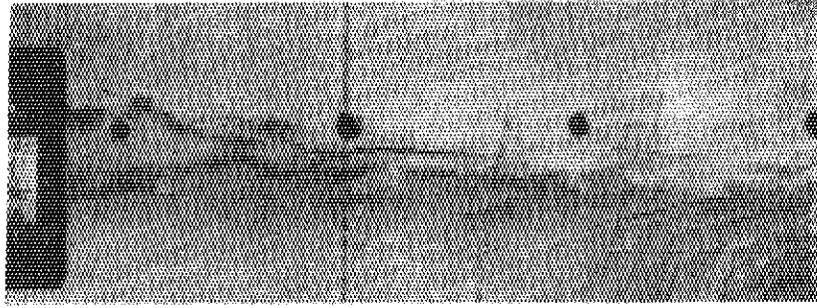
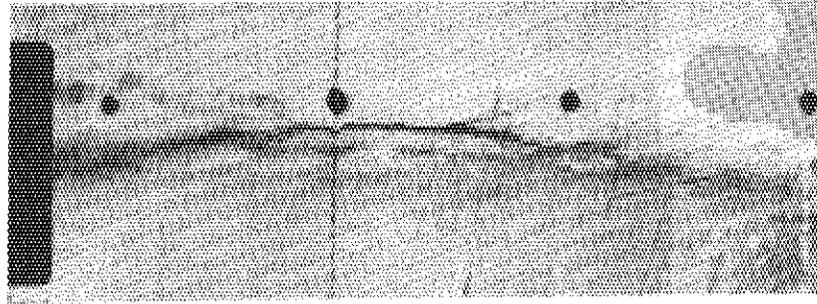
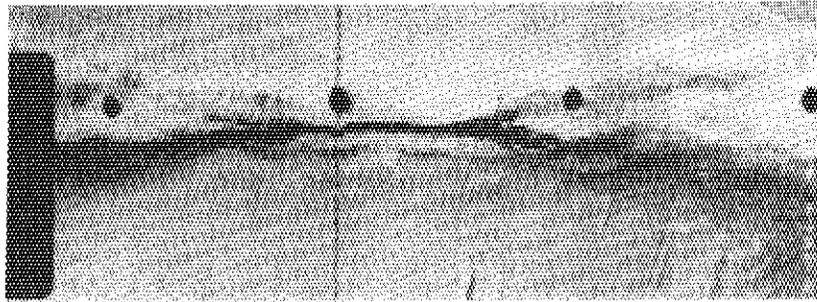
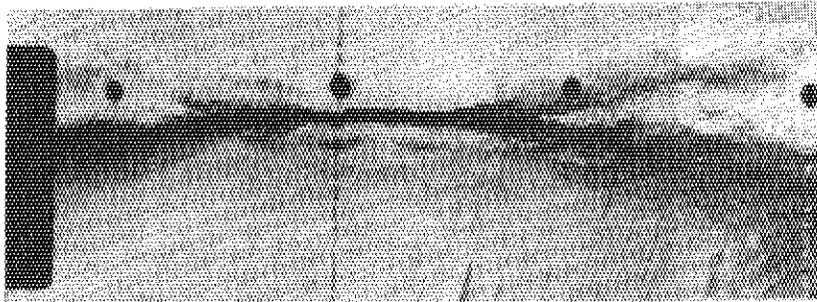
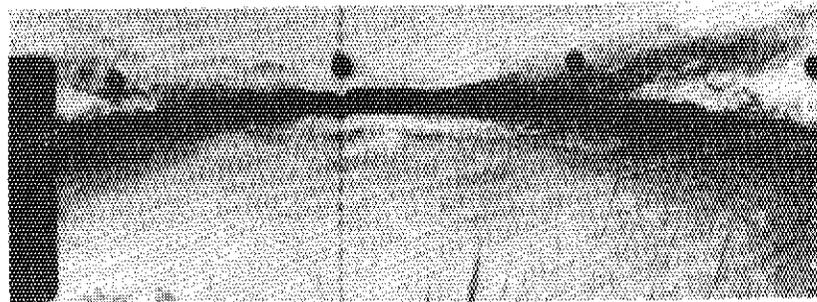
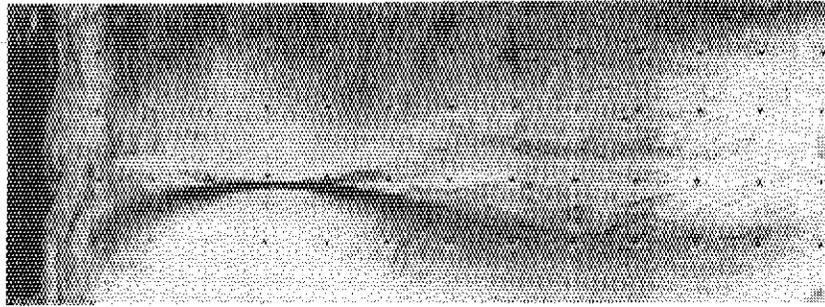
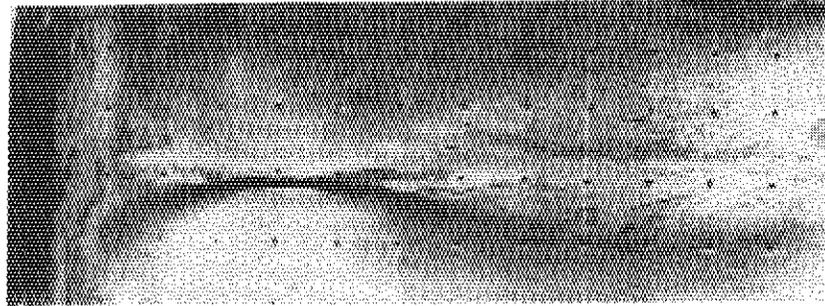
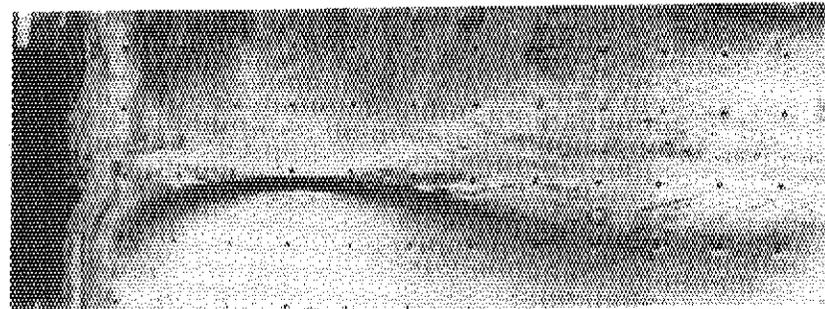
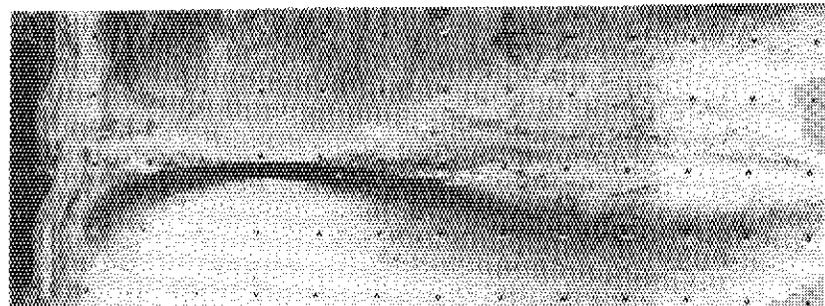
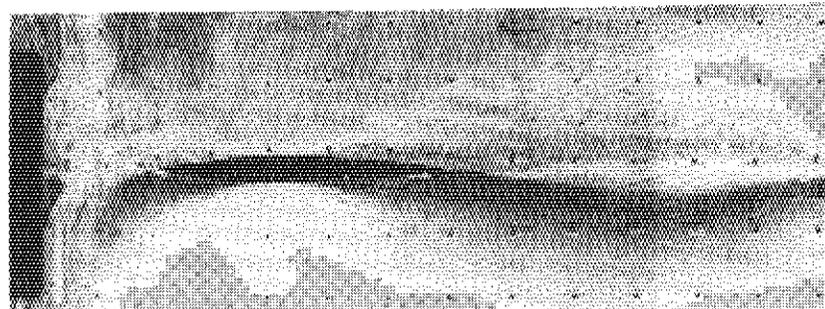
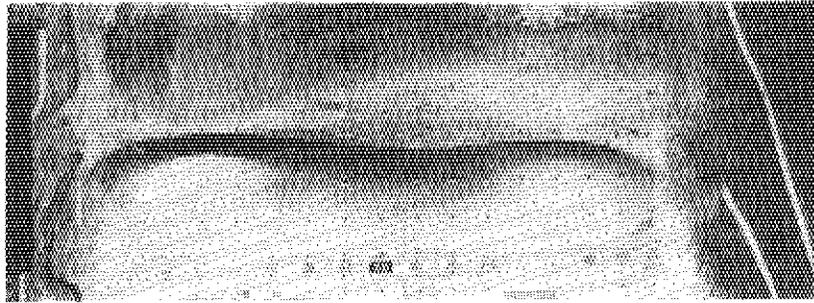
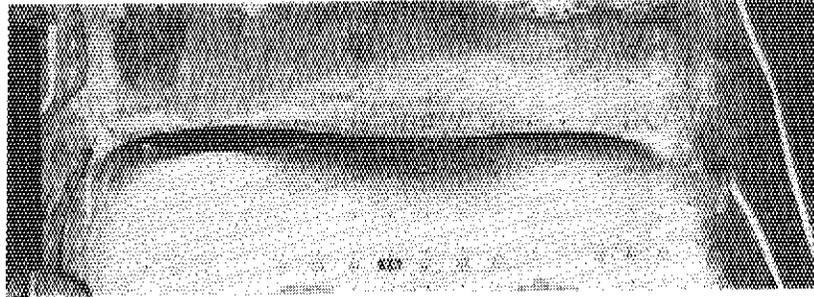
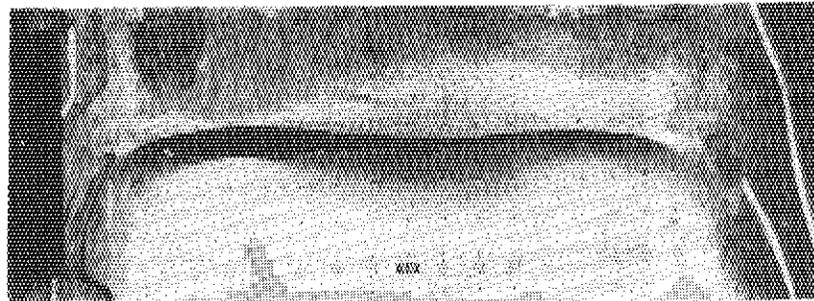
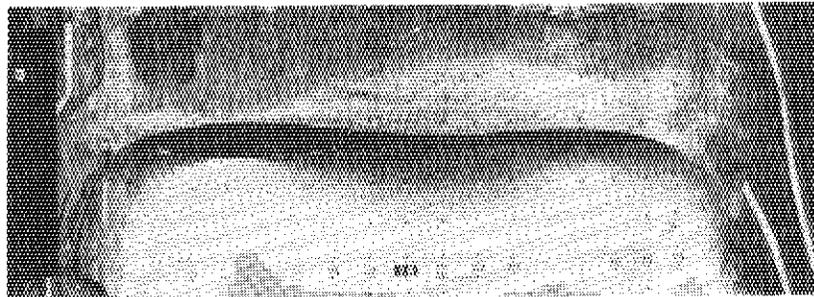
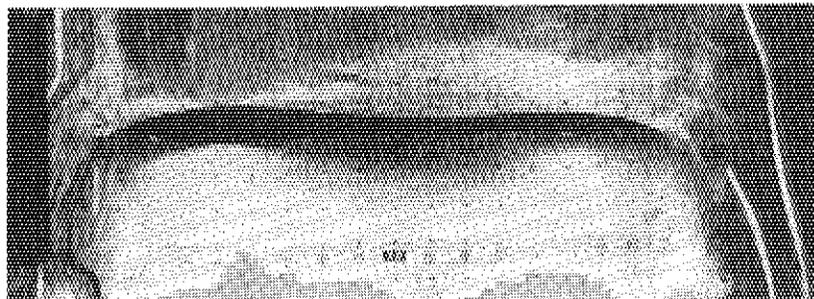
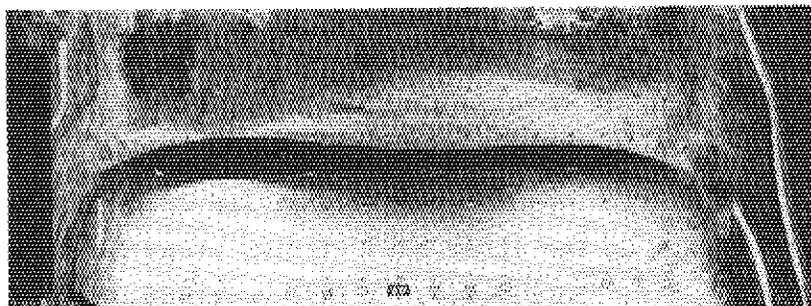
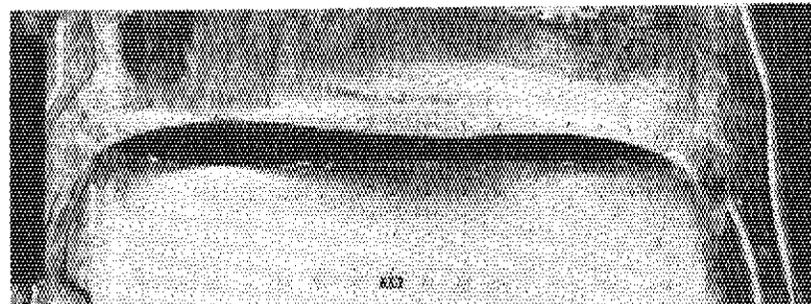
Photo. 6.2 State of the crack extension in the fracture test (ST-1) (1/4)

In case of ST-2 test pipe a secondary crack penetration is caused at the C3 side as shown in Photo.6.2. Subsequently two cracks extend to circumferential direction and coalesce in the outer surface. These crack extension and coalescence are caused while the applied load is locally decreasing. This means that an unstable crack extension is caused though it is quite local.

When the load is more than 45 ton, the crack extension is low, but the crack opening displacement is very high, as shown in Photo.6.2.
