# 「常陽」MK-II炉心燃料(PFD001)の 照射後試験(2)

燃料要素の組織観察及び機器分析  
(Vol. 2 データ編)

技術資料コード	
開示区分	レポートNo.
T	N9410 87-189 Vol.2

動力炉・核燃料開発事業団  
大洗工学センター

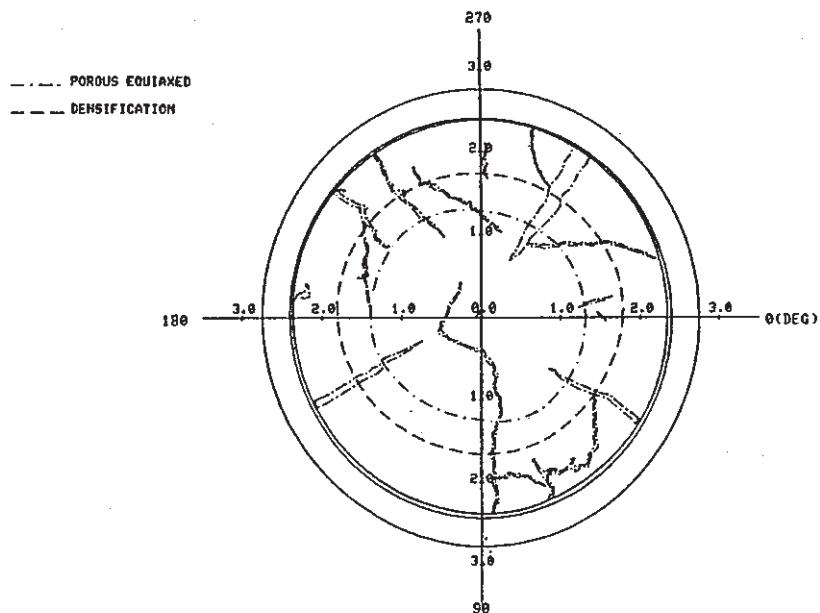
Fig. 1 A Transverse Section of a Core Fuel Pin  
Illustrated by PINATD (Specimen No. 815226)

輪切り試料、815226, 815244, 815262, 815282につき、タブレット・ディジタイザーで描いた燃料ピン断面図をそれぞれFig.1, 6, Fig.12及びFig.17に示す。この図をもとに各試料につき円周方向の被覆管内径、外径、ペレット外径（直径値）をそれぞれFig.2, Fig.8, Fig.13及びFig.18に示す。同じくギャップ幅をFig.3, Fig.9, Fig.14及びFig.19に示す。高密度化領域、ガスバブル領域の直径値をFig.4, Fig.10, Fig.15及びFig.20に示す。なお試料No.815244の中心空孔径、柱状晶領域の直径値は、Fig.7とFig.10に示す。クラック面積がペレット面積に占める割合をFig.5, Fig.11, Fig.17及びFig.21に示す。

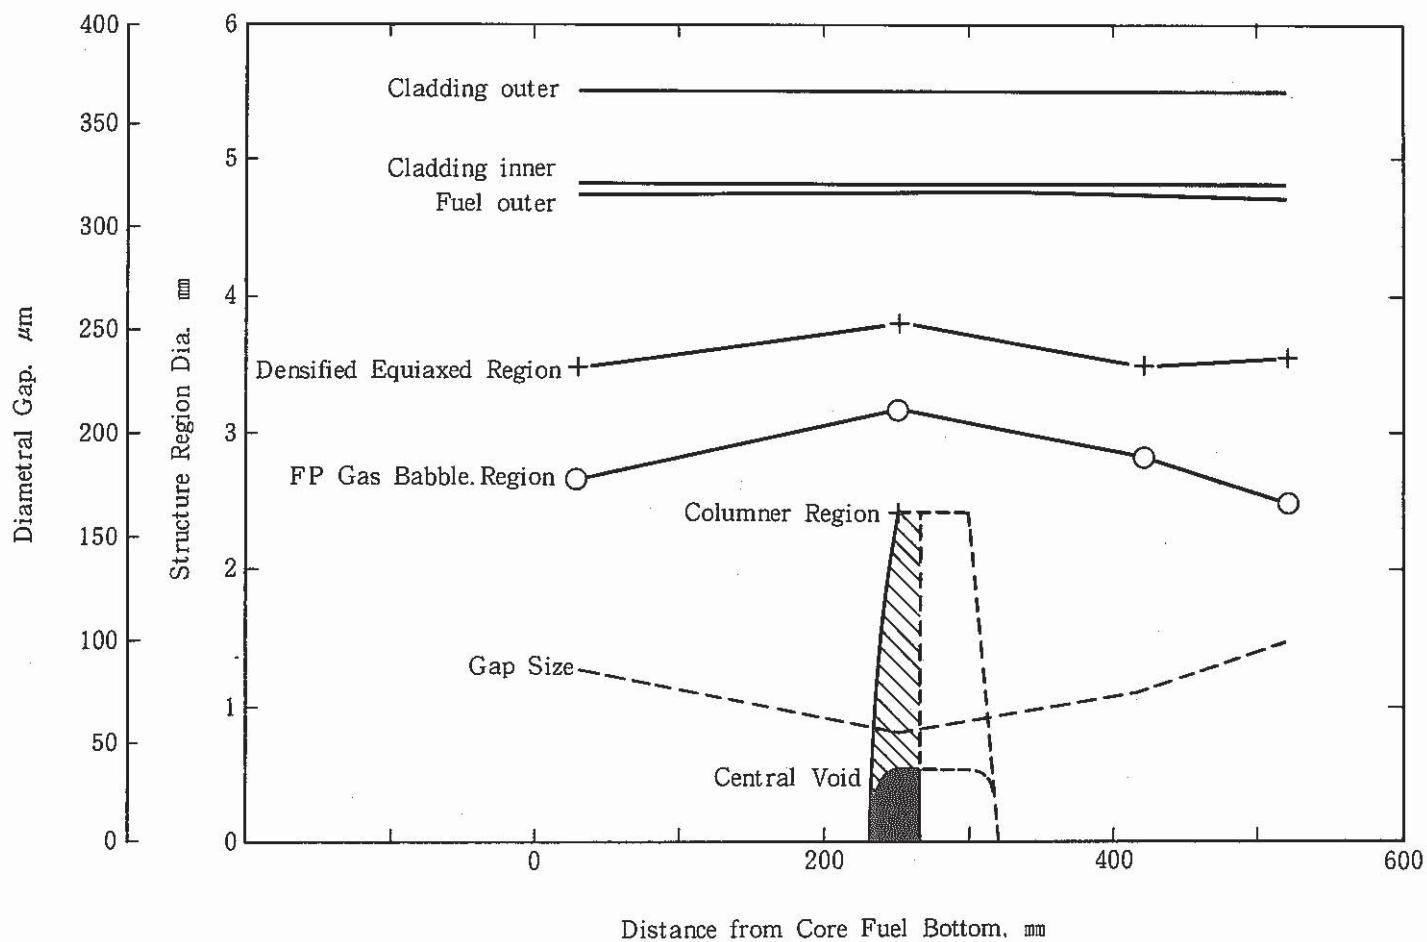
Fig. 22 Axial Profile of the Gap and Fuel Structure

これらの値から各試料につき各領域径を0°～180°の平均値で整理した表をTable.1に、またピン軸方向位置に対応させたものをFig.22に示す。

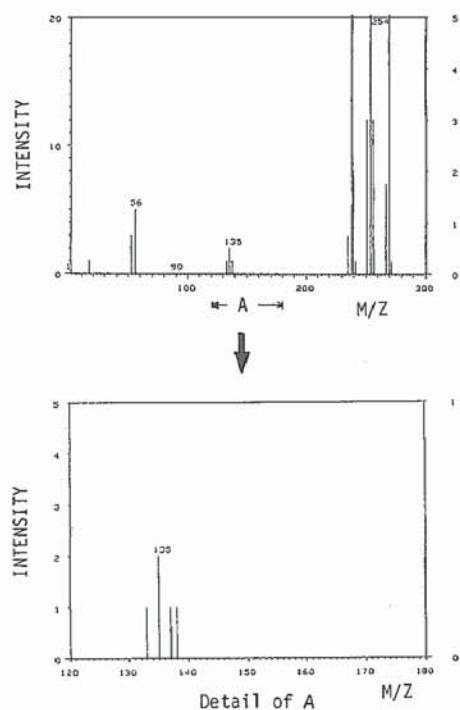
Fig. 28 Ion Mass Spectrum of the Fuel-Cladding Interface (Specimen No. 815226)

燃料-被覆管境界部（イオンビーム径  $150 \mu\text{m} \phi$ ）の質量スペクトルを Fig. 28 に、燃料半径方向中間部（イオンビーム径  $1 \text{ mm} \phi$ ）の質量スペクトルを Fig. 29 に示す。燃料-被覆管境界部では、 $^{135}\text{Cs}$ ,  $^{133}\text{Cs}$ ,  $^{137}\text{Cs}$ ,  $^{138}\text{Ba}$  が検出される。燃料中間部では、質量数 90, 138 及び 160 近辺にピークが観察される。但し、160 近辺のピークについては、140 近辺の希土類元素の一酸化物と思われる。

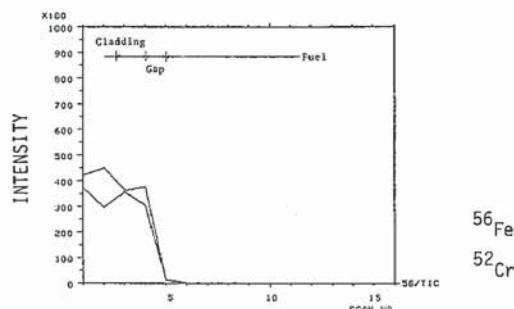
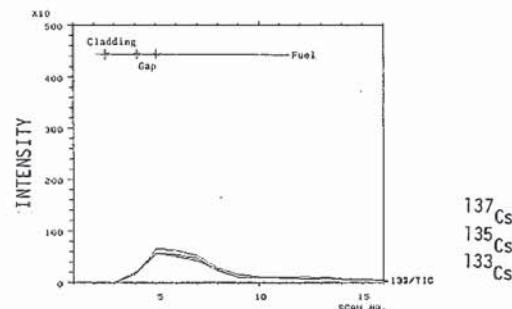
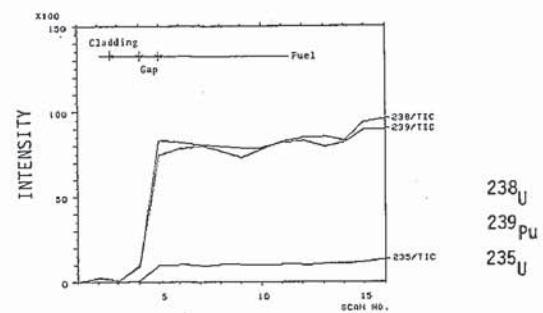
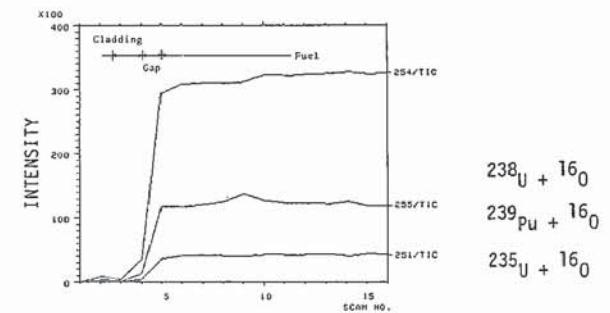
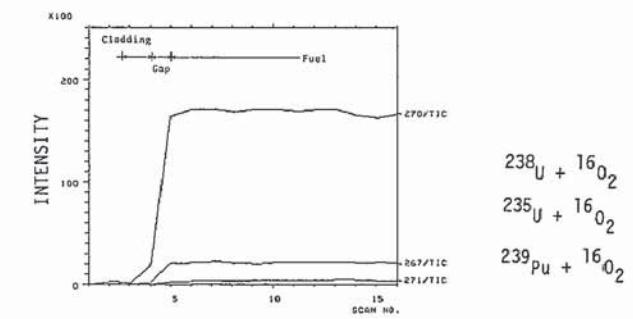
次に、イオンビーム径  $150 \mu\text{m} \phi$  で被覆管外側より燃料中央部まで連続スキャンを行うことにより、各核種のペレット径方向分布を求めた。 $^{56}\text{Fe}$ ,  $^{52}\text{Cr}$ ,  $^{137}\text{Cs}$ ,  $^{135}\text{Cs}$ ,  $^{133}\text{Cs}$ ,  $^{238}\text{U}$ ,  $^{239}\text{Pu}$ ,  $^{235}\text{U}$ ,  $^{238}\text{U} + ^{16}\text{O}$ ,  $^{239}\text{Pu} + ^{16}\text{O}$ ,  $^{235}\text{U} + ^{16}\text{O}$ ,  $^{238}\text{U} + ^{16}\text{O}_2$ ,  $^{235}\text{U} + ^{16}\text{O}_2$ ,  $^{239}\text{Pu} + ^{16}\text{O}_2$  に関する測定結果をそれぞれ Fig. 30～34 に示す。

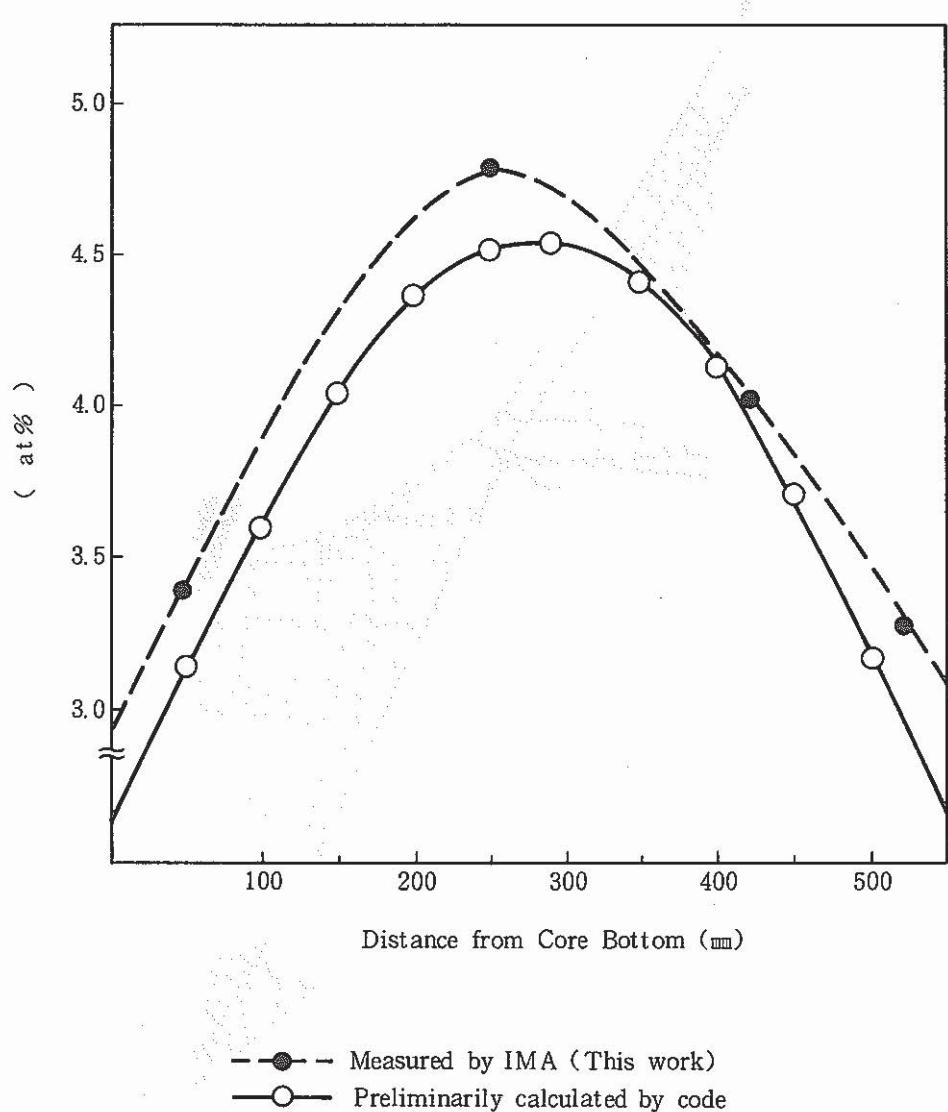
Fig. 49 Axial Distribution of Measured Burnup  
of PFD001 (Pin No. 8152)

IMA 測定より求めた燃焼度と計算値を、燃料ピン軸方向位置に対してプロットしたグラフを Fig. 49 に示す。

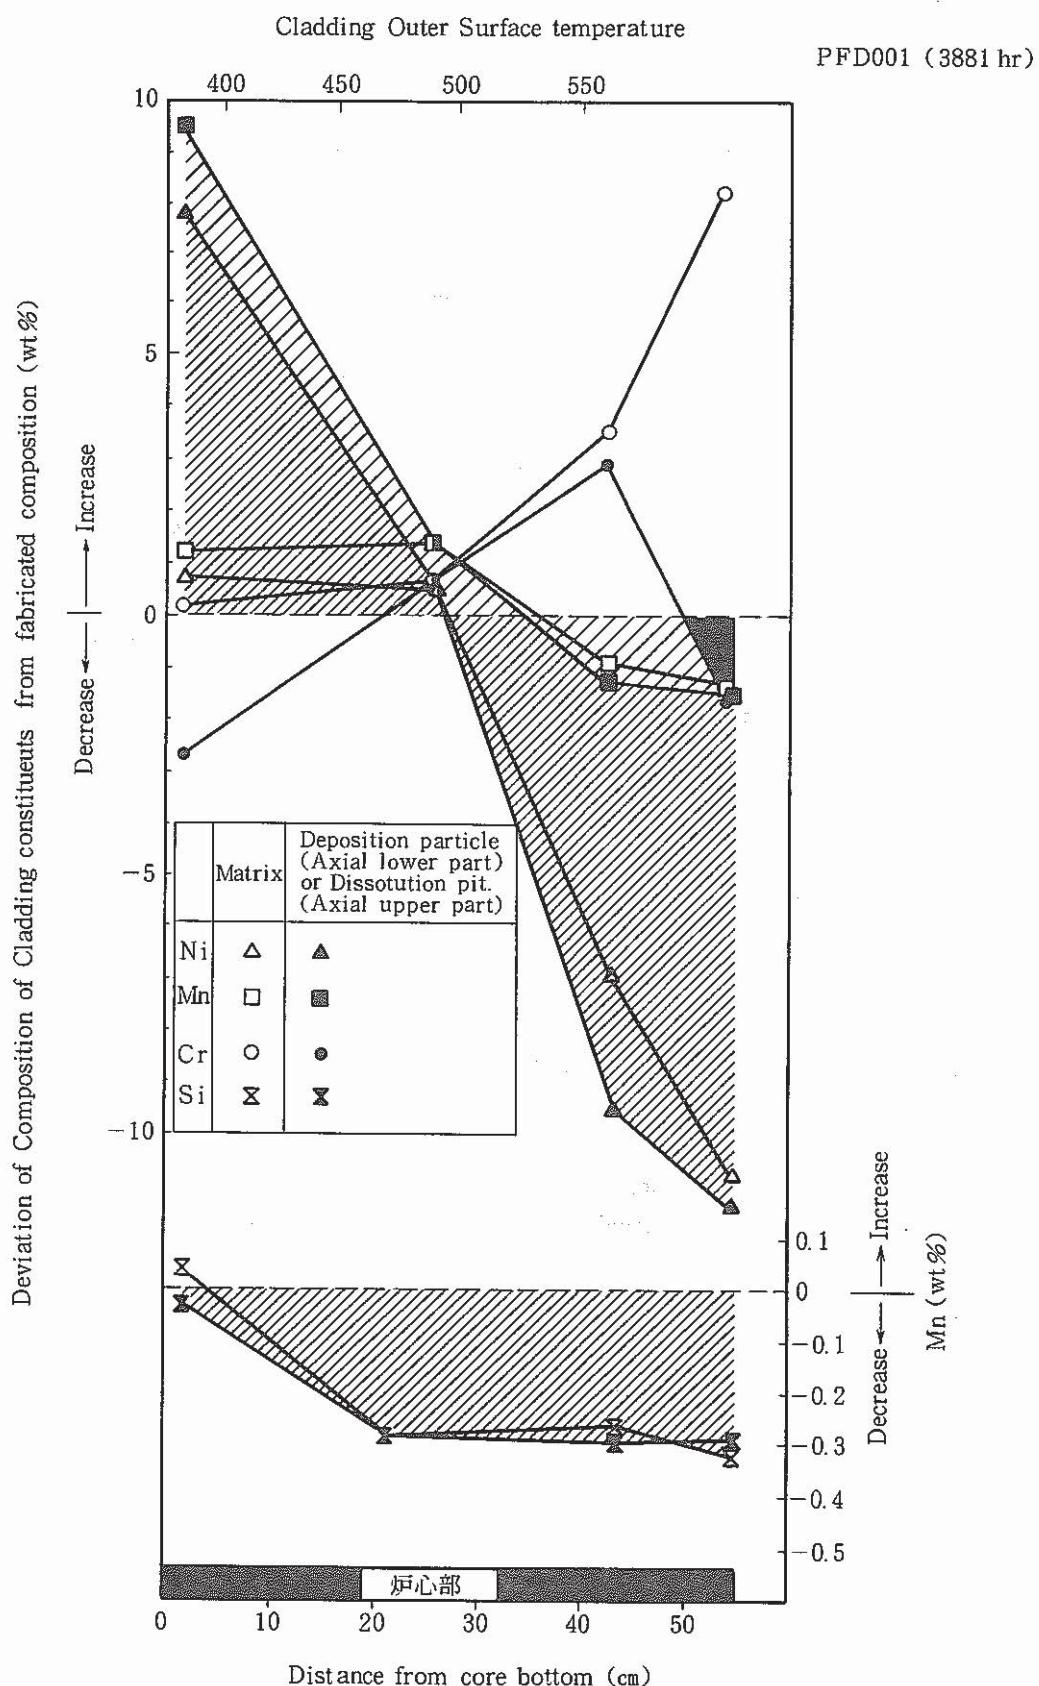
**Fig. 50** Composition Change of Cladding Constituents as a Function of Distance from Core Bottom and Cladding Outer Temperature

燃料部軸方向各位置から採取した被覆管外表面試料につき、EPMPによる定量分析を実施した。Fig. 50に下端からの位置に対して、各元素の表面組成を製造時組成からの増減(wt%)でプロットした関係を示す。炉心中心から下側の低温部で認められた微粒子は、Mn, Ni が高濃度化したものであり、母材でも若干 Mn, Ni 濃度が高くなっていることがわかる。炉心中心の中温部では、組成の変化は少ない。一方、炉心中心から上側の高温部では、逆に Mn, Ni が溶出し、低濃度化していることがわかる。炉心上端では、Crの溶出も認められる。また、Si は、炉心全域から溶出している。

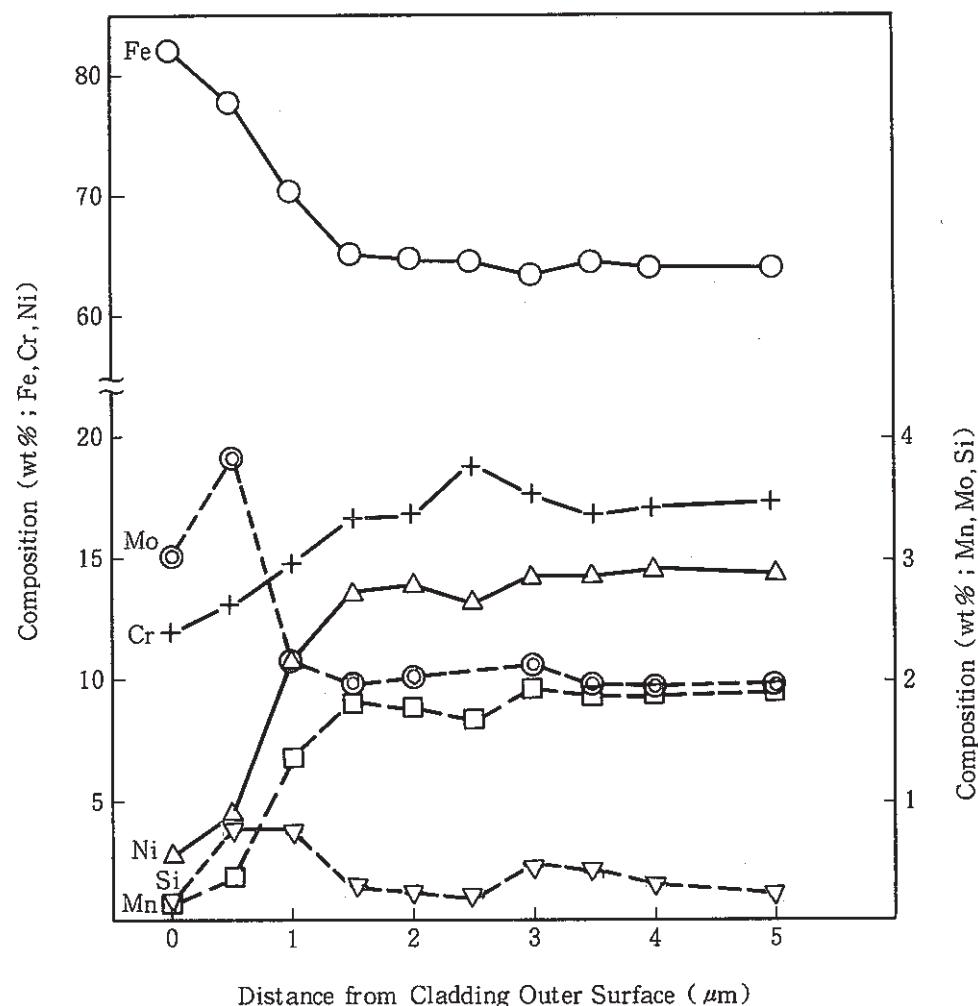
Fig. 51 Results of Line Analyses Across the Transverse Section Sample (No. 815284)

次に、被覆管表面温度が最も高い試料（No. 815284）の試料につき、被覆管の横断面試料を作製し、表面から  $5 \mu\text{m}$  の深さまでの定量線分析を行った。その結果を Fig. 51 に示す。一方、IMAにより被覆管外表面からスパッタを繰り返すことにより、深さ方向の各元素の定量分析を行った結果を Fig. 52 に示す。これらの結果から、Ni, Mn, Cr の溶出が生じている領域は表面から約  $1.5 \mu\text{m}$  の範囲の極く表面層に限られていることがわかる。

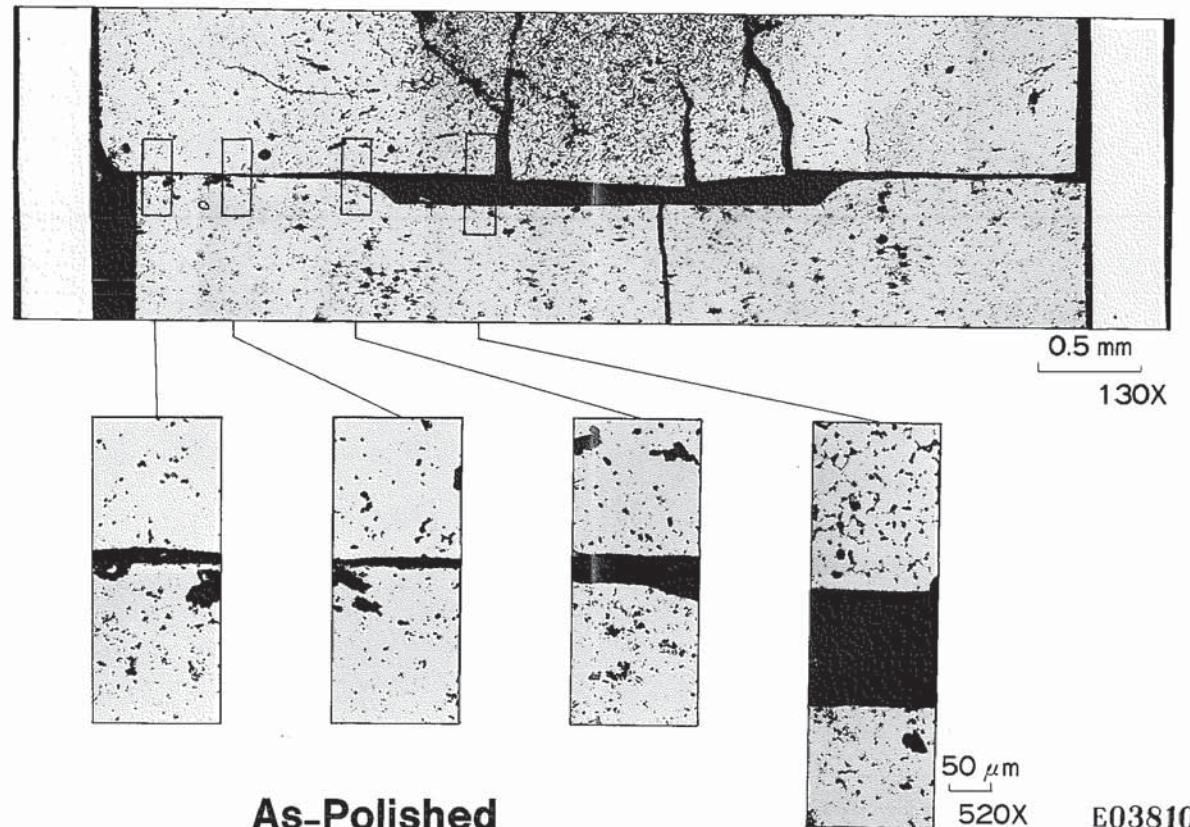
Photo.0-3 Optical Microstructure of the Core and Blanket Fuel Pin  
(Specimen No. 815223) As-Polished

本試料は, 下部インシュレータペレットを含む縦断面試料であり, Photo. 0-2, 3 に As-Polished 状態における光顕写真を示す。インシュレータペレットは, 軸方向に長いクラックが入っているが燃料組織は, 製造時とほとんど変化がなく, ディッシュ部もそのまま観察される。炉心燃料ペレットは, FP ガスバブル領域, 高密度化領域, 製造時領域の三層に区分される。また被覆管についても内外面共に異状は認められない。

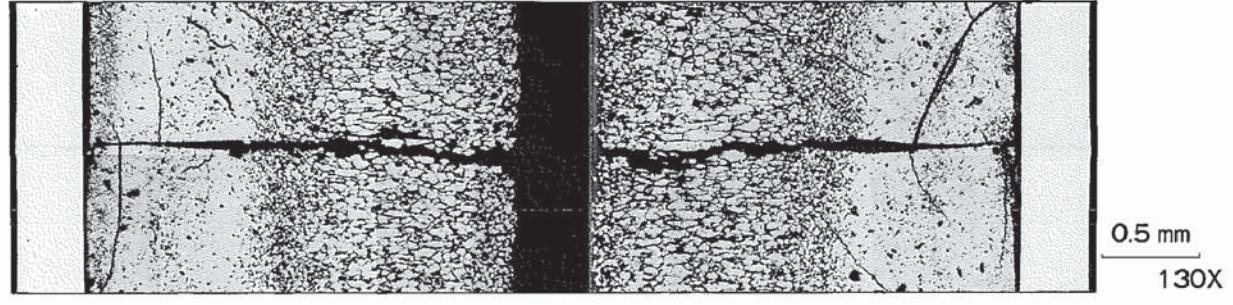
Photo.0-7 Optical Microstructure of the Core Fuel  
(Specimen No. 815243) As-Polished

Photo. 0-6, 7 に As-Polished 状態における光顕写真を示す。燃料組織は, 中心空孔, 柱状晶領域, FP ガスバブル領域, 高密度化領域, 製造時領域の五層から成っている。Bottom 側で中心空孔が細くなり, 本試料において中心空孔の軸方向下端が現われていることがわかる。ペレット-ペレットの境界部が 2ヶ所観察され, 境界部付近の被覆管には, 若干の腐食と FP 等が観察される。白色析出物は, 中心空孔内壁から柱状晶, 高密度化領域に多く観察され, 製造時領域では, ほとんど見られない。

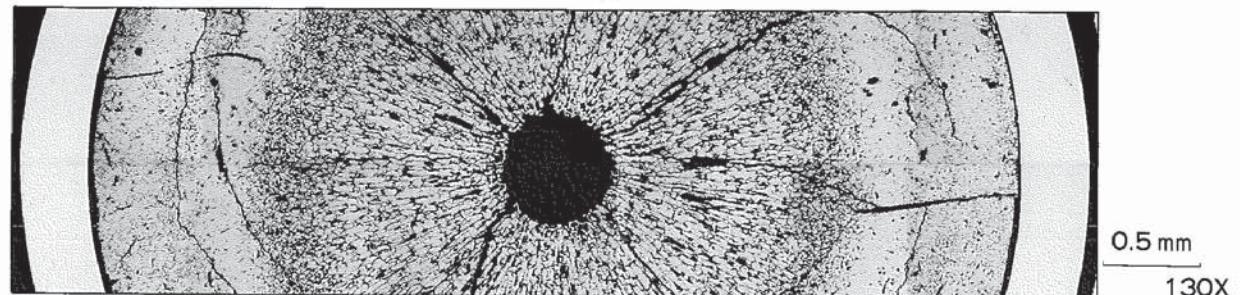
Photo.0-9 Optical Microstructure of the Core Fuel  
(Specimen No. 815244) As-Polished

本試料は, 炉心燃料部軸方向中心部の輪切り試料であり, その As-Polished 状態及び Etched 状態における光顕写真をそれぞれ Photo. 0-8, 9 と Photo. 0-17, 18 に示す。燃料組織は試料 No. 815243 と同様で, それらの領域はほぼ同心円状になっている。中心空孔の大きさは, 直径約 0.56mm で PFD003 の 0.43mm より成長している。また, 柱状晶長短軸比は, PFD003 の 3.3 : 1 に対し, 本試料では, 6.9 : 1 と約 2 倍になっている。白色析出物は, 中心空孔内壁から高密度化領域にかけて多く観察され, 中心ほど粒径が大きい。また燃料-被覆管ギャップ内に局部的に FP 等が観察され, 一部全面腐食も観察される。

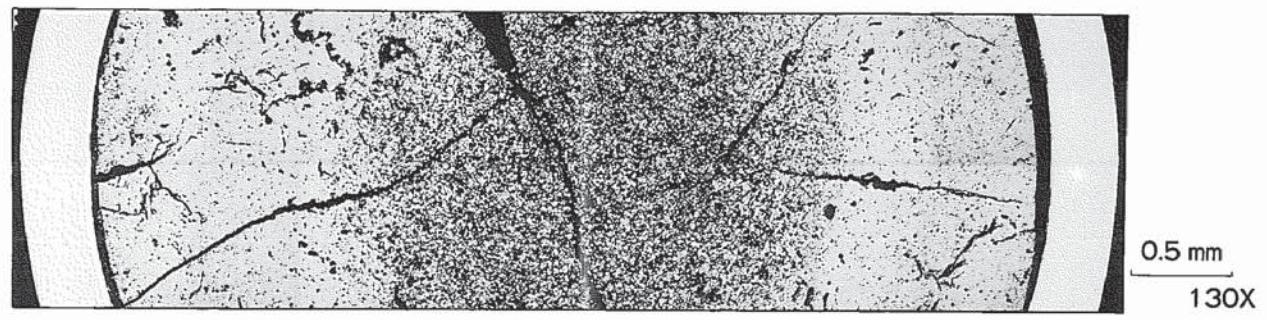
Photo.0-13 Optical Microstructure of the Core Fuel  
(Specimen No. 815282) As-Polished

本試料は、炉心燃料上端部の輪切り試料であり、As-Polished及びEtched状態における光顕写真をそれぞれPhoto.0-12, 0-13とPhoto.0-21, 0-22に示す。燃料組織、白色析出物は、試料No.815226とほぼ同様である。被覆管内面は、ほぼ全面に渡り剥離（全面腐食）し、特にギャップ幅が広い所及びクラック開口部付近は剥離が著しい。またクラック開口部付近には、FPが多く観察される。

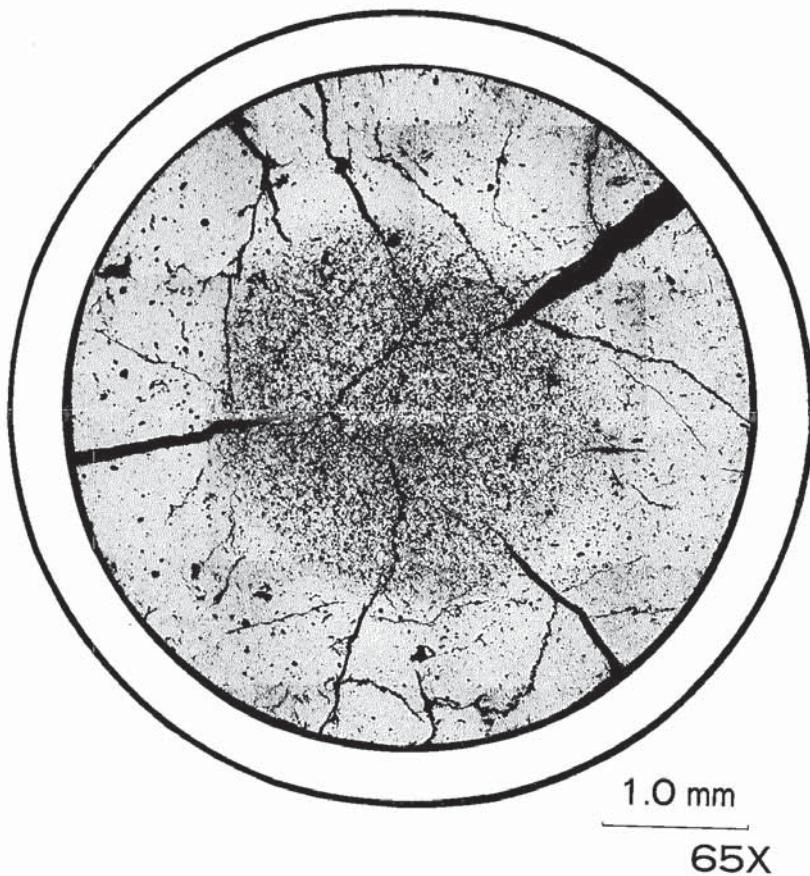
Photo.0-15 Optical Micrograph of the Transverse Section of the  
Core Fuel Pin (Specimen No. 815226) As-Etched

本試料は, 炉心燃料下端部の輪切り試料であり, As-Polished 状態及び Etched 状態における光顕写真をそれぞれ Photo. 0-4, 5 と Photo. 0-15, 16 に示す。燃料組織は, ピン中央から FP ガスバブル領域, 高密度化領域, 製造時領域からなる。クラックは, 外周部で広く, 中心部で狭いクサビ形である。
