# Irradiation Test Progress for the ITER Maintenance Robot

Y. Noguchi, K. Anzai, H. Kozaka, A. Aburadani, M. Kazawa, N. Takeda, S. Kakudate,  
Division of ITER Project, Directorates of Fusion Energy Research, JAEA

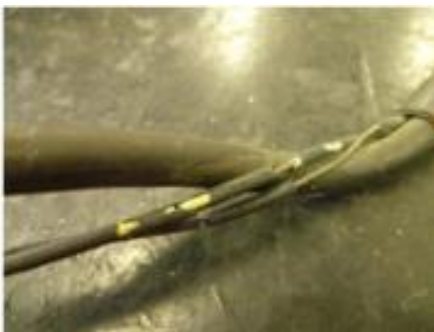
3) Improved components  
In [3], new AC servo motors were developed and showed high radiation tolerance. However this turned out to be too expensive. We are modifying commercial AC servo motors to reduce the manufacturing cost. Preliminary radiation tests of the commercial AC servo motors have been done at the Takasaki Advanced Radiation Research Institute. The total dose was 8 MGy and the dose rate was 500 Gy/hr. Then it was found that the motors fail because of failures in the insulation. Figure 2 shows the brake cable after being irradiated. The outer cable jacket made of Polyolefin cracked and the cable insulation made of ETFE (yellow) peeled partially and the bare conductor cable was exposed. Thus the cable material was replaced from ETFE to polyimide for better radiation tolerance. The radiation tests are ongoing.

Figure 2. The brake cable after being irradiated
