Safety Operation of Tokai Reprocessing Plant

- Record of Oral Presentation at International Forum on Nuclear Safety -

TOKAI WORKS

POWER REACTOR AND NUCLEAR FUEL DEVELOPMENT CORPORATION

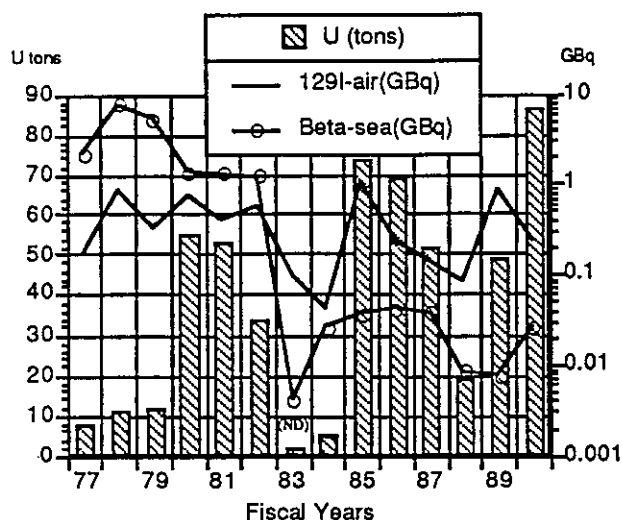
Figure 3. Activity Discharge

The sea discharge amount of β was reduced by additional installations of liquid treatment evaporators,

and atmospheric ^{129}I discharge is adequately controlled by installations of silver impregnated filters for iodine trap.(see Figure 3.)

Estimated annual effective dose equivalents are only less than 0.1 percent of the annual effective dose equivalent limit for the public recommended by the International Commission on Radiological Protection (ICRP) since the operation of the TRP was started in 1977.
